**Costelloe, Marina (2003) *Environmental review of the Mary Kathleen uranium mine*. Masters (Research) thesis, James Cook University.**

## Chapter 4 Tailings dam and evaporation ponds

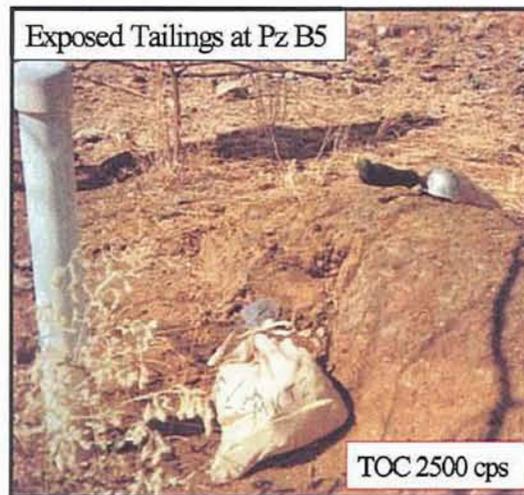
Tailings samples were taken near Piezometer 16 (MKT1 395806 E 7708073 N), Piezometer B5 (MKT2, Figure 4.3) and from a small gully near the NW corner of the tailings dam (MKT3). Tailings exposed at these former two areas cover approximately 1m x 1m and occur where the installation of piezometers in the 1980s caused minor spills. Tailings are very fine grained as processing reduced 55% of the ore to less than 75  $\mu\text{m}$  (MKU, 1982).

Figure 4.3. Photograph of tailings spill at Piezometer B5 (Photographed 10-10-1999).

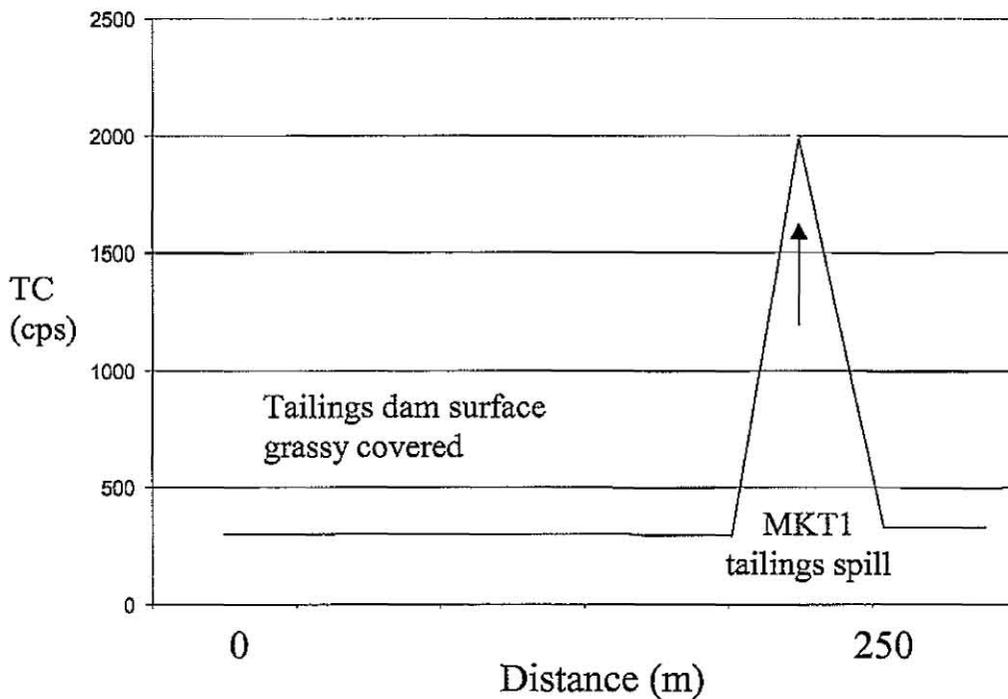
Tailings surface total count readings along traverse 9 averaged 300 cps which is below acceptable background levels (Figure 4.4). Elevated readings were recorded at the MKT1 sample site. Elevated radiation levels (up to 2500cps) were also recorded at 2 other small isolated areas (MKT2, MKT3). As previously discussed, these areas are the result of minor tailings spills.

Figure 4.4. Tailings dam surface total count (cps) traverse, including a brief description of surface features.

Unmineralised waste rock materials were used to construct the dry cover and surface readings (300 cps) are similar to those of soil covered waste dumps present at the mine site. Overall, the dam cover appears to attenuate radiation from underlying tailings.

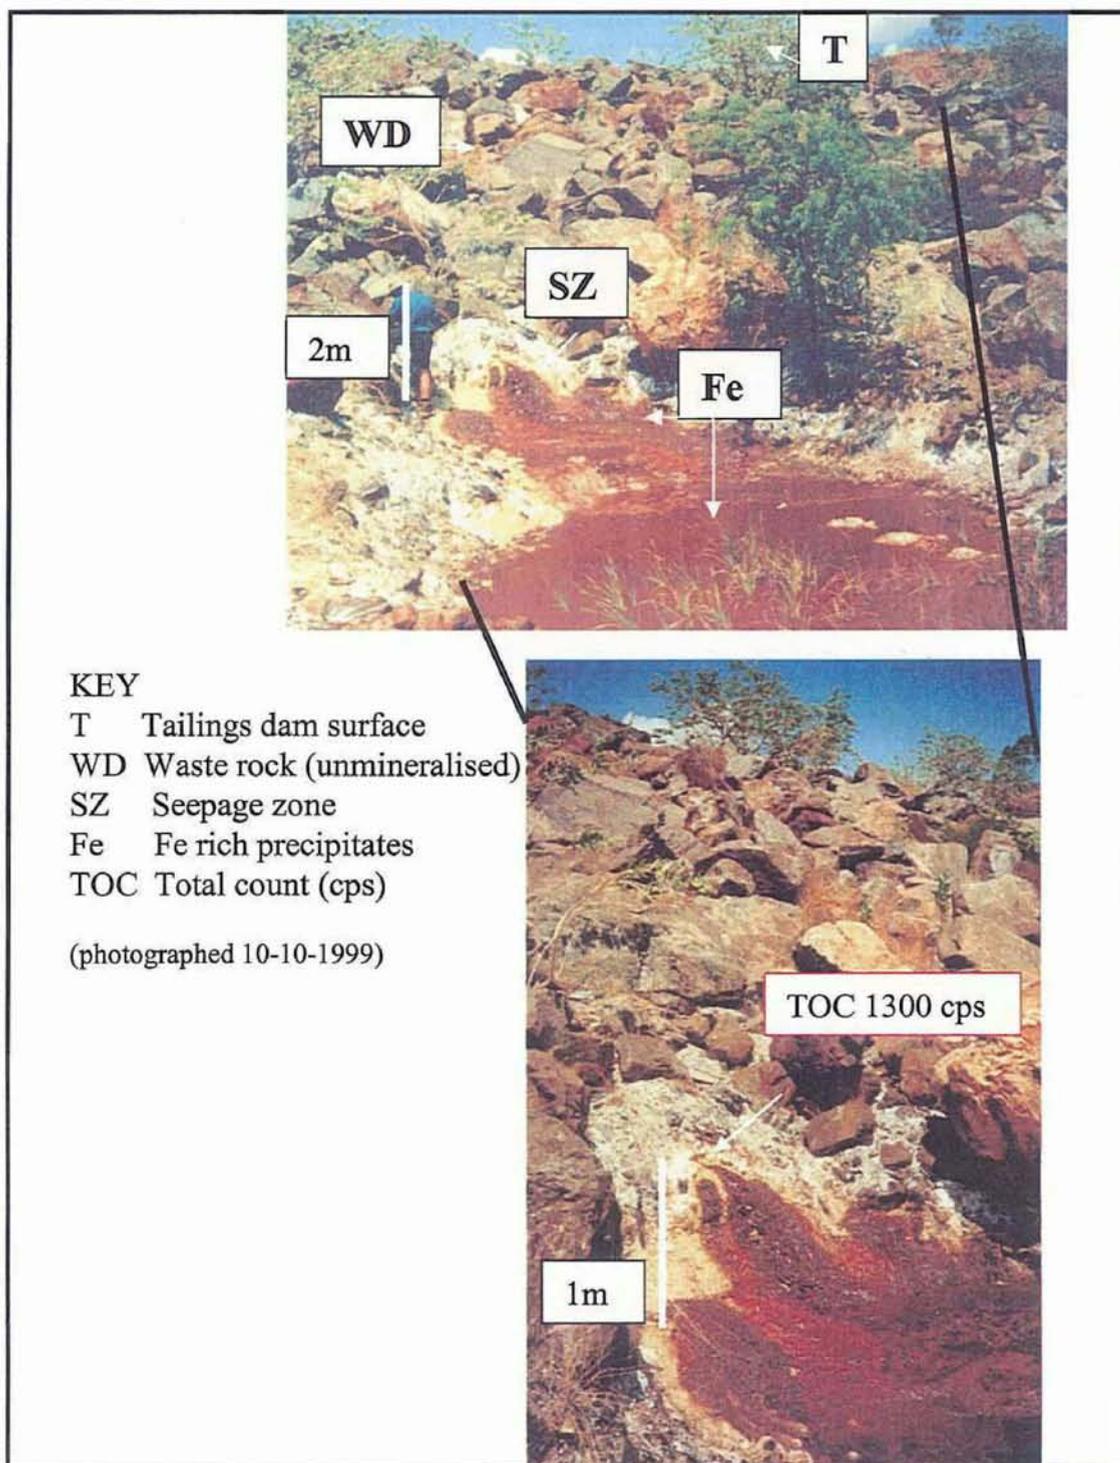
Tailings water seeps from the base of the tailings dam and flows toward the former evaporation ponds (Figure 4.4a and 4.4b).

Figure 4.4a. Photograph of tailings seepage area (395878 E 7708353 N)

The seepage water is acidic (pH 5.7), saline (0.31 %) and radioactive (TC 1300 cps) with low dissolved oxygen (2.6 mg/L) and emanates at a rate of approximately 0.5 L/s. Field water quality measurements from the seepage point toward the evaporation pond area are listed in Table 4.6.

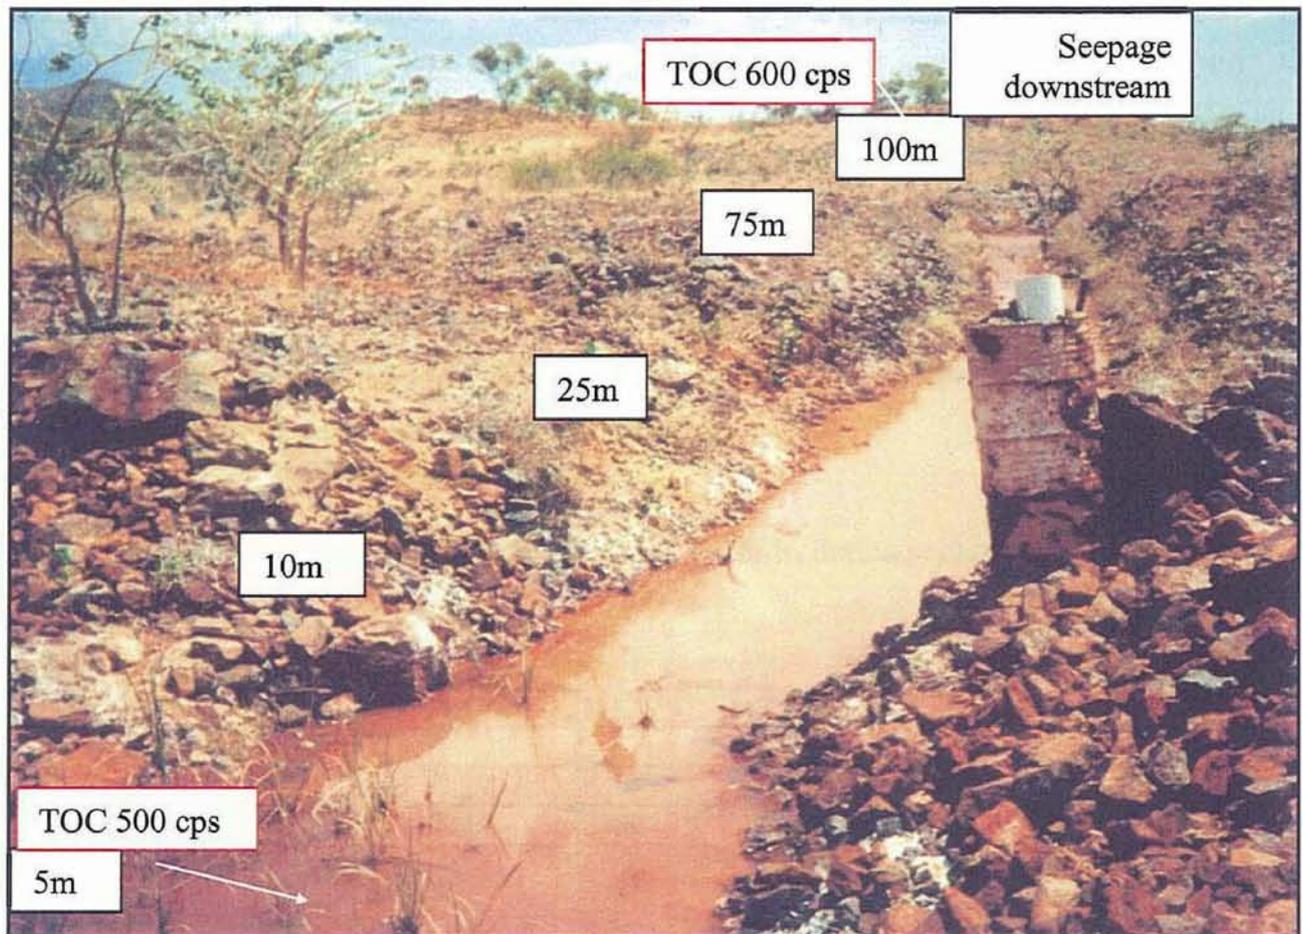
Figure 4.4b Photograph of tailings seepage drainage area (Photographed 10-10-1999)

Continuing downstream (Figure 4.4b), surface waters from the drainage trench and in the evaporation ponds have higher pH, dissolved oxygen, and salinity values than at the seepage point. Seepage waters are radioactive with total count readings at 1300 (background TOC for this site is 400 cps).

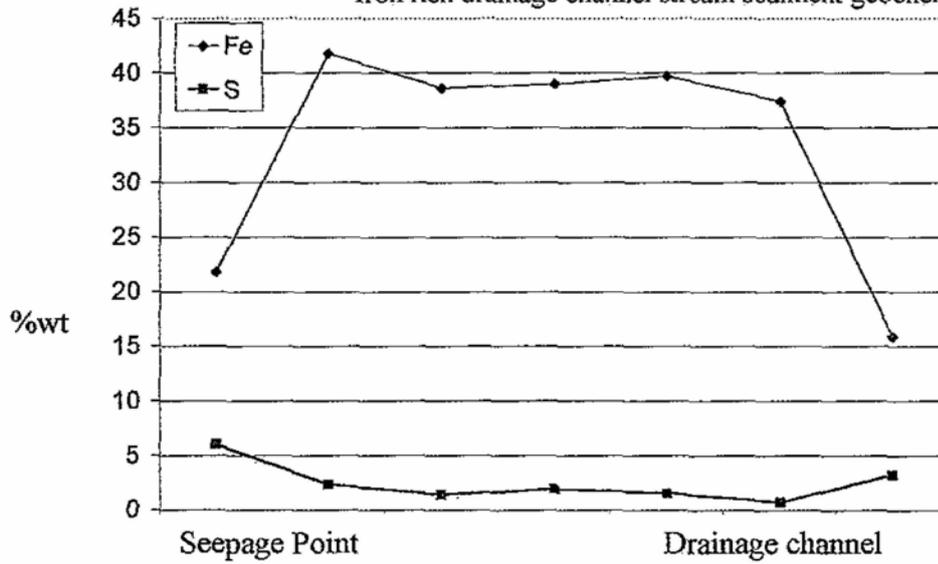
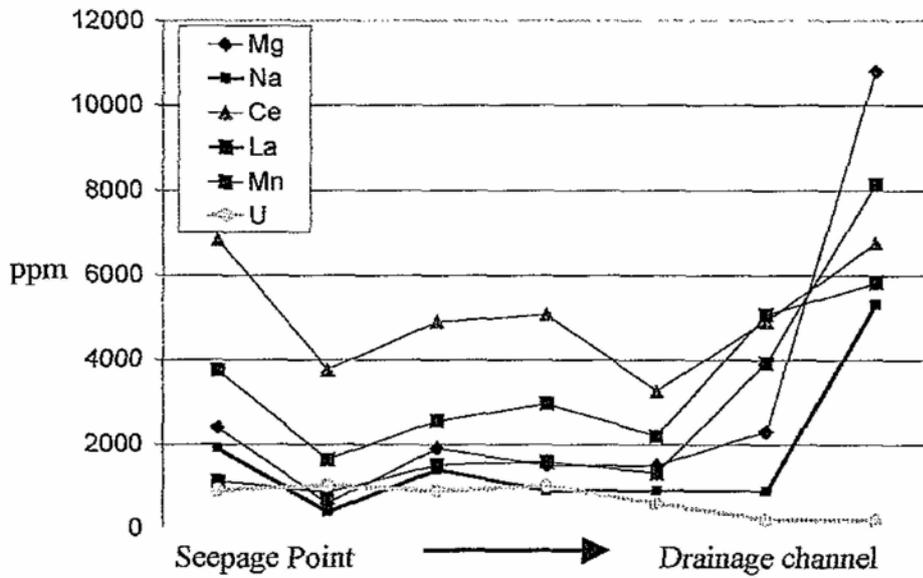
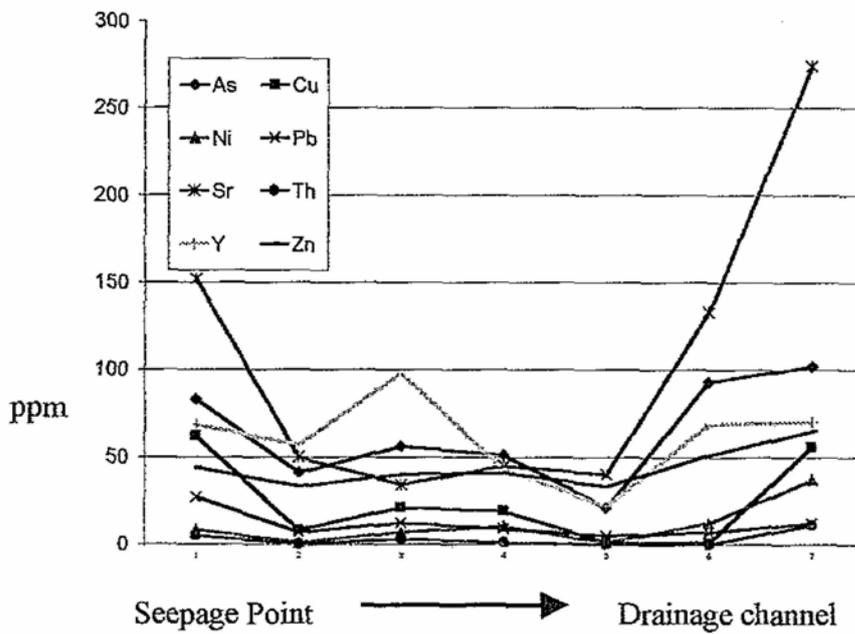
The coarser-grained fraction (63  $\mu\text{m}$  – 2 mm) of the sampled Fe-rich precipitates displays higher Ba, Ca, K, Mg, P, S and Sr values and lower Ce, La, Fe, Mn, U, Y and Zn contents than the fine-grained fraction (< 63  $\mu\text{m}$ ). The oxygenation of  $\text{Fe}^{2+}$  bearing seepage and surface waters causes the hydrolysis of dissolved  $\text{Fe}^{2+}$  and leads to the precipitation of  $\text{Fe}^{3+}$  phases. Co-precipitation and adsorption processes are likely responsible for the distinct metal (U, Y), metalloid (As) and rare earth element (Ce, La) enrichment of Fe-rich flocculants and sediments (Figure 4.6).

Figure 4.6 Spatial distribution of metals and metalloids in the tailings drainage channel.  
 Iron rich drainage channel stream sediment geochemistry (2mm fraction).
