TROPICAL CYCLONE YASI – LOAD TESTING OF TIMBER HOUSES ON A LARGE SCALE

Geoffrey N Boughton¹ and David J Henderson²

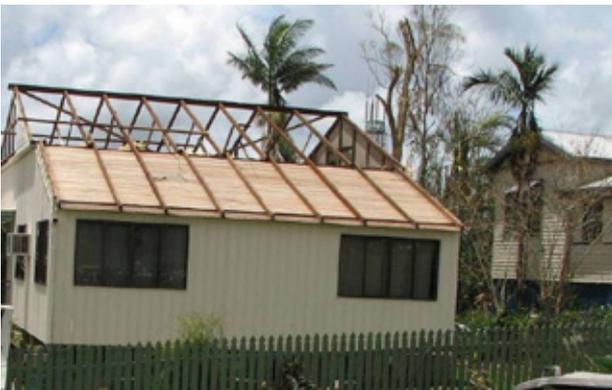
Figure 4: Roof damage to Pre-80s house

Figure 4 illustrates some of the roof damage to Pre-80s housing. Many of the Pre-80s houses had hardwood timber wall and roof frames. In some cases, the roofs were trussed, but in many the rafters were supported by ridge boards and underpurlins as shown in Figure 4.

Both Figures 4 and 5 show connection failures. The most common failure in the Pre-80s housing was the batten-to-rafter connection as shown in Figure 4. Current requirements are not satisfied by the nailed connections that were commonly used prior to the release of Appendix 4 [6].

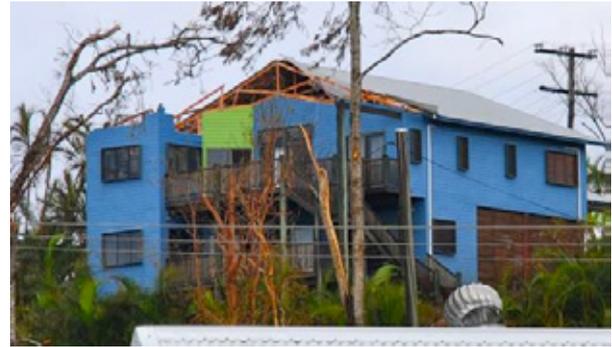
Figure 5 shows roof damage to a Post-80s house. Many of the Post-80s houses had reinforced concrete blockwork walls with timber trussed roofs. Many of the houses built in the 1980s and early 1990s had hardwood roof frames, but from the mid 1990s onwards, softwood roof trusses predominate. No difference in performance of hardwood and softwood roof frames was noted.

Figure 5: Roof damage to Post-80s roof

In most of the damaged Pre-80s houses, the roofing had been replaced at least once since the release of Appendix 4, but no attempt had been made to improve the connections within the roof structure. In contrast, the majority of the relatively smaller number of failures observed in the Post-80s houses were deeper in the structure such as the truss to wall connection failure shown in Figure 5.

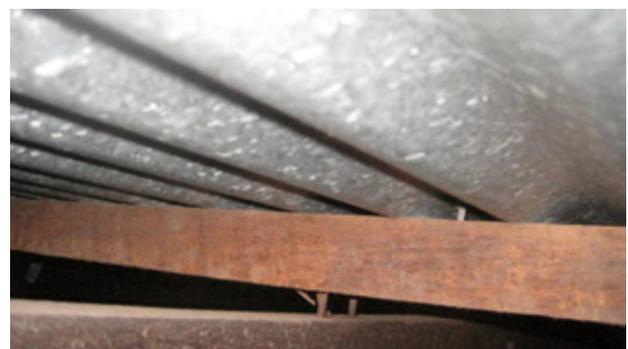
Figure 6 shows a batten-to-rafter connection in an apparently undamaged Pre-80s house. (This damage would not have been captured during the street survey) It is clear that under the actions of the wind forces, the nailed connection had started to work free, but had not completely withdrawn [7]. This type of connection would be compromised in its ability to resist future events.

Figure 6: Partial withdrawal of nailed connection

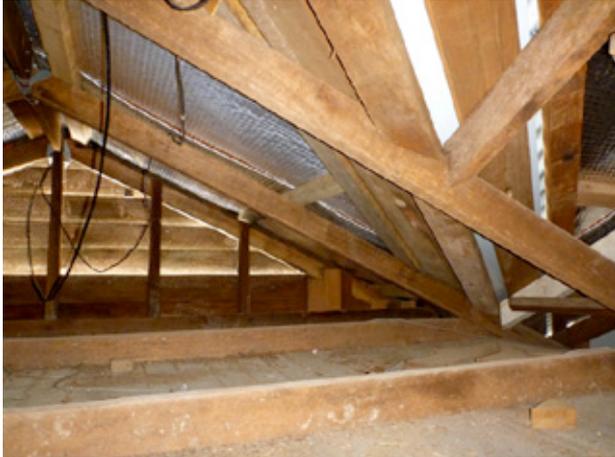
By contrast, Figure 7 shows a roof structure from a house that was a similar age, but had its roof sheeting replaced 4 years prior to TC Yasi. All of its roof

connections were also upgraded while the roof was off. There was no observed incipient connection damage.

Figure 7: Better performance of refurbished roof

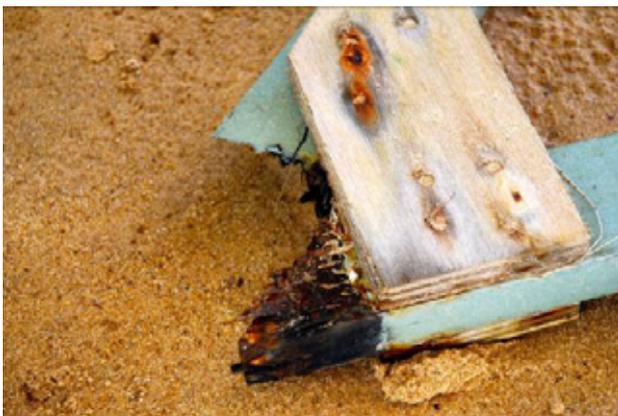
A number of older beach-side structures showed significant signs of corrosion of connections. The truss anchorage brackets shown in Figure 8 had almost completely disappeared. Wood rot at the same location had compromised the holding power of the timber as well.

Figure 8: Corrosion of fasteners

Regular building maintenance should find and address corrosion or rot in structural elements. A number of owners we spoke to were unaware of the extent of the deterioration of structural elements in their homes.

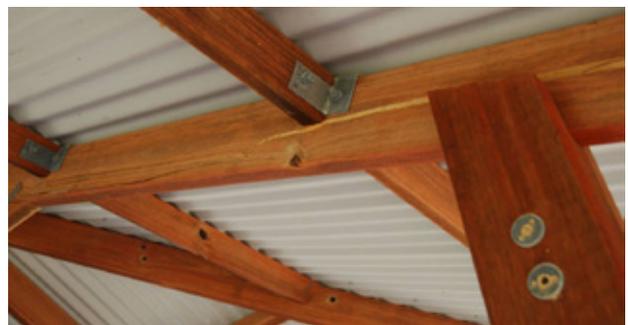
In Figure 9, the roof on an outdoor entertainment area had appeared to perform well under the wind actions, but a split had opened up under the action of tension perpendicular to the grain. In this case, the purlins are securely bolted to the rafters, but the brackets fix only to the upper edge of the timber rafter. With the post anchorage only engaging the lower edge of the rafter, wind forces must be transmitted across the centreline of the rafter by tension perpendicular to grain. This type of failure could have been avoided by ensuring that the rafter to post connection extended to the top surface of the rafter. Connecting the purlins to the full depth of the rafter may also have helped.

Figure 9: Tension perpendicular to grain in rafters

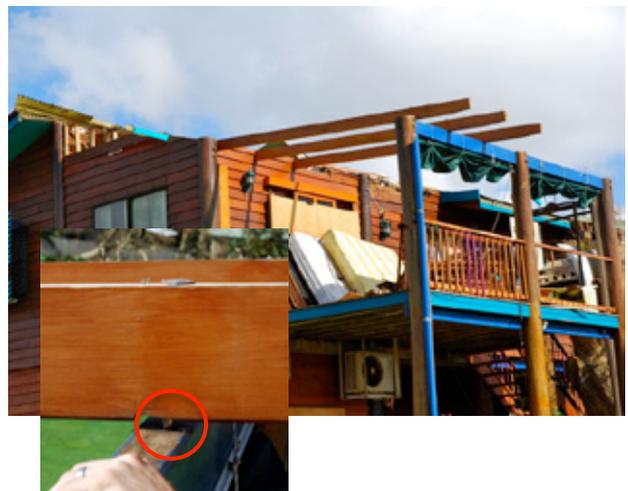
The roof damage shown in Figure 10 was caused by failure of bolted connections between the roof structure and verandah beams and top plates. Careful study of bolts that had been removed, and some that were still in place but partly undone (circled in inset in Figure 10), showed that the nuts had come off the bolts during the event. It was postulated that the repeated loading had enabled them to rattle themselves free.

Figure 10: Roof loss as a result of bolts rattling undone

Both of these connection failures were associated with details that complied with current standards, however, in both the difference between compliance and fitness for purpose was quite subtle. The small improvement in detail for the rafter to post connection in Figure 9 has already been discussed. In the case of the bolted connection, the galvanised nut turned freely on the stainless steel bolt. It is recommended that the replacement nuts be self-locking nuts.

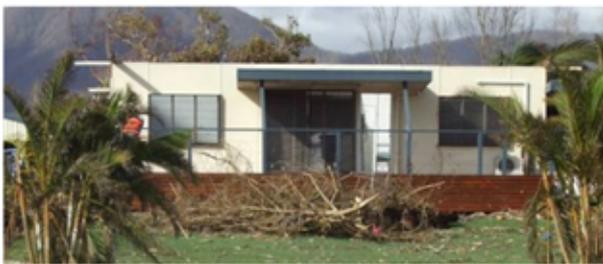
Figure 11 shows a house in which “cyclone screens” had been installed to protect windows, but in which a door had failed and still caused the high internal pressures that initiated the roof loss.

Figure 11: Roof loss as a result of door failure

Currently, AS/NZS 1170.2 [10] allows design for lower internal pressures in tropical cyclone-prone areas where openings are protected against debris impact. Many of these failures (including the one illustrated in Figure 11) would not have been avoided by debris protection measures. The wind loads on houses taken from AS 4055 [11] use full dominant opening internal pressures by default.

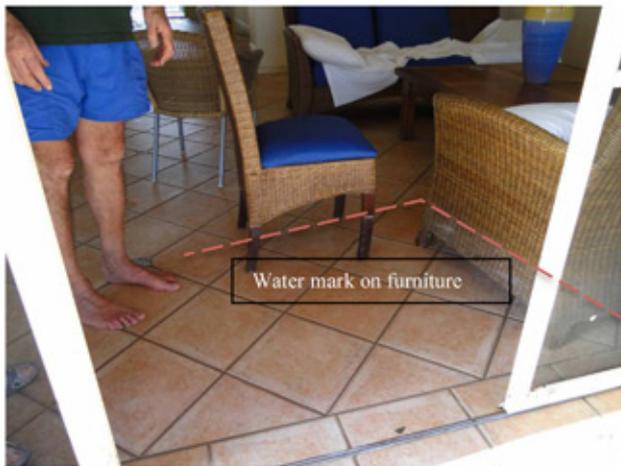
Where the level of water in a house was less than about 0.2 m as illustrated in Figure 13, there was minimal damage to the house itself.

Figure 13: Water 200 mm above floor

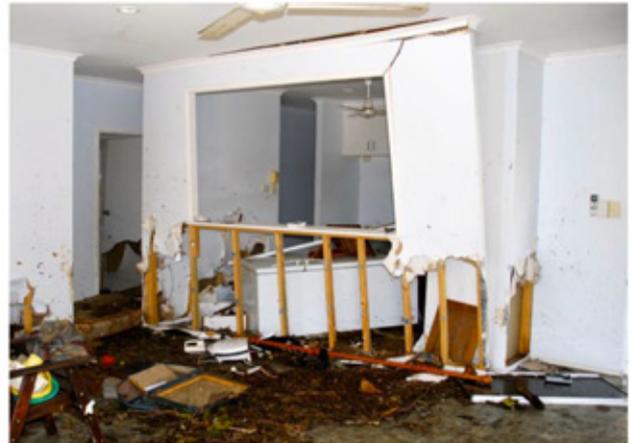
However, where the level of water in the house was around 1 m, there was sufficient water movement to cause largely non-structural damage. For example, the displacement of non-structural walls, movement of contents and damage to linings, as shown in Figure 14.

Figure 14: Water 1 m above floor

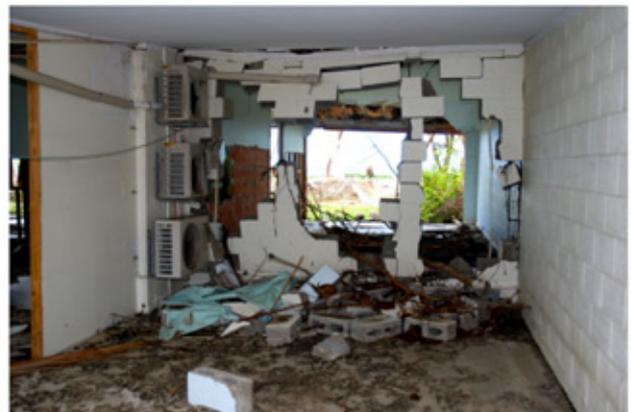
A 1 m level of water above the floor is sufficient to sustain wave action. Where waves had broken against a door, window, or non-structural wall when the depth of water through the house was around 1 m, the wave was able to break all of those elements as shown in Figure 15.

Figure 15: Damage to non-structural masonry wall

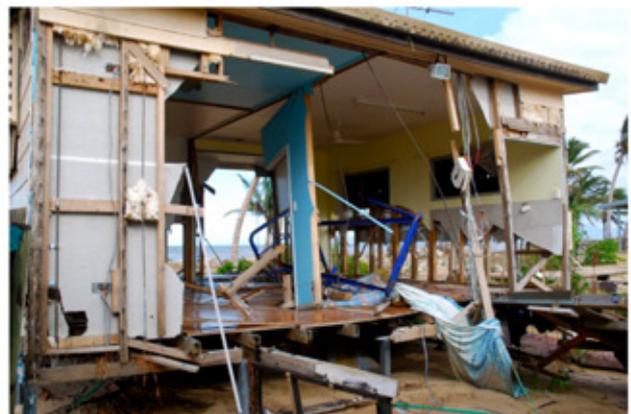
A 2 m level of storm tide above floor level in a house was able to break structural walls, as shown in Figure 16.

Figure 16: Water up to 2 m above ground

Figure 16 shows a house in which some structural timber remained although the storm tide was close to the top of the walls. However, in this case, the under-floor structure was compromised and many of the structural walls failed.

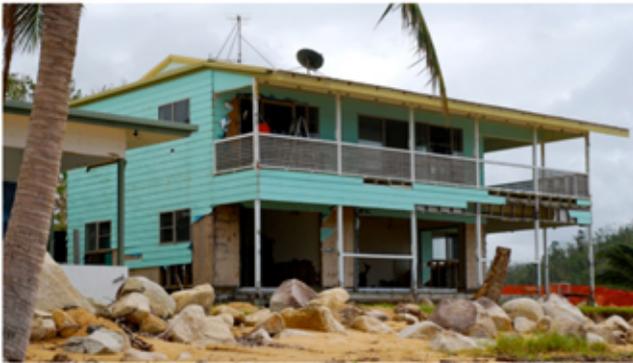
Figure 17 shows a timber framed house in which the timber framing and structural plywood cladding remained intact through the event with a similar height of water in the house.

While the structure of this house survived, the internal linings, electrical wiring and particle board floors did not and the building shown has been demolished and a new house built on the site.

Figure 17: Structural timber intact

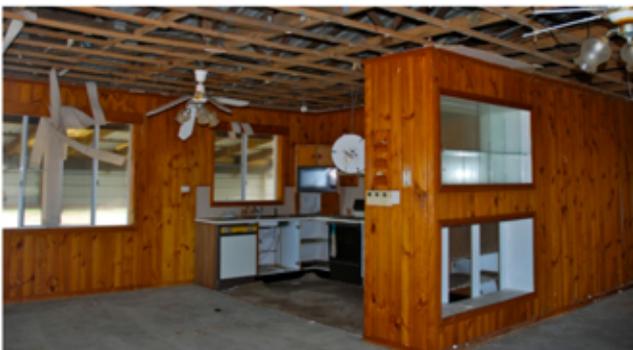
A number of other high-set timber houses were able to remain serviceable after the event as the bulk of the wiring and linings were not submerged. Solid timber linings were able to withstand inundation by the storm tide as shown in Figure 18. However, particle board and interior plywood was not. The plasterboard ceiling was in the splash zone and was destroyed.

Figure 18: Solid timber linings after submersion

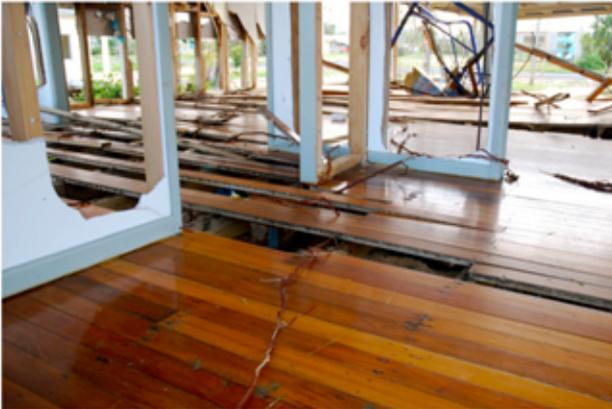
Figure 19 shows a timber floor that had performed satisfactorily except near a concrete wall under the floor space. Waves striking this wall were reflected up into the floor and caused significant damage, but only within 3 m of the under-floor obstruction.

Figure 19: Floor damage near an under-floor obstruction
