Tropical Cyclone Larry: Estimation of wind field and assessment of building damage *

JD Ginger[†], DJ Henderson and CJ Leitch

Cyclone Testing Station, School of Engineering, James Cook University, Townsville

SUMMARY: *Tropical Cyclone Larry made landfall on 20 March 2006 near Innisfail, causing significant damage to buildings in the surrounding areas. This paper is based on the field survey and assessment of the performance of buildings, which experienced severe winds in the Innisfail region during Tropical Cyclone Larry. The peak gust wind speeds in the study area are estimated at 50 to 65 m/s, which is less than the region's current design wind speed. Damage to the housing stock was estimated at about 20% (not including water ingress). Contemporary housing fared considerably better than older housing, reflecting marked improvement of construction detailing and better structural condition, and satisfactory performance of relevant standards. Failure of roller doors, loss of roof battens when fastened to rafters with one or two nails, and loss of rafters or trusses when anchored to top plates with skew nails only, were common. Structural component failures of under-designed cold-

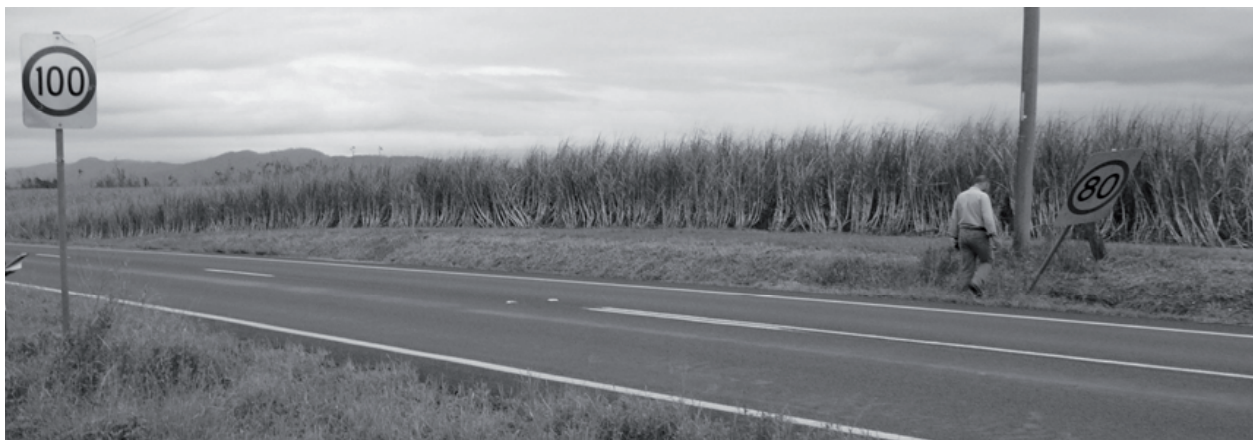
Figure 5: Road-signs giving Upper (ie. upright) and Lower (ie. bent) bound wind speeds (Bruce Highway, south of Innisfail).

The estimated values of V_r are dependent on the dimensions of the sign and posts, the strength of the post material, and the values of $C_{F,n}$ and terrain roughness. Sample specimens of these posts were subjected to third-point bending tests at the CTS to determine their plastic moment capacities M_p . Figure 5 shows a bent-over larger signage area road sign and an upright smaller signage area road sign located on either side of the Bruce Highway, just south of Innisfail. The corresponding 10 m Terrain Category 2 wind speeds required to create the plastic hinges are

51 and 72 m/s, respectively, giving a lower bound (L) from the larger sign and an upper bound (U) from the smaller sign, indicating that the maximum gust wind speed was between these two values in this area. Similar analyses were conducted on a number of signs in the study area, and the U and L wind speeds obtained are indicated on the map in figure 6. Based on this and other damage, the maximum (10 m reference height, in flat open terrain) gust wind speeds in the study area are estimated at between 50 and 65 m/s. Local wind speeds can, however, be greatly affected by topographic features such as hills, escarpments and valleys.

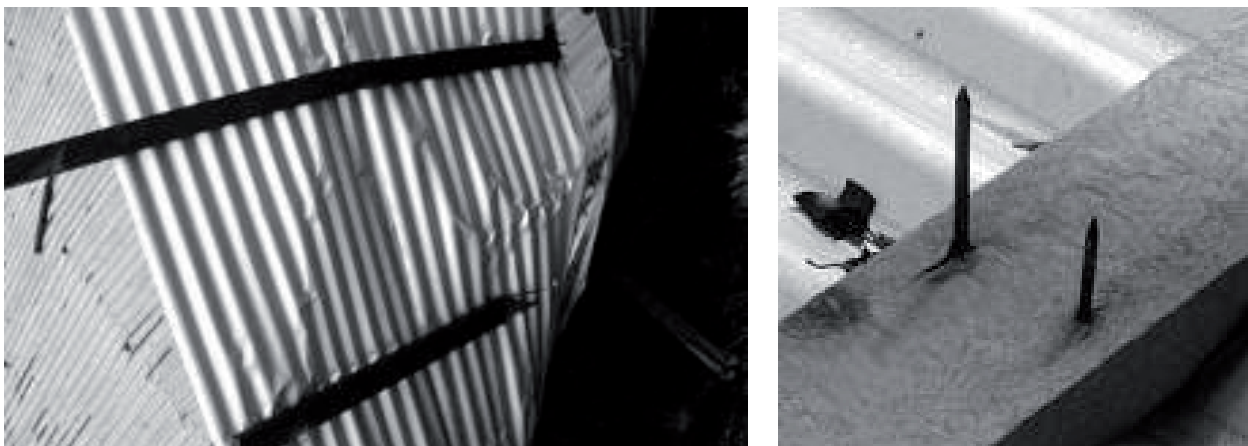
Figure 8: Failure of batten-to-rafter connection.

The most common type of failures in housing of this era was at the batten-to-rafter connection, as illustrated in figure 8. In a number of cases, the roofing had been replaced, and stronger Type 17

roofing screws replacing the spring-head nails used during the original construction. However, the original batten-rafter connections, which typically had two 75 mm nails or in some cases one nail per connection, were generally not upgraded to the required strength. The next point of weakness along the hold-down chain was at the rafter-to-wall connection, where the roof is anchored to the top of walls with skew nails, a potential failure mode if the cladding and battens stay attached to the rafter.

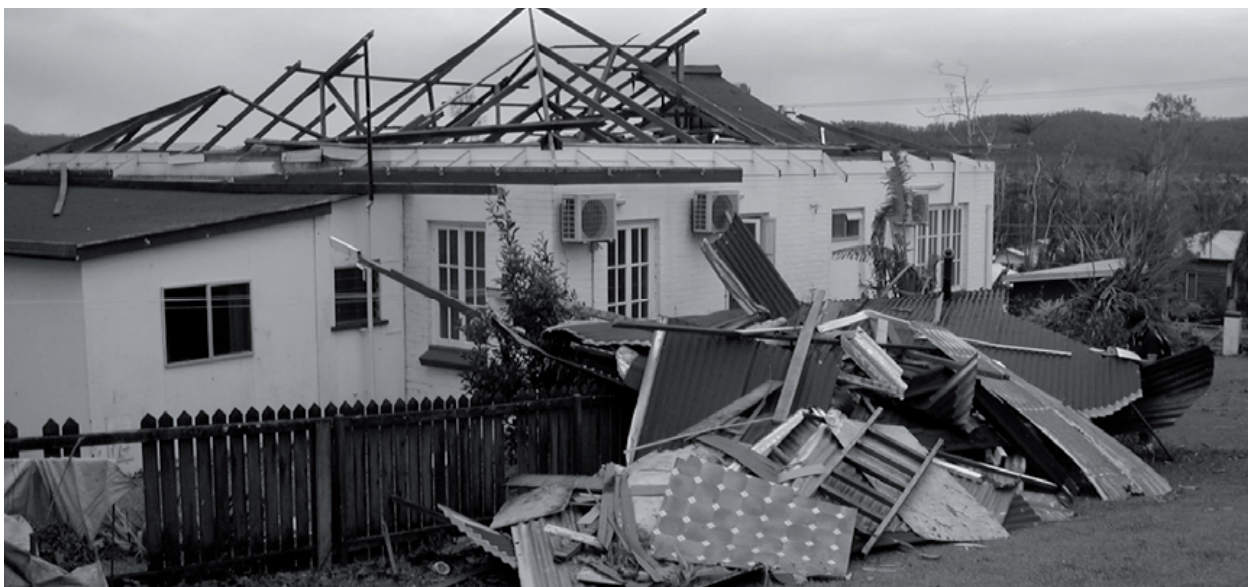
Figure 9: Loss of ridge beams.

Another type of failure was the loss of the central part of the roof as shown in figure 9. Generally, these roofs were anchored with over-battens around the edge and relied on ridge beams and underpurlins for support of the rafters at the top and centre of each rafter run. When these support points did not offer enough anchorage against the wind uplift forces, they failed, sometimes leaving the outside connection of the rafters still attached to the wall, but the centre part of the roof missing.

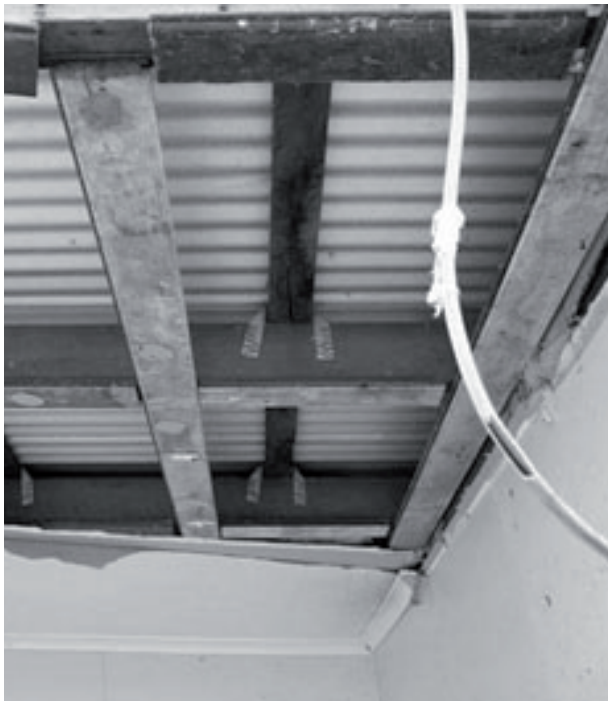
Figure 10 shows a house in which batten-to-rafter connections were upgraded with straps at the same time that the roofing was replaced. This roof section remained intact, but extensive damage to the windward wall and roof edge combined with water ingress caused the ceiling collapse that enabled this photograph to be taken. Batten to rafter connection failures were rare in houses that had been fitted with batten-to-rafter straps, although there were a number of cases of loss of the roof structure due to failure of the connection at top plate level.

Figure 10: Improvements in batten-to-rafter connection.

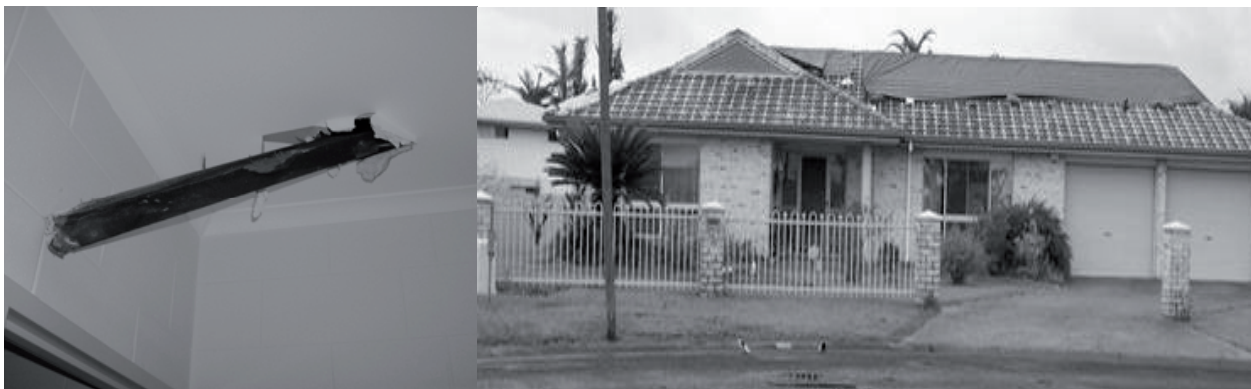
Figure 11: Debris damage to contemporary housing – (left) debris penetration through metal roof; (right) tile damage after debris impact.

Most of the contemporary houses in the study area were slab-on-ground houses. The majority of these had hollow masonry block walls. Figure 7 shows that contemporary housing suffered less structural damage than pre-1985 housing. Damage to contemporary housing could mainly be traced to either debris impact, or to inadequate fastening of windows, roller-doors, tiles, fascias and guttering. There were examples of wind driven debris penetrating both metal deck roofs and tile roofs causing damage, as shown in figure 11.

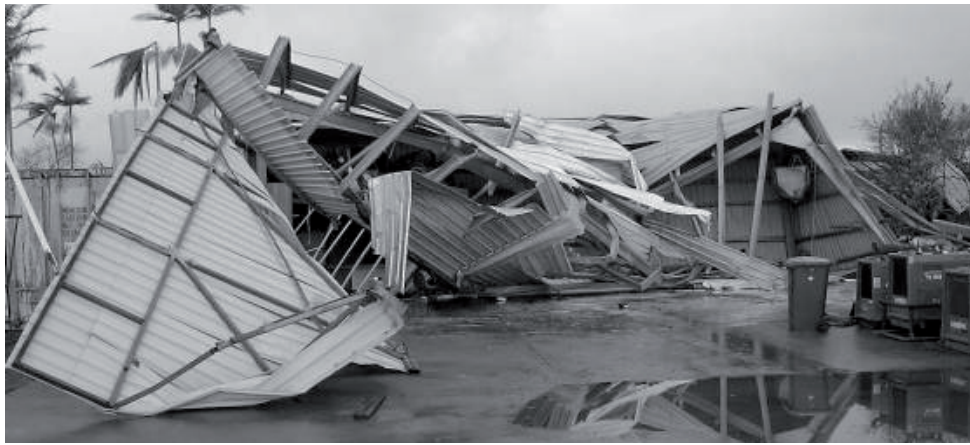
Figure 12: Collapse of cold-formed steel industrial shed.

Approximately 30% of these "engineered" buildings suffered damage ranging from loss of cladding through to complete collapse. Of the buildings that had roller doors, 60% had failed doors, often causing additional internal damage and, in some cases, leading to structural failures. These failures took place at wind speeds significantly lower than the design value, where structural failures are not expected. The major structural failures were all in the cold formed steel frame sheds (figure 12). The hot-rolled buildings performed better, notwithstanding the failure of the roller doors, or failures due to corrosion of elements, as shown in figure 13.

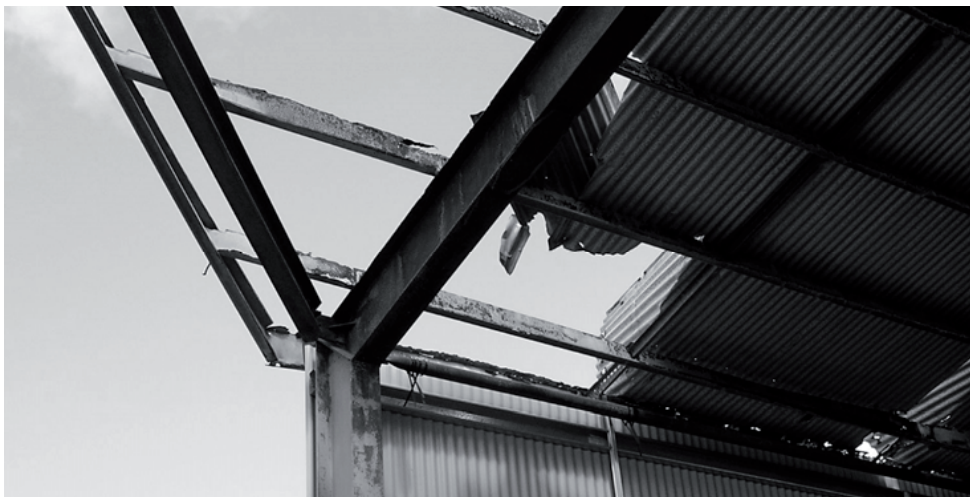
Figure 13: Hot rolled steel framed shed with severe corrosion of purlin.

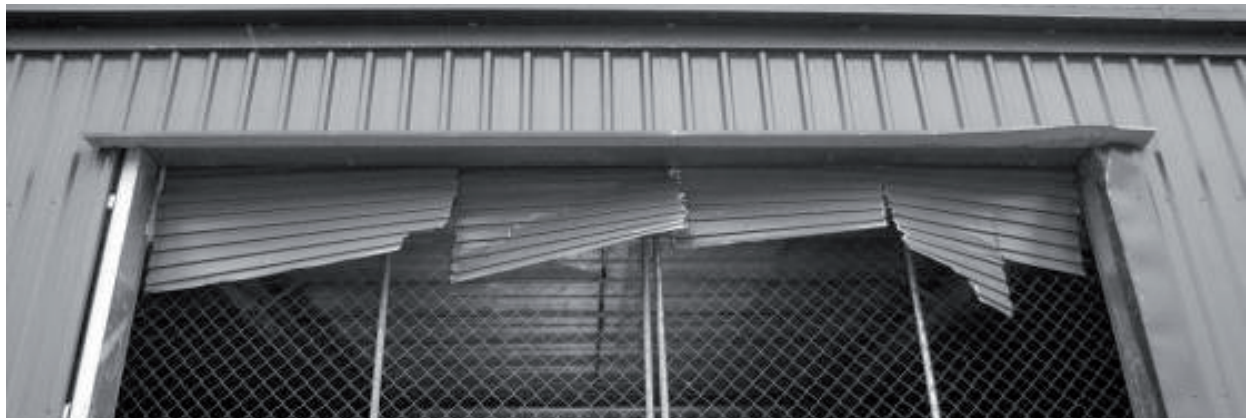
The ratio of the depth of the roller door slats or ribs to the span across the door opening is very small, and so they are very flexible. Consequently, a moderate wind pressure (either inwards or outwards) causes large deflections in the mid-span region of the roller-door causing the ends of the slats or panel to be pulled inwards, followed by the roller door failure when the sides become disengaged from the tracks (figure 14).

Figure 14: Torn sheet-type roller door.

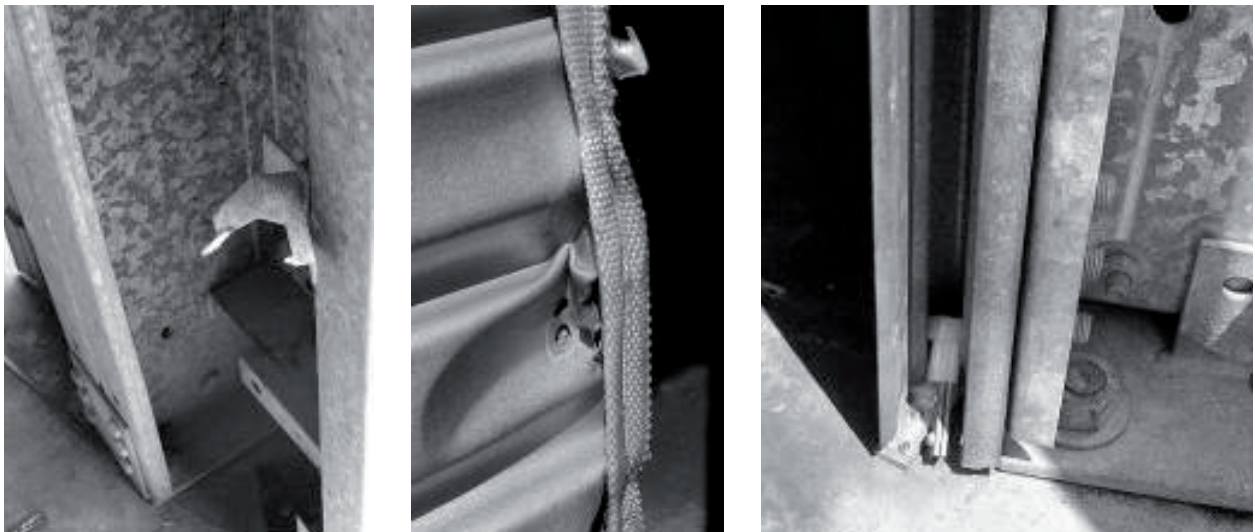
Roller doors can be designed with hooks fitted to the ends of the slats (wind locks) so that when the slats are subjected to wind loading they can use membrane action to support this pressure. However, the tensile forces generated in the slats by this membrane action can be quite large (especially if the deflection at the centre of the slat span is small) and so the tracks to each side of the slats need to be fixed very securely. Typical failures associated with wind locks are shown in figure 15.

Figure 15: Failures associated with wind locks – (left) failed track bracket, (centre) wind lock torn from door and (right) wind lock in track.
