Impact of Cyclone Yasi on the Wreck of the *SS Yongala* Documented by Comparative Multibeam Bathymetry Analysis

In February 2011, north Queensland experienced one of the largest and most severe tropical cyclones on record. Category 5 Cyclone Yasi caused substantial structural damage not only on land, but also at sea, including to the historic shipwreck of the *SS Yongala*. The *Yongala* is of high cultural and natural heritage value and is a major dive tourism attraction. As part of a Queensland Government initiative to document the degree of damage by Cyclone Yasi, changes to its structure were documented by comparative analysis of multibeam bathymetry data of the wreck collected in August 2004 and May 2011 (i.e. pre- and post-Yasi respectively). The storm had a significant physical impact on the c.110m-long wreck. The most pronounced changes occurred in the forward section of the wreck. A 35m section forward of the central deck citadel has rotated around its own axis and the bow dropped more than 5m in depth. Minor deformations were observed at the stern of the wreck and debris was identified on the seafloor around the wreck. The impacts of the cyclone will exacerbate deteriorat

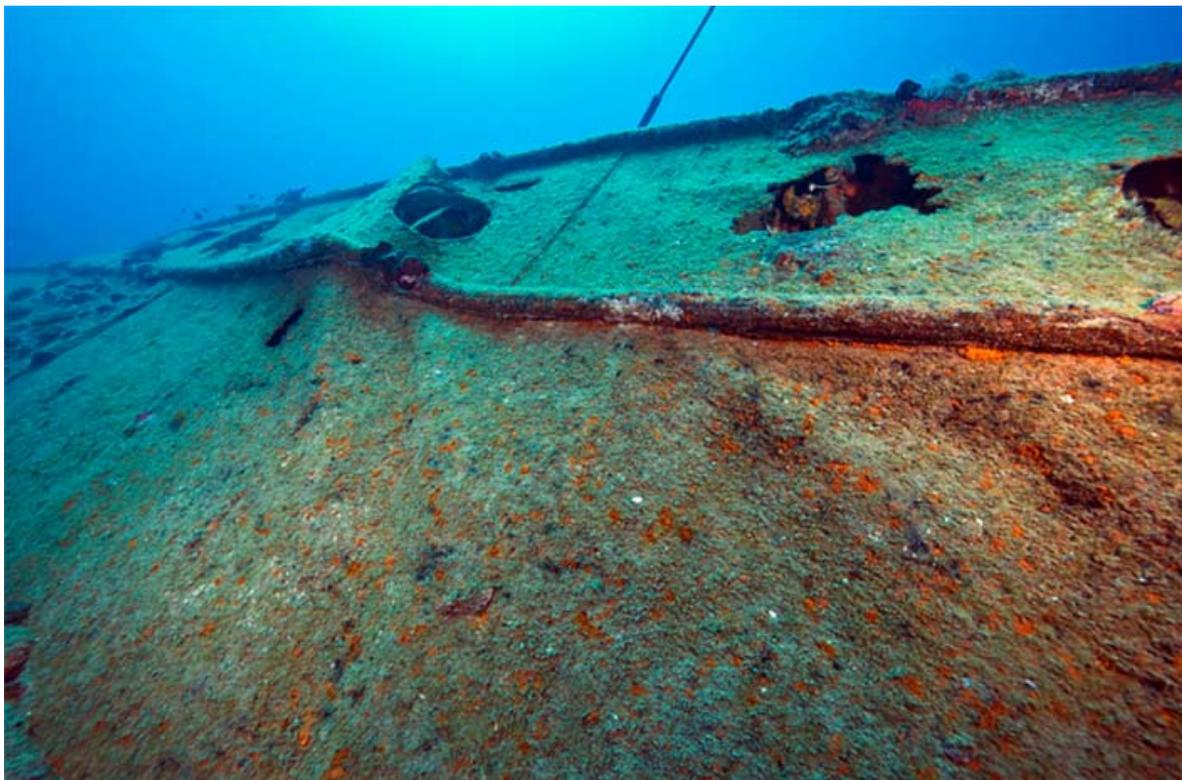
Figure 2. Hull buckling and warping is clearly visible in dive inspections after Cyclone Yasi's passage (Photograph: David Wachenfeld, Triggerfish Images).

17 July 2012) has further estimated the 'to-and-fro' water movement across the surface of the wreck to be 5m per second or 10 knots. Initial reports from divers indicated that the wreck of the *SS Yongala* had received significant permanent damage to its structure (Figure 2). A preliminary site inspection by a government dive team confirmed the high degree of impact by visual observations, but the size of the wreck (c.110m in length), the low visibility and relative depth complicated the collection of quantifiable data on the scale of impact (Waterson 2012).

Post-Yasi dive inspections (not reported in detail here) are consistent with the assessment of multibeam data. Visual inspections by divers provided important supplementary information on conservation issues (e.g. areas of active corrosion) and identified specific structural elements, which although at a smaller spatial scale, facilitated a more nuanced understanding of structural decay and physical changes. Divers immediately observed signs of stress and fatigue at the outer hull (e.g. Figure 2).

Numerous openings have appeared where benthos has been removed exposing either pre-existing corrosion holes or paper thin metal to the highly corrosive environment. Where metal integrity is relatively high, stress forces have created buckles or ripples in the hull (G. Hewitt, pers. comm., 10 September 2012). In sections, cracks are running across the deck from port to starboard, while in others the hull plating is separating. The openings to the two forward holds have buckled, and sections of the central deck citadel have collapsed, causing some materials to fall onto the adjacent seafloor. In both multibeam and visual observations, the forward section of the wreck's upper port side showed the most obvious signs of physical stress, with buckling and warping of the exposed metal hull (Figure 2). It is interesting to note that visual inspection revealed significantly more coral concretions remaining on the aft section compared to the upper centre and forward sections, which have been left virtually bare by Yasi, possibly indicating smaller impact by shear forces towards aft. However it is possible that the poor ductility of hard-bodied epifauna and concretions also contributed, and that their loss was proportional to the level of movement in the hull's shell plating (G. Hewitt, pers. comm., 10 September 2012).

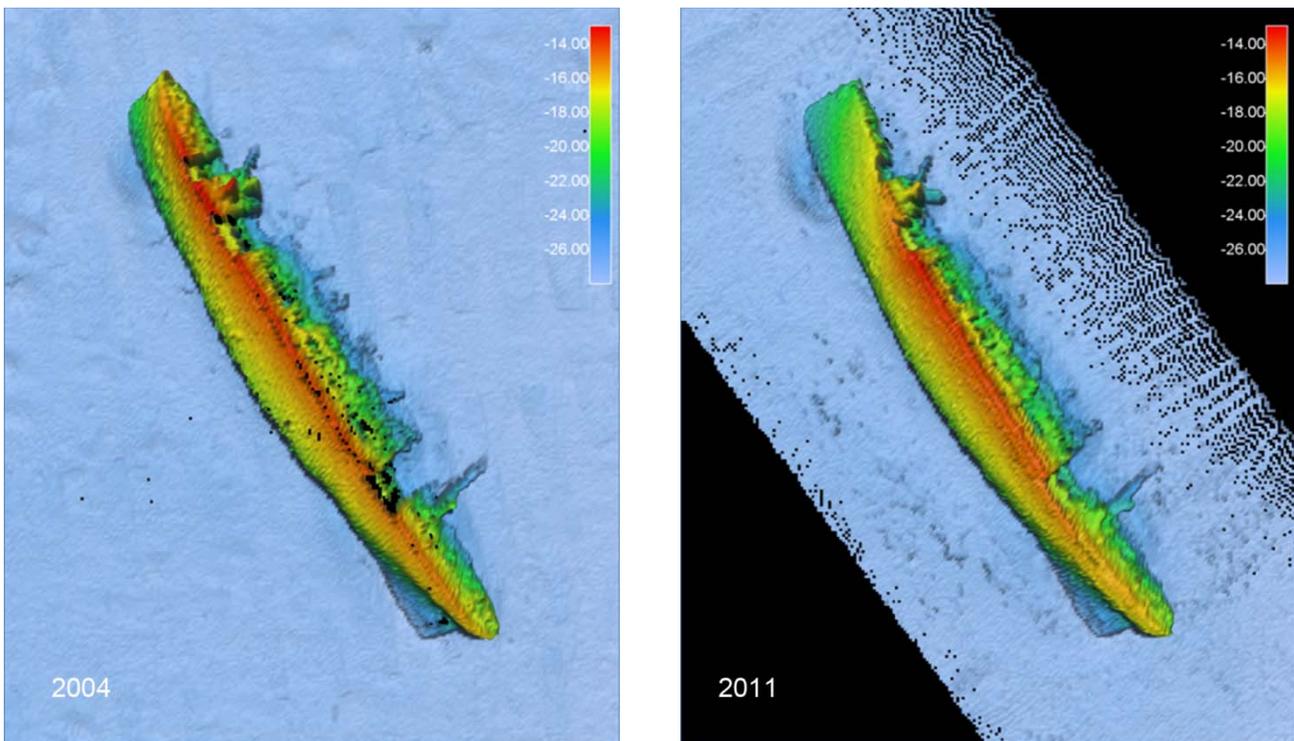
Figure 3. Plan view of color-coded sun-shaded bathymetry grid (shoal biased). The digital terrain models are displayed with an identical colour-code for comparison (legend shows depth in metres LAT).

Major features such as hull shape, cargo holds and superstructure are prominently visible in both datasets (Figure 3). The 110m-long wreck is oriented in an approximate NNW-SSE direction. Water depth of the surrounding seafloor is approximately 27m lowest astronomical tide (LAT), and the wreck rises to less than 14m depth. Overall, the position of the wreck remained unchanged. Importantly, it did not rotate or shift in X-Y direction.

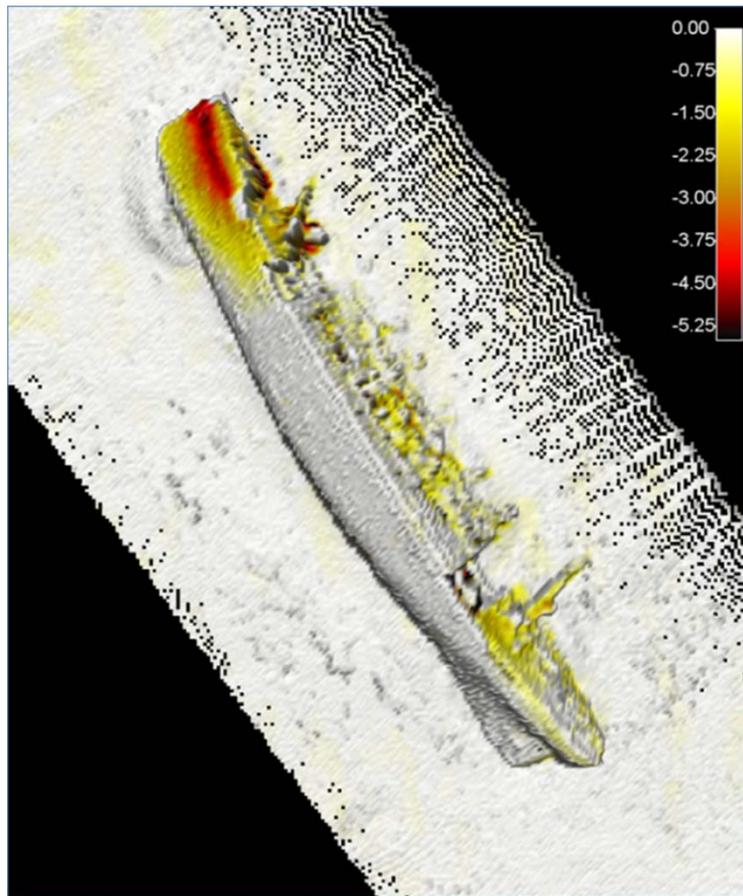
The most pronounced changes occurred in a c.35m-long section forward of the first cargo hold (highlighted in red, Figure 4). The bow at its tip has dropped in height by just over 5m. The forward section of the hull has rotated towards the east, with a pivot point located 35–40m aft of the bow (Figures 5–6). Hull cross-sections X11 to X14 in Figure 6 provide a quantitative determination of this rotation around the wreck’s axis.

The results of the survey and the impacts of the cyclone are clearly illustrated in 3D images (Figures 7–8). The main body of the wreck amidships is in the same position as pre-Yasi and appears to be largely stable (Figures 4, 6). Impacts in the centre of the ship have been largely restricted to the exposed deck levels and superstructure (Figure 7). For example, the forward derrick mast is now at a less pronounced angle to the ship’s deck (Figure 7), consistent with the identified twisting and rotation of the forward section of the ship. The stern of the wreck has only slightly dropped (Figures 4, 7). Cross-sections X03 to X05 (Appendix A),

Figure 4. Plan view of difference in depth between 2004 and 2011 shoal-biased grid data (i.e. difference between the datasets shown in Figure 3), draped over the 2011 bathymetry data. The colour code denotes changes in meter for each grid cell. Red colours indicates largest changes between data sets at the bow section.

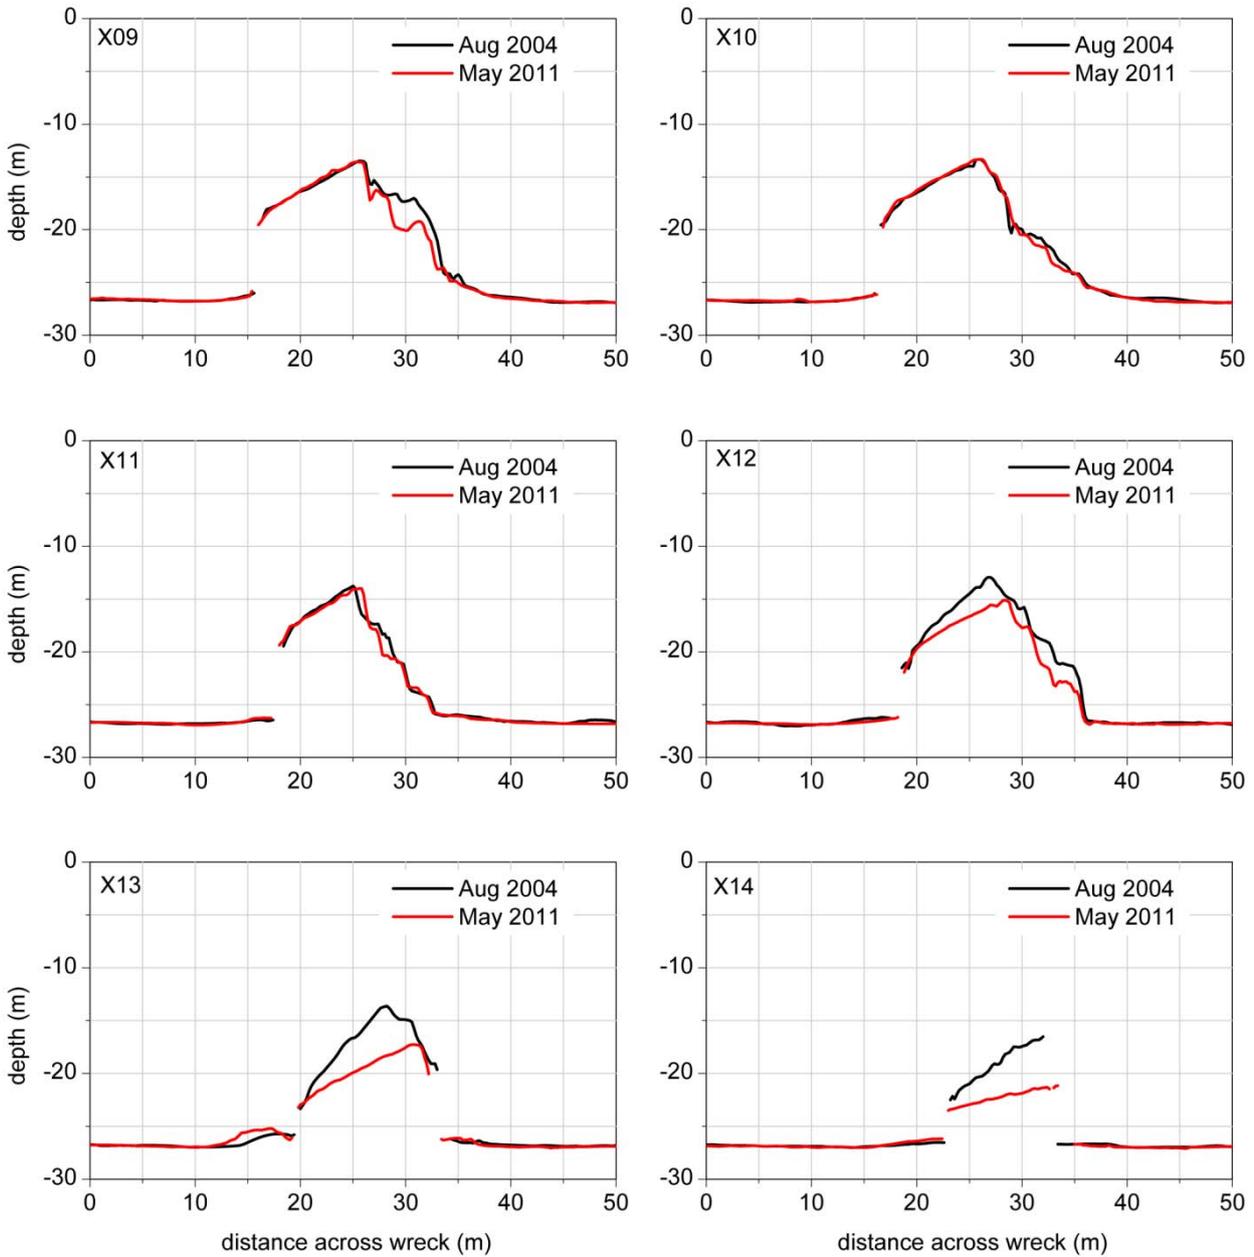
Figure 6. Quantitative comparison of wreck morphology in sections across the hull forward from the centre of the wreck (X09–X14). Cross-sections are drawn from SW to NE. The rotation and drop of the bow section is evident in sections X11–X14. For completeness, all sections X01–X16 are shown in Appendix A.

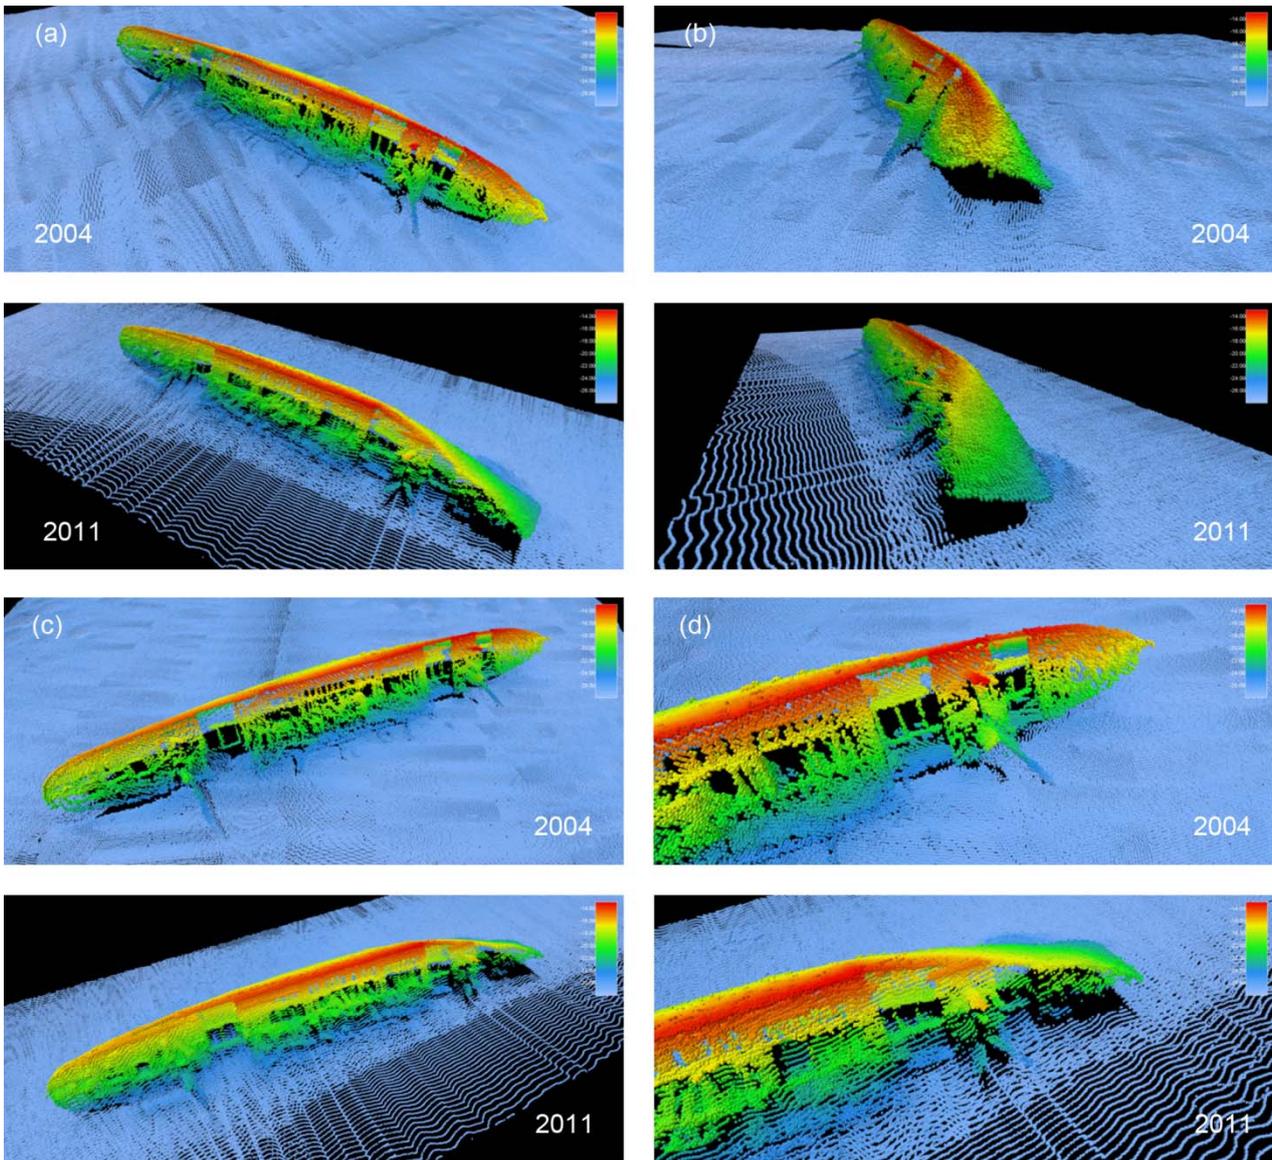
The survey also produced clear evidence of debris fields surrounding the wreck (Figure 8). A substantial number of new meter-scale positive bathymetric features were identified, especially to the west and southeast of the main wreck. New features are also evident along the base of the deck level (Figure 7), likely a combination of exposed wreckage and superstructure damaged during the storm.

Figure 7. Qualitative comparison of 3D point cloud data. 3D view from (a) ENE, (b) N and (c & d) E respectively. The rotation and drop of the bow section and rearrangement of forward masts/stacks are prominently visible. In addition, a small difference is noticeable at the stern section: the deck part has slightly dropped (compare colour in (c)). At the stern, the difference in sounding density of the superstructure may preclude or mask the detection of some small-scale changes.

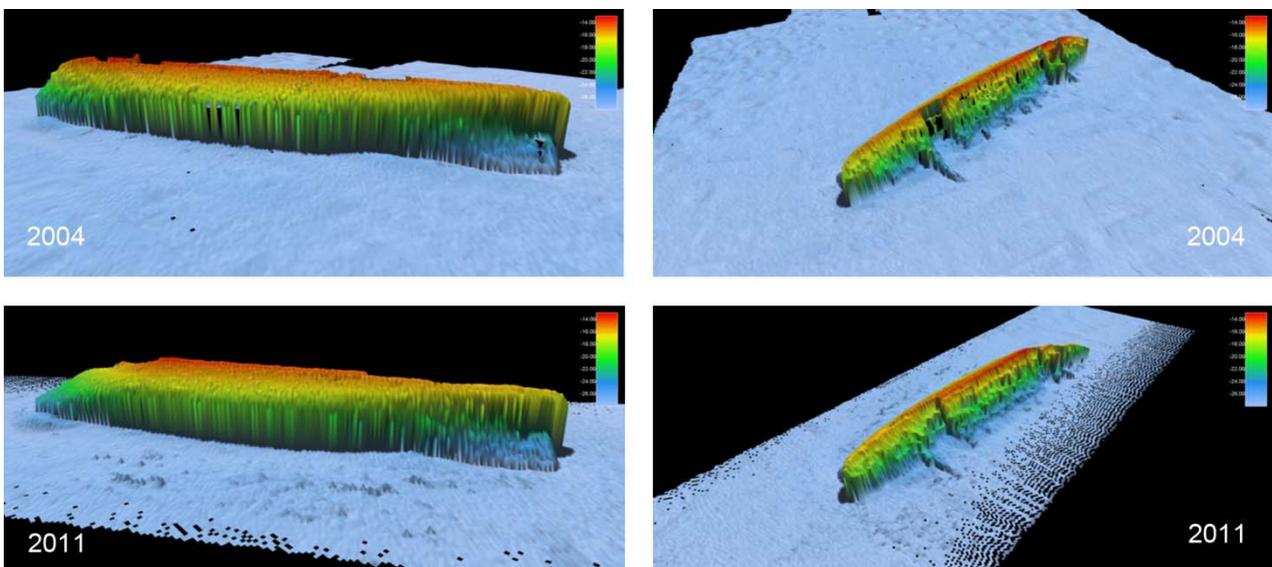
Figure 8. 3D view of the shoal-biased grid from approximately SE (left) and SSE (right), indicating debris on the seafloor to the west of to the west of the hull and to the east of the stern section of the wreck.

At present, most of the known debris field and newly identified anomalies have not been properly assessed. Their proximity to the wreck clearly suggests that they are associated with the *Yongala*, but they remain to be confirmed as archaeological or biological debris (i.e. abraded coral and shellfish cover).

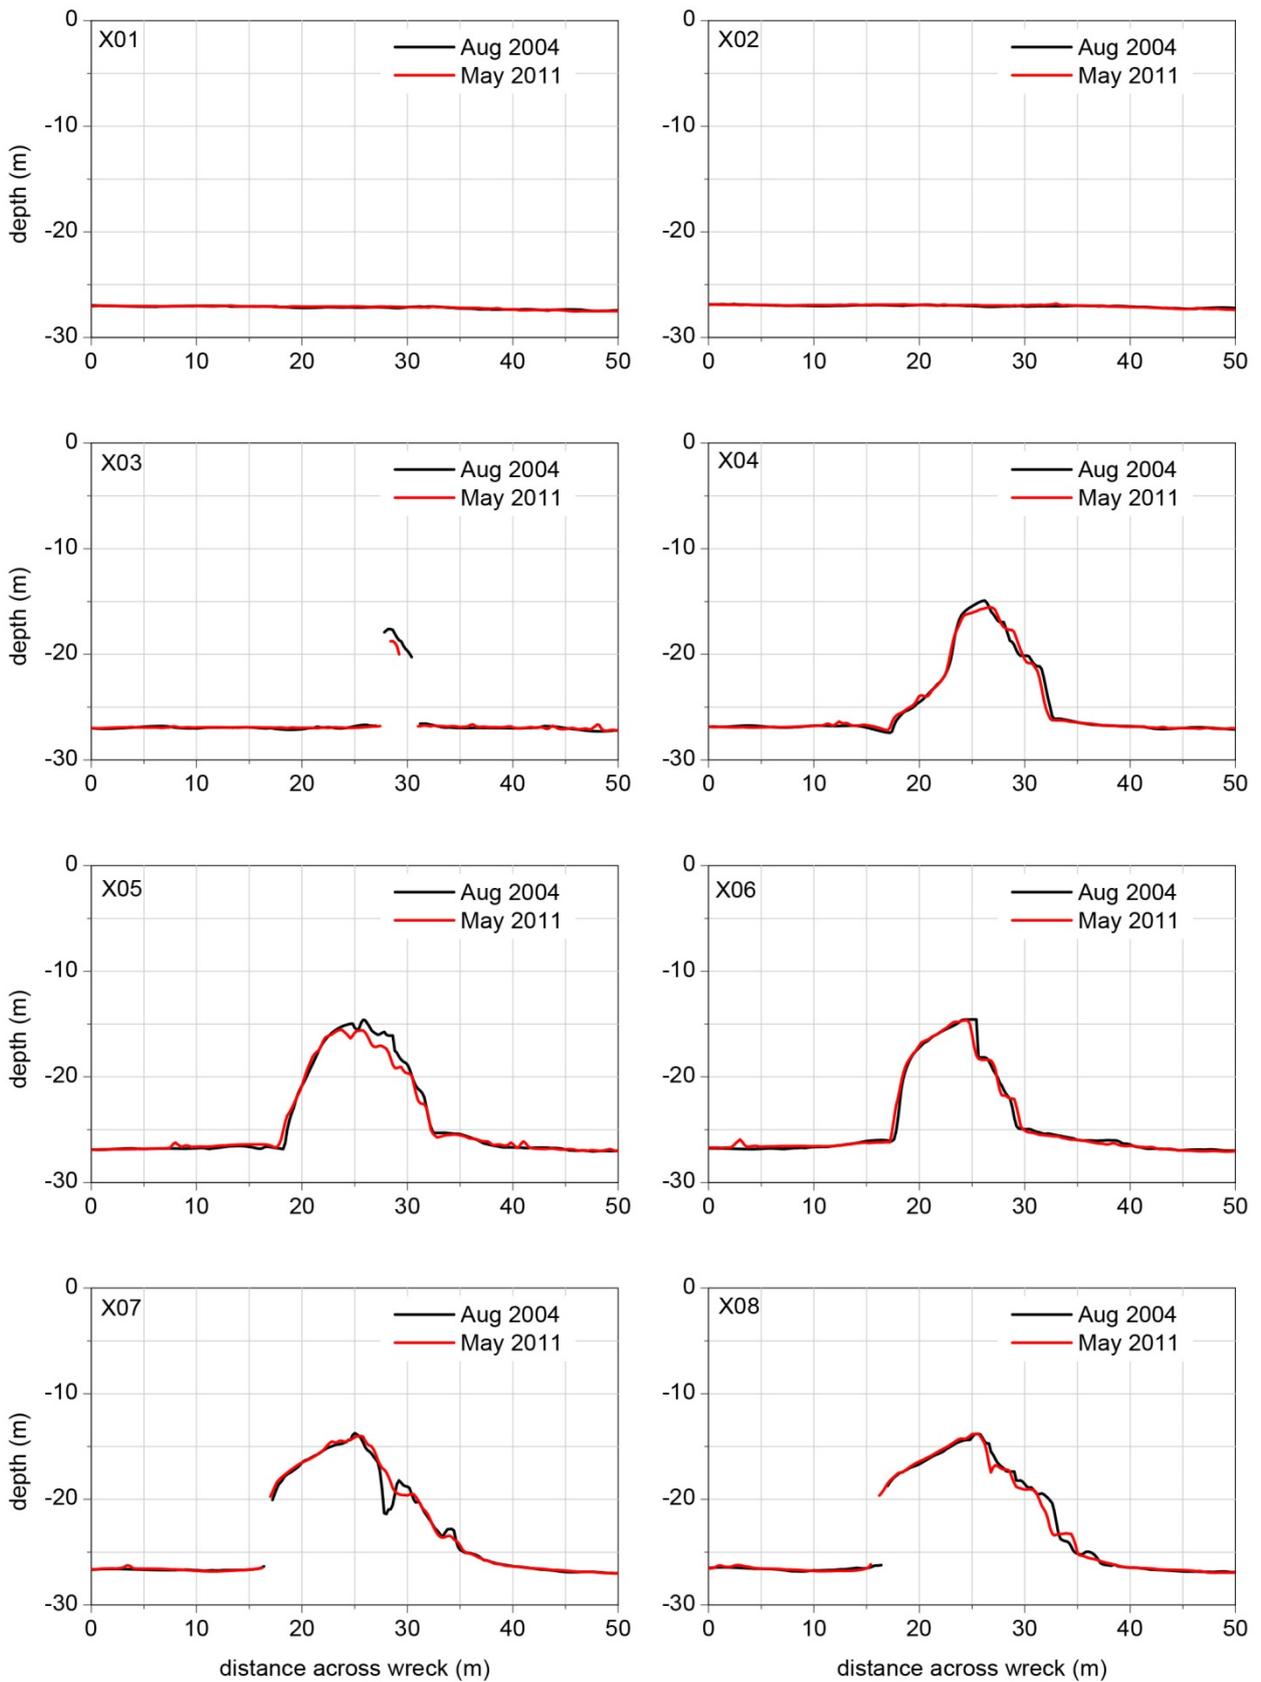
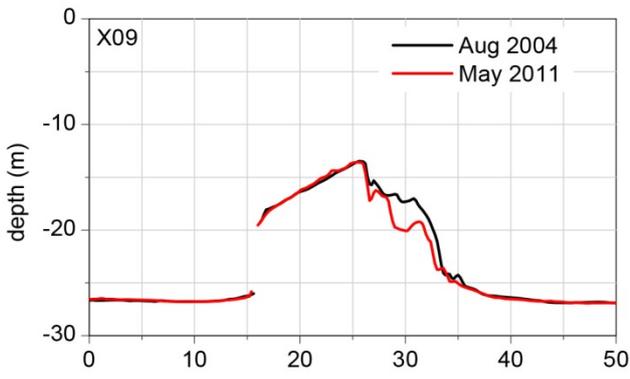
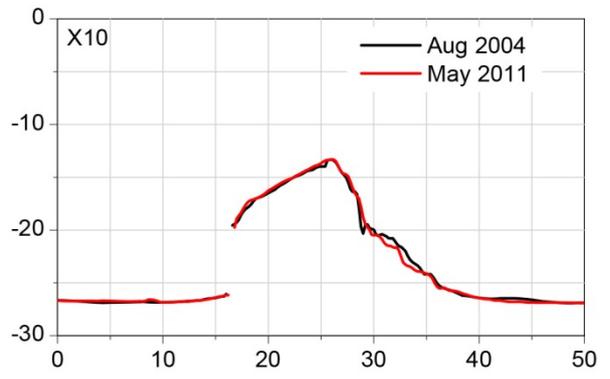
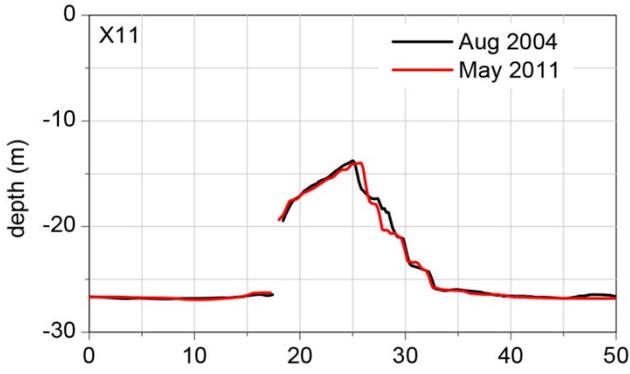
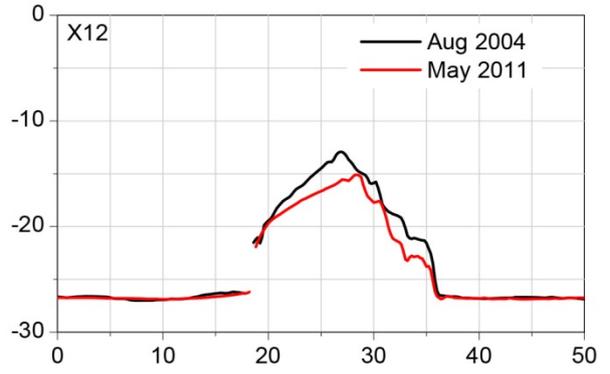
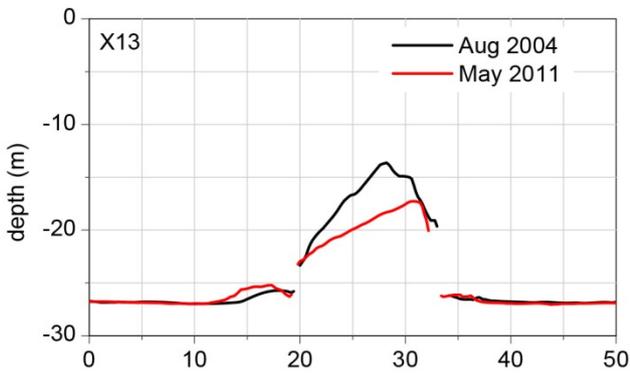
Appendix A. Sections across the SS Yongala hull in 10m intervals. Section locations are shown in Figure 5.

representing the aft 30m section of the wreck, show small, possibly rotational variations between 2004 and 2011 data.
