# Assessing the Gulf of Carpentaria mangrove dieback 2017–2019

## Volume 1: Aerial surveys

by Norm Duke, Jock Mackenzie,  
John Kovacs, Grant Staben, Rob Coles, Apanie Wood & Ysabel Castle

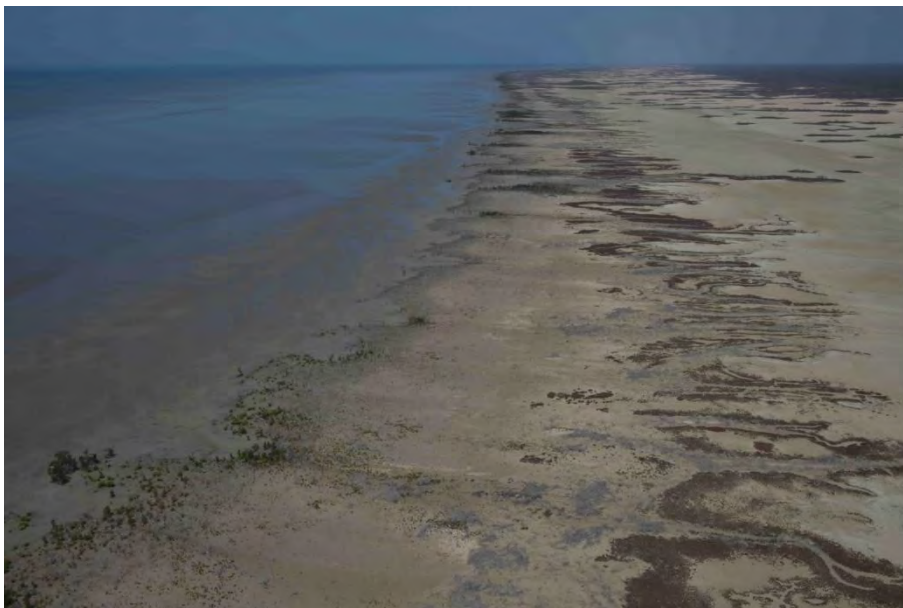
*Figure 0.7. The impact on the Limmen shoreline of Category 3 Tropical Cyclone Owen in December 2018 on 2015–2016 dieback areas. This is more evident when comparing this ‘after’ image taken in September 2019 with the image taken ‘before’ in September 2018 (Figure 0.3). Standing dead stems and seedling recruits seen before have been scoured and dumped inland. Note the piles of wood wrack evident as grey patches centre foreground extending into the distance.*

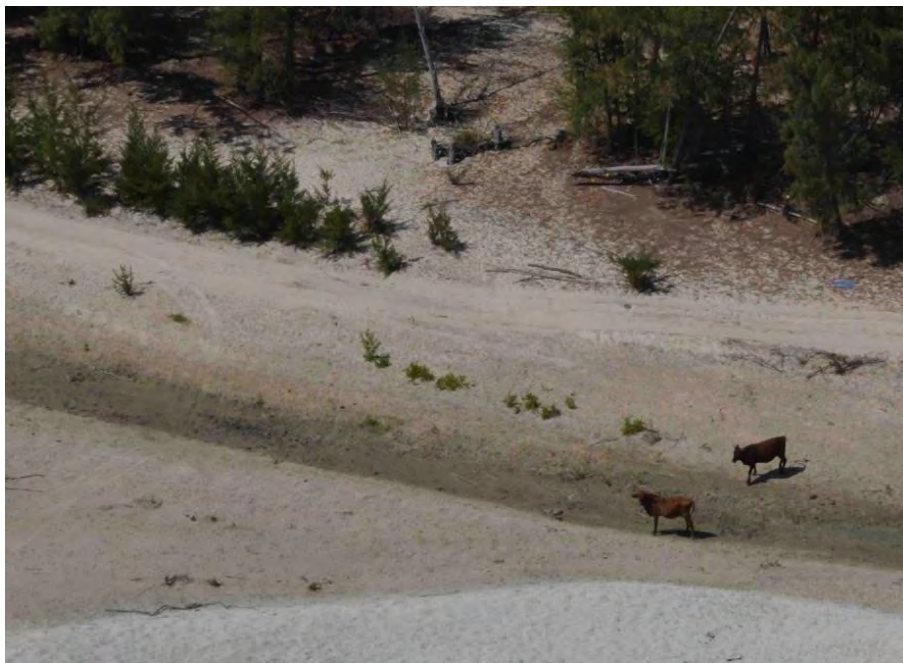
*Figure 2.9. Trampling damage caused by cattle roaming amongst tidal wetlands.*

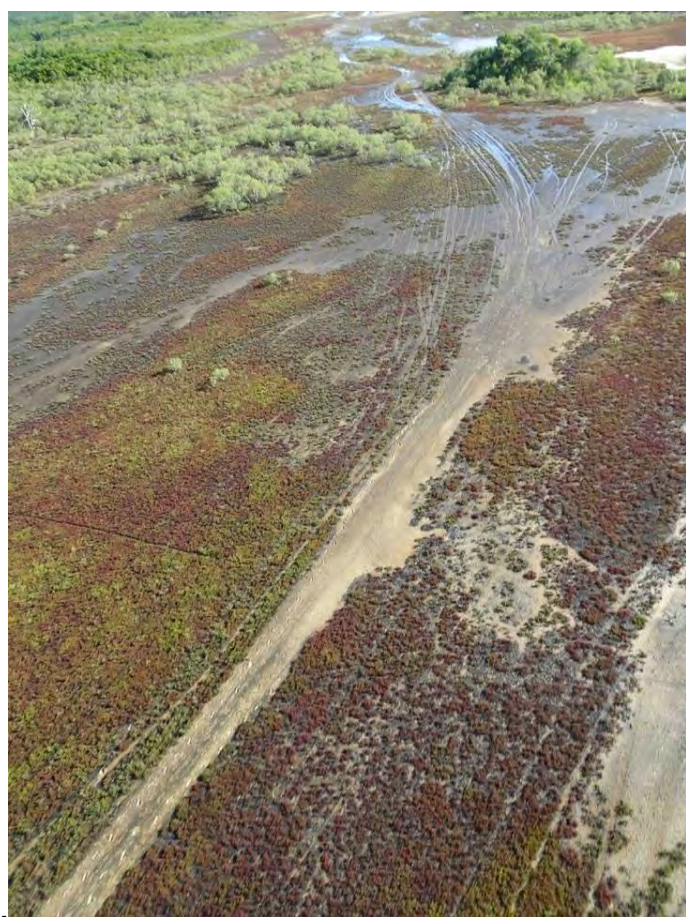
*Figure 2.10. Track damage caused by vehicles driving across tidal wetlands.*

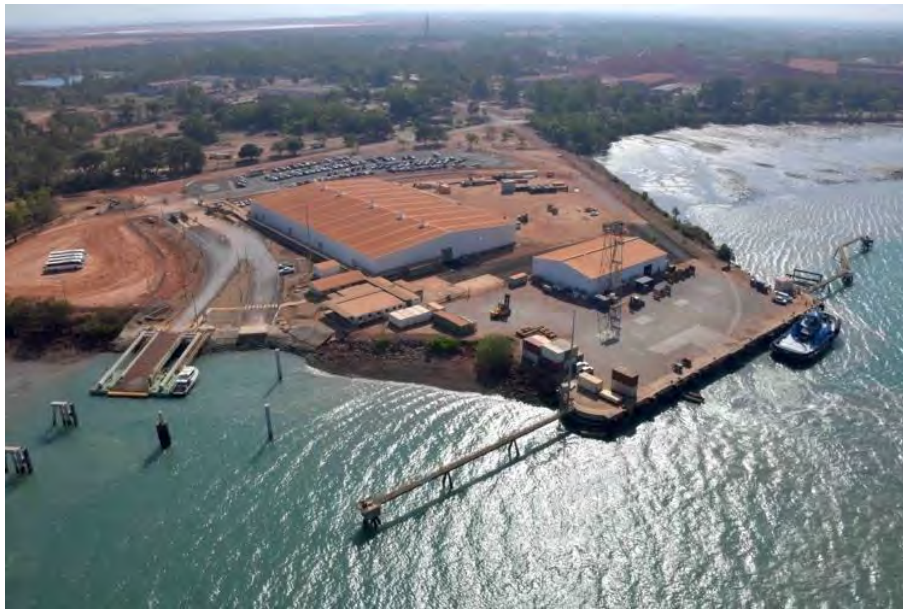
*Figure 2.11. Replacement marginal mangrove areas and encroachment reduces the function and condition of tidal wetlands*

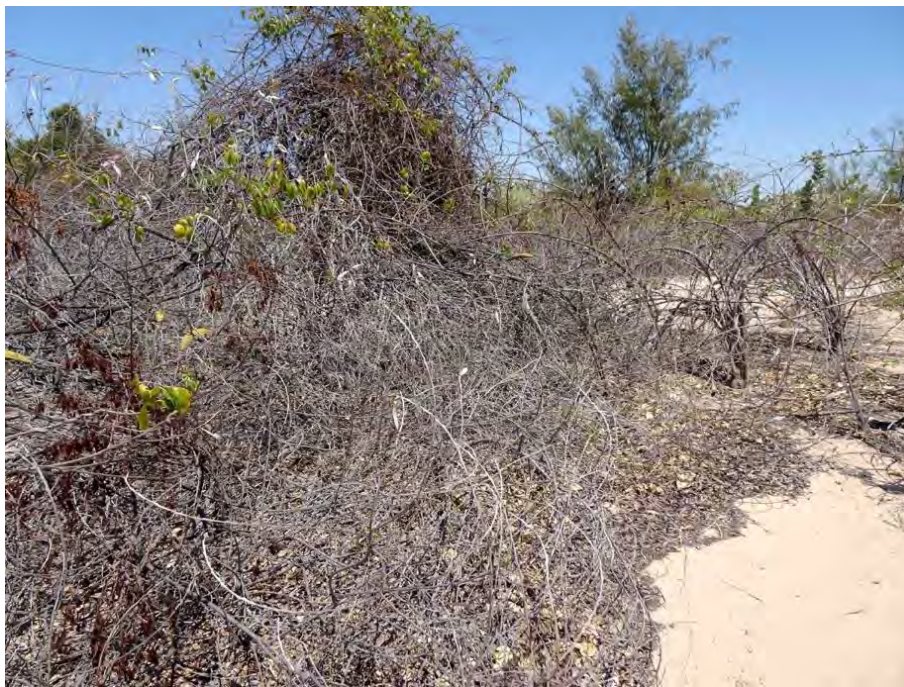
*Figure 2.12. Invasive weeds like Rubber Vine spread along the upper margins of tidal wetlands to smother mangrove habitat and increase fire damage risk.*

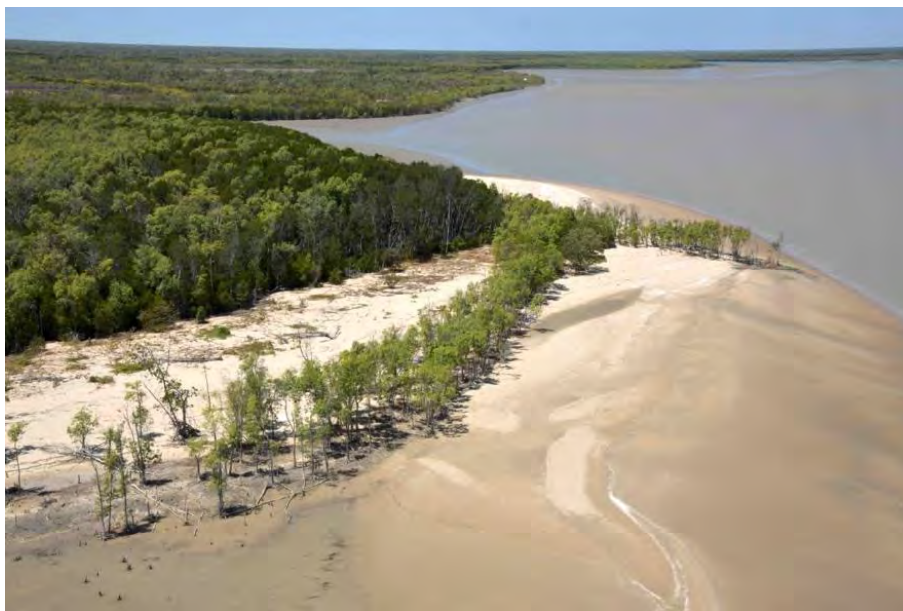
*Figure 2.18. Root burial, linked to shoreline erosion, storm damage and mangrove dieback, is caused by a natural shift in sand and sediments that bury roots and suffocate mangrove plants.*

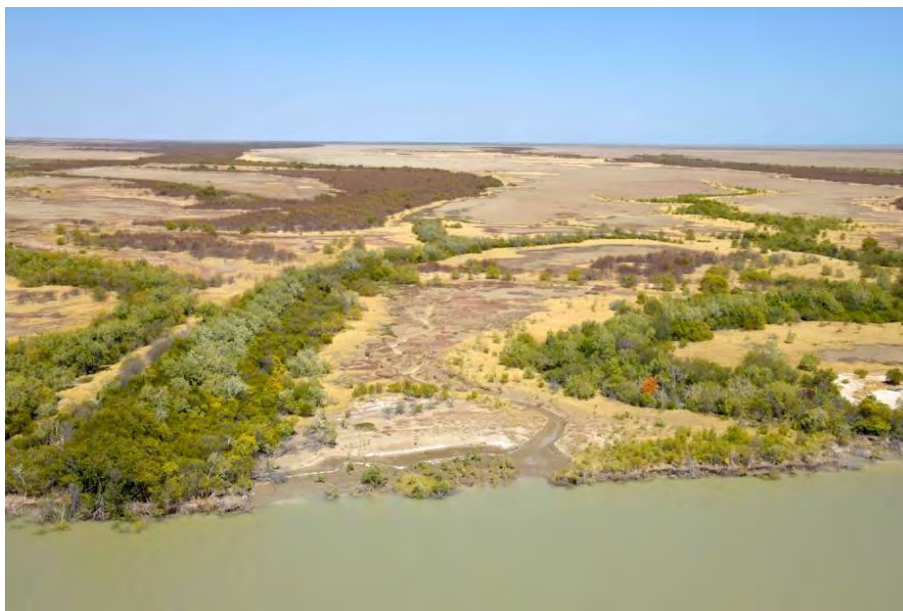
*Figure 2.23. Flood damage is indicated by bank erosion, uprooted trees, scouring of saltmarsh, and tree remains in estuarine tributaries.*

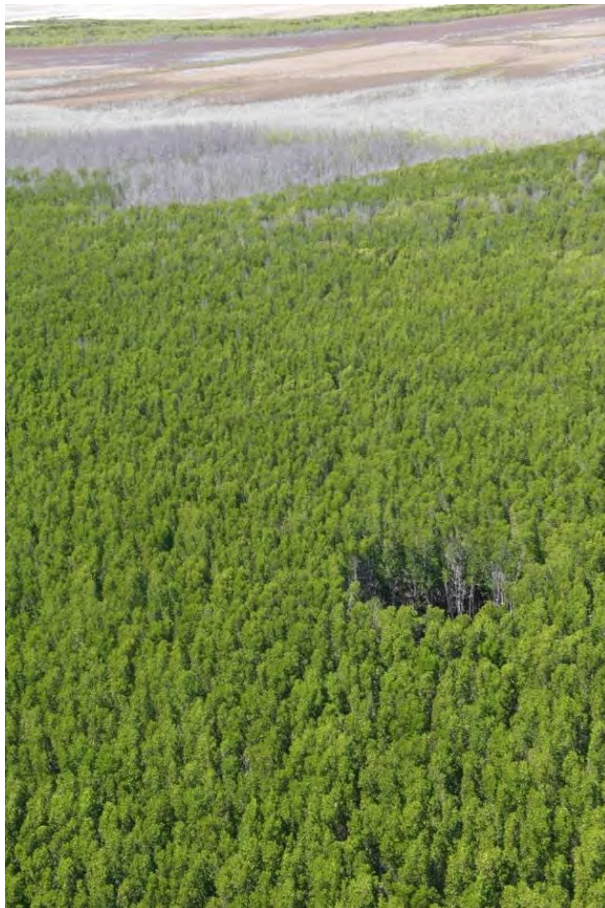
*Figure 2.24. Light gaps are caused by lightning strikes killing a small patch of mangrove trees in amongst otherwise undamaged surrounding mangrove forests. The impact and its recovery are distinct and unlike that in terrestrial forests. The number of gaps is an indicator of the frequency of storms.*

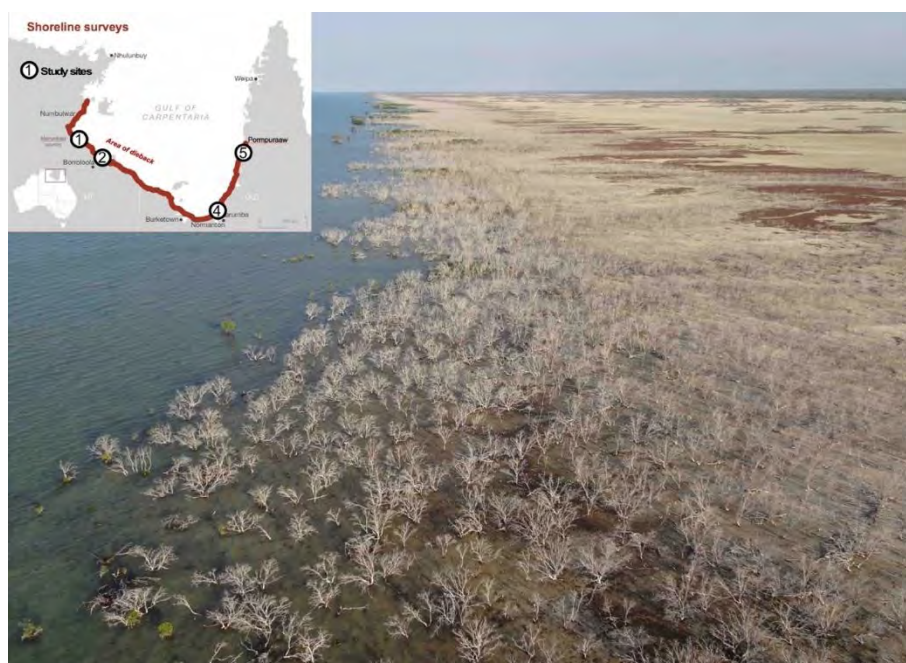
Figure 4.1. This image shows dead shoreline three years after the 2015–2016 event (Limmen Bight shoreline at site 1, Northern Territory, 2018). The inset shows the extent of the impacted shoreline along with four study site locations (Figure 2.1) where detailed field investigations assessed topography, vegetation and fauna (described in Vol. 2). Note: the state of degradation of dead trees at the time was such that they were standing and holding small twigs on branches.

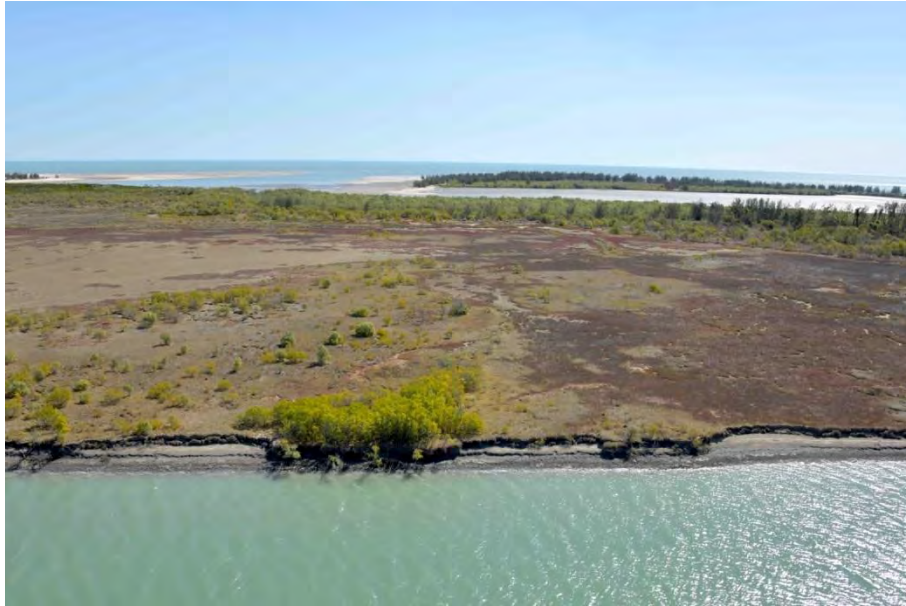
Figure 5.29. Damage from bank erosion, a notable issue for the Nassau estuary.

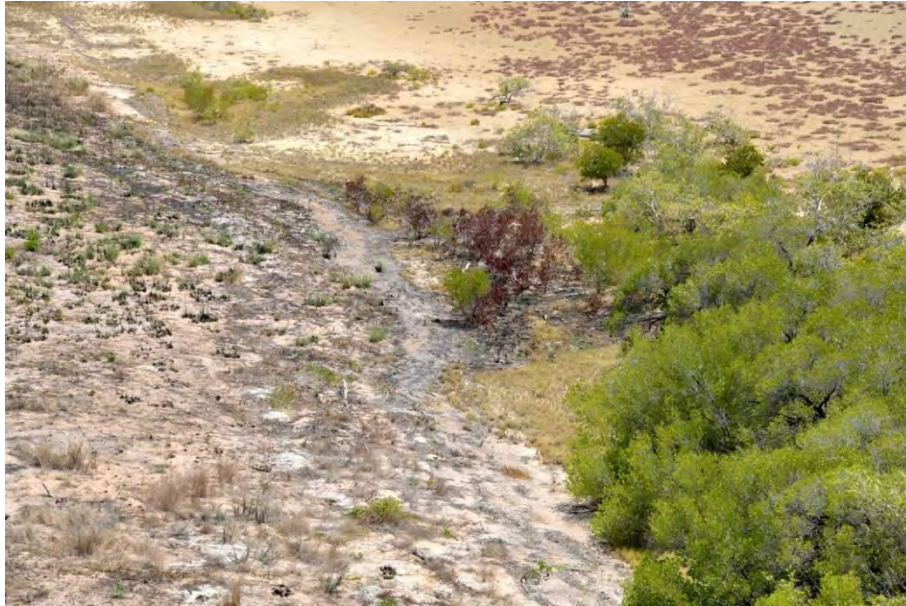
Figure 5.65. Damage from grass fires, a notable issue for the Syrell estuary.

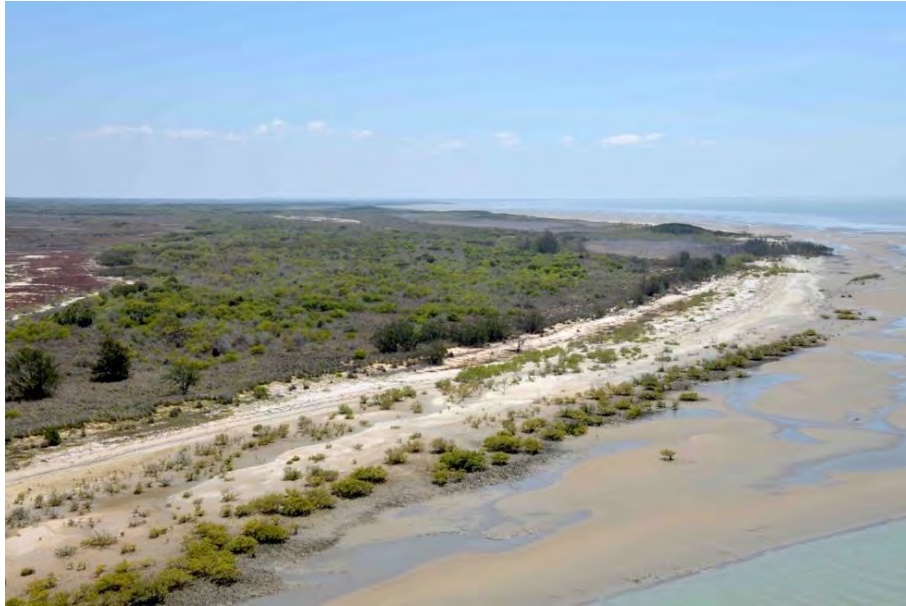
Figure 5.106. Damage from the 2015 mangrove dieback, a notable issue for the Towns estuary.

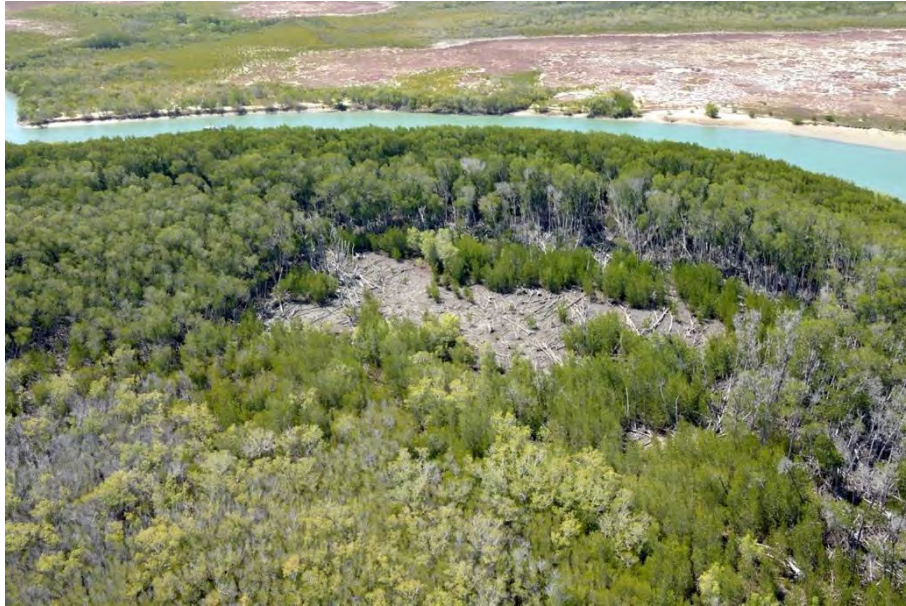
*Figure 5.112. Damage from a decade-old severe storm, a notable issue in the Miyangkala estuary.*
