# Trialling different low cost methods of water hyacinth removal in tropical coastal wetlands

Vern Veitch<sup>1</sup>, Damien Burrows<sup>1</sup> and David Hudson<sup>2</sup>

1 Australian Centre for Tropical Freshwater Research, James Cook University, Townsville, Queensland, 4811

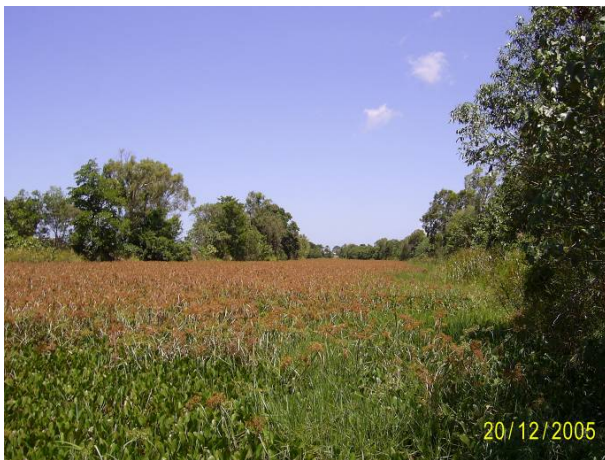
**Figure 2a. Lagoon Creek prior to treatment.**

spraying. It saved an estimated 10 day harvesting operation with an estimated additional cost of \$30 000. The series of images at Figure 2 shows progress made on weed removal prior to harvesting.

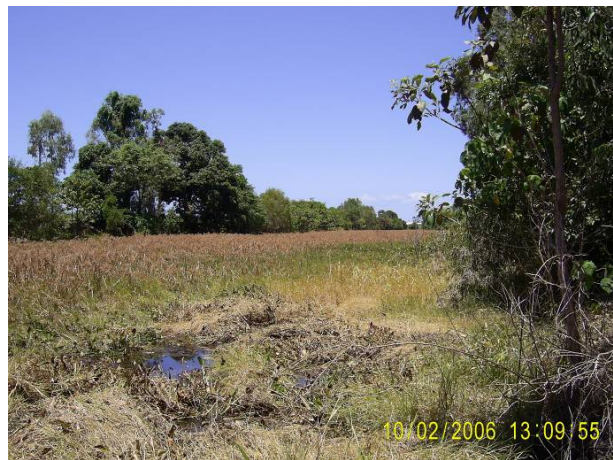
**Figure 2b. Effect of bankside herbicide spraying.**

Herbicide spraying effectively killed the bankside weeds but six weeks later the dead weeds had not decayed sufficiently to break the hold on the banks, enabling them to resist movement with minor flooding. However a 2<sup>nd</sup> event 10 weeks after spraying resulted in approximately 5 ha being flushed downstream.

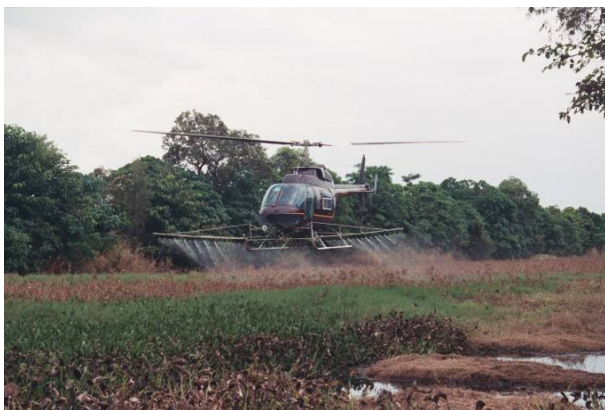
**Figure 2c. Brine spraying.**

After an initial trial of aerial brine spraying that did not seem to affect the water hyacinth, ground-based field trials were undertaken on 10 February 2006 to determine appropriate application strengths and volumes. Brine spraying was subsequently undertaken on 22 February 2006 in the most downstream lagoon using a helicopter fitted with spray booms for agricultural spraying. The effective swath of the booms was 11 metres with 50 Teejet air injected nozzles on the booms. Ten loads of 450 litres per load containing ~100Kg of salt/load were applied over ~ 10 ha. The operation took ~ three hours including an unexpected ~30 minute rain shower and cost \$5000.

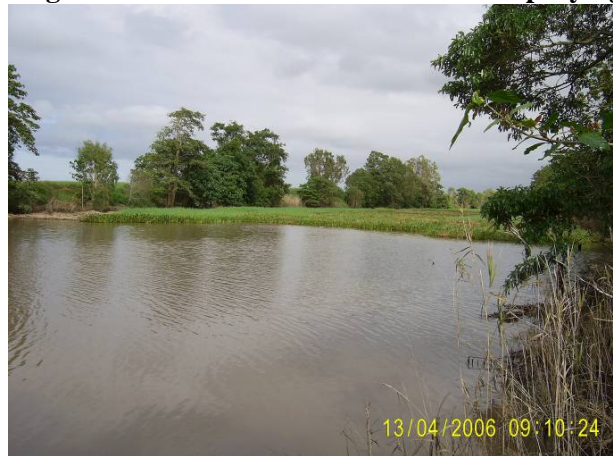
**Figure 2d. Weed flushed from lower half of lagoon after aerial brine spraying.**

The brine was not intended to kill the water hyacinth but to desiccate the leaves, causing them to shrink and/or burn. While the observed impact on the hyacinth was minor it killed the secondary infestation of plants (mostly sedges) that were binding the mat surface, which proved successful in reducing the integrity of the underlying weed mat. A subsequent rain event in April 2006 caused water in the lagoons to rise ~2 metres above normal height and this flushed out ~5ha of weeds in the downstream half of the lower lagoon though the remaining mats remained intact (Figure 2d). This second rain event cleared out 5ha of water hyacinth when the previous similar-sized event 5 weeks earlier had no effect, indicating the success of this method when combined with bank-side

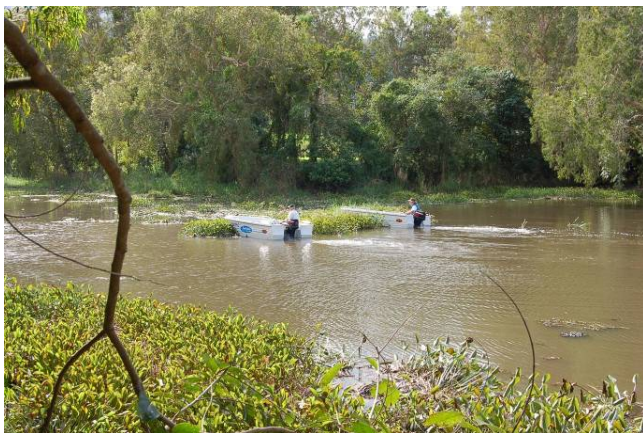
**Figure 3a. Small (4.3 m) boats without rakes pushing weed to the excavator.**

Methods trialled with the small boats included using a net to encircle weed “islands” cut by the harvester, and towing captured weed mats with one or both boats; using a net draped over a plastic floating pipe and pushing the pipe; or dropping an anchor over the bow and using it to “hook” weed islands and push or pull them with the bow of the boat overhanging the weed (Figure 3a). The latter two methods proved successful in enhancing the operation of pushing weed mats (up to tennis court size or larger) to where it could be reached by the excavator for removal. An important aspect of this operation was the use of prevailing winds to assist the boats and harvester in moving weeds to the excavator. Although precise quantification of costs is difficult, it was estimated that the small boats saved up to 4 additional days work for the harvester and excavator. Including operators, the costs for the weed harvester and excavator totalled \$2500/day compared with \$720/day for both boats. This suggests a cost saving of \$2800 for weed removal from 5 ha of waterway. It was thought however that the boats could be more effective if fitted with a rake and a design was developed and built to trial in a second lagoon (Figure 3b). Two small boats were fitted with mesh blades with one design constructed from a discarded security door. Construction and equipment costs for one boat totalled \$200 plus one day's work by a local stakeholder and a cheap second hand outboard motor costing \$800. The small boats fitted with mesh blades were then able to push much larger weed mats than those without rakes. Rake boats were also effective in pulling weeds from the banks and in collecting smaller patches of weeds that unmodified boats were unable to clean up.

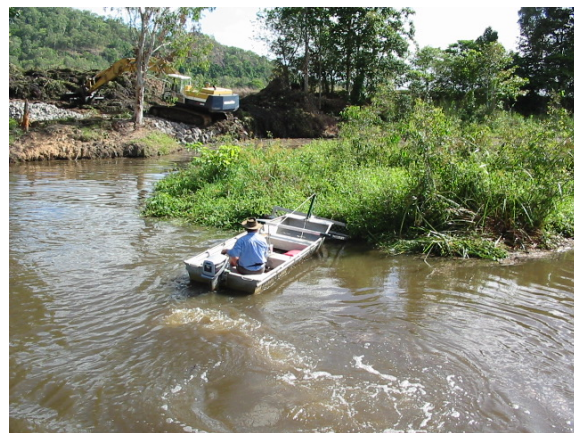
**Figure 3b. Punt with rake pushing weed mat.**

There has not yet been an opportunity to employ rake boats in regular maintenance of regrowing weed mats but limited trials have shown they can pull weed mats out from the bank in areas inaccessible to the harvester. If maintenance is well managed and timely, the weed harvester may not be needed. In addition, small boats may make mechanical harvesting viable in small wetlands that cannot presently be targeted by the heavier equipment. Their basic design, ease of deployment and low operating costs make maintenance simpler and more affordable.

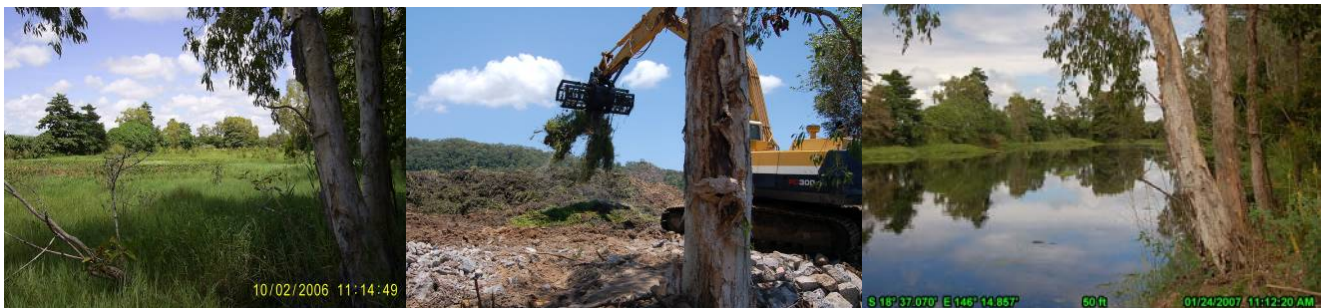
**Figure 5. Lagoon Creek with and without water hyacinth mats.**

Lagoon Creek now looks like a healthy floodplain wetland (Figure 5) although there is much more work to be done yet. Further monitoring after wet season rains will be necessary to measure the ecological responses to the improvements in visual and water quality aspects of weed removal, as well as faunal recovery.
