MINING ENVIRONMENTS: THE GOOD, THE BAD, AND THE UGLY¹

Bernd G Lottermoser²

¹Paper was presented at Mining and the Environment IV Conference, Sudbury, Ontario, Canada, October 19-27, 2007.

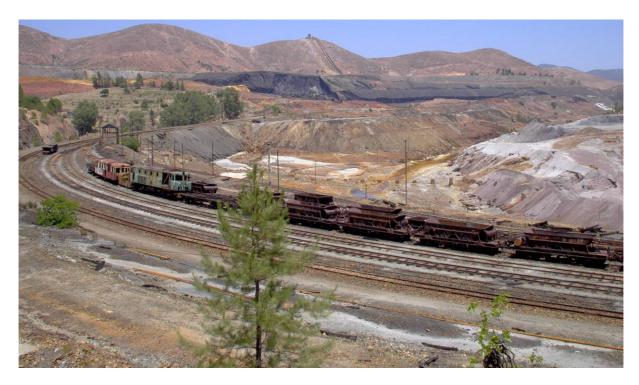
Figure 1: Slag heap, sulfidic waste dumps, and abandoned railway carriages at Rio Tinto, Spain. The mining activities have left uncountable waste rock heaps, ore stockpiles, tailings dumps, slag deposits, and settling ponds, most of which do not support any vegetation. The exploitation of sulfidic ores has created a unique "mining landscape" and caused massive ARD flowing into the Rio Tinto.

At Rio Tinto, successive mining activities have resulted in the creation of a unique "mining landscape" (Fig. 1). The region has numerous abandoned mine workings and is littered with derelict buildings and disused mining and processing equipment. There are also uncountable waste rock heaps, ore stockpiles, tailings dumps, slag deposits, and settling ponds, most of which do not support any vegetation. The lack of vegetation on sulfidic wastes and local soils increases erosion rates into the headwaters of the Rio Tinto. Pyritic waste particulates are transported into the river tens of kilometers downstream of the mine and processing sites (Hudson-Edwards et al., 1999). The erosion processes exacerbate the "moonscape appearance" of the area affected by mining, mineral processing and smelting activities. Most importantly, the Rio Tinto mining district is characterized by uncontrolled pyrite oxidation in exposed mine workings and waste materials (Romero et al., 2006). The oxidation of pyrite causes formation of sulfuric acid and the dissolution of many metals. Mine waters are quite acid (pH 2 or less) due to the oxidation of abundant pyrite.

The Rio Tinto mining district is drained by the Odiel and Tinto rivers (Fig. 1). The Tinto river is 90 km long and remains strongly acid (pH <3) for its entire length (Leblanc et al., 2000; Braungardt et al., 2003). Tinto is Spanish for "red wine" and clearly refers to its turbid red, acid water. The stream's distinct turbidity is the result of abundant iron-rich suspended colloids and gelatinous flocculants. The river also carries very high dissolved sulfate, metal, and metalloid loads (As, Fe, Cu, Cd, Ni, Pb, Zn) from the headwaters to its estuary (España et al., 2005). Part of this dissolved metal load is precipitated into fluvial and estuarine sediments. Another part of the metal load enters continental shelf sediments and waters of the Gulf of Cadiz and contributes to the metal content of the Mediterranean Sea through the Strait of Gibraltar. The waters and sediments of the Rio Tinto are strongly polluted with metals and metalloids. In fact, the Tinto river is one of the most polluted streams in the world. Despite its pollution, the Rio Tinto acts as an ecological niche for at least 1300 different microorganisms including algae, fungi, bacteria, yeast and protists (e.g. Ariza, 1998).

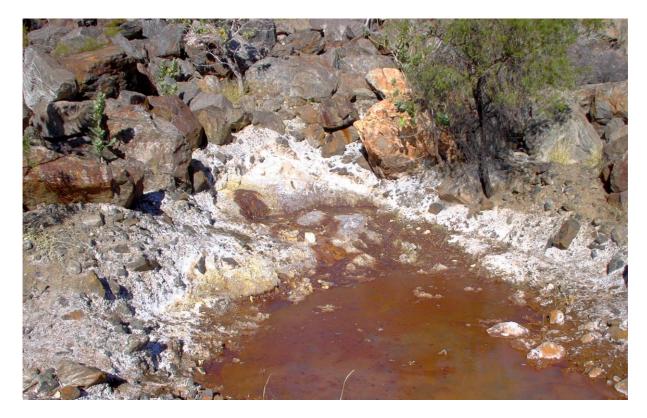
Figure 2: Seepage point at the base of the tailings dam wall, Mary Kathleen, Australia. Abundant sulfate efflorescences and Fe-oxyhydroxide precipitates form from the acid, saline, radioactive seepage water (pH: 5.5; salinity: 0.31 %). Bolders in the retaining wall are approximately 1 m in diameter.

Seepage water from the TSF is slightly acid (pH 5.5), metal- and SO_4 -rich, and radioactive (Fig. 2). There is rapid precipitation of Fe oxyhydroxides, with absorbed U, REE, Y, As and radionuclides. Further downstream, surface and groundwaters become near-neutral, but increase in salinity such that there is widespread precipitation of sulfates. Although release of U and other metal/metalloid contaminants from the TSF is insignificant, concentrations of TDS, U and SO_4 in surface waters exceeds livestock water guidelines.

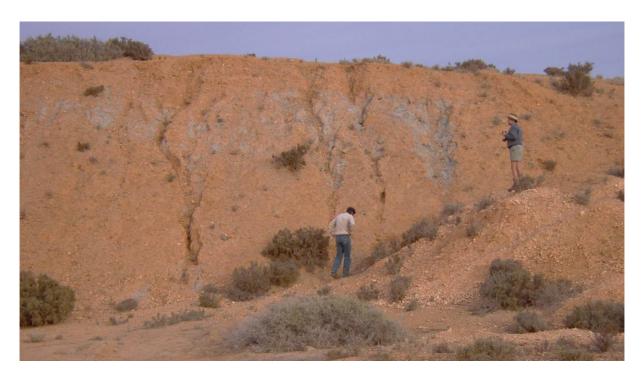
Figure 3: Rill erosion of the soil capped tailings storage facility, Radium Hill, South Australia (height of facility approximately 6 m). The soil capping is being removed, resulting in the exposure of radioactive tailings in rills.

At Radium Hill, rehabilitation efforts have been restricted to capping of tailings, but following a 20 year period of prior extensive wind dispersal of exposed tailings that has impacted local soils. Physical erosion of waste repositories is of on-going concern (Lottermoser and Ashley, 2006). It is evident that the capped tailings repositories will degrade in time, causing increased erosional dispersal unless further remediation measures are implemented. The erosion of capped waste repositories, particularly by infrequent rainstorm events, highlights the fact that dry capping of waste dumps in semi-arid terranes may not necessarily lead to the permanent containment of wastes.

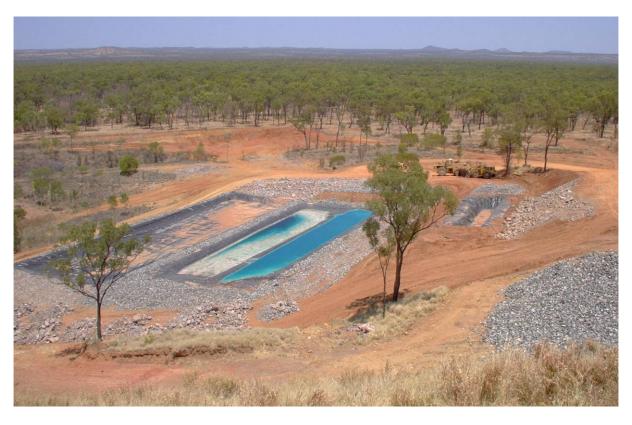
Figure 4: View from the tailings storage facility, Red Dome gold mine, Queensland, Australia. Cyanide-bearing seepage waters (~200-500 mg/l total cyanide, 80-300 mg/l WAD cyanide, 200-600 mg/l Cu) emanate from the capped tailings repository. The seepage is collected via a series of ponds where chemical degradation of cyanide and precipitation of copper cyanide salts occur. The passively treated effluent is discharged to the local stream system.

In 2001, seepage from the Red Dome Mine TSF was characterised as being relatively alkaline, saline and containing high concentrations of cyanide and Cu (Fig. 4). The seepage was collected via a series of tanks and ponds where chemical degradation of the cyanide occurred. Monitoring carried out within the heap leach impoundment system illustrated that degradation and dilution of cyanide to below

EMOS (Environmental Management Overview Strategy) criteria readily occurred. However, EMOS criteria require that the concentration of Total Cyanide (TCN) and Cu in water do not exceed a limit of 1 mg/L and 2.3 mg/L, respectively. While disposal and treatment of the seepage via the tanks and ponds were effective, it required regular pumping. Hence, the State Government advised the lease holder to set up a more appropriate and fail safe system of treatment and disposal that required less human intervention. To date, such a fail safe treatment system for Cu-cyanide rich mine drainage waters remains to be identified.

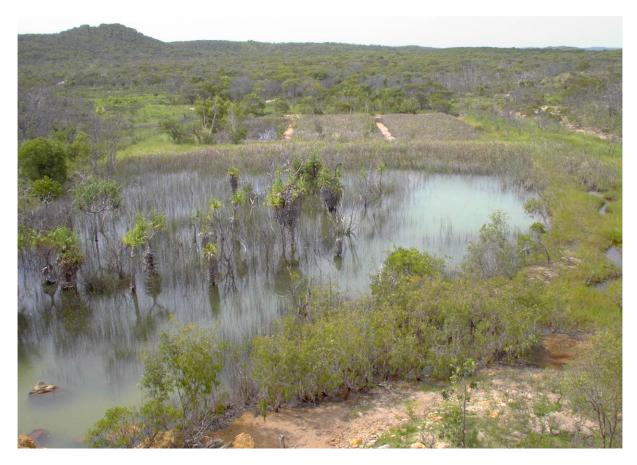
Figure 5: Wetland at the Horn Island gold mine, Australia. The wetland has failed because an adjacent damwall was constructed using acid generating waste rocks (foreground), which resulted in significant ARD and caused plant death.

In 1989, the mining operation went into liquidation and the State Government became responsible for its restoration. Rehabilitation efforts to date include dry capping of the tailings storage facility and ore dump, creation of wetlands and diversion of creeks to fill the open pits with freshwater. These rehabilitation efforts have been of very limited success. While the rapid filling of the open pits with

freshwater has resulted in acceptable water quality, there is ARD from the ore stockpile and waste rock dumps, affecting vegetation and possibly littoral marine fauna and flora of the Great Barrier Reef. Also, tailings placed into a shallow water pond (max. ~6 m deep) release metals into the overlying water column. Moreover, the installed wetland has failed as materials used for the construction of the wetland and adjacent dam are acid generating (Fig. 5). Additional rehabilitation would be necessary. However, the lack of suitable capping materials in the Torres Strait region, its remote location and seasonal rainfall pattern, and the intended return of the mined land to indigenous landholders pose an extraordinary reclamation challenges.
