FINAL REPORT

MISSION BEACH ROAD RESEARCH: TRAFFIC IMPACTS ON CASSOWARIES AND OTHER FAUNA AND STRATEGIES FOR MITIGATION

Miriam Goosem, Leslie Moore, Peter Byrnes,
Marina Gibson

School of Earth and Environmental Sciences
James Cook University, Cairns

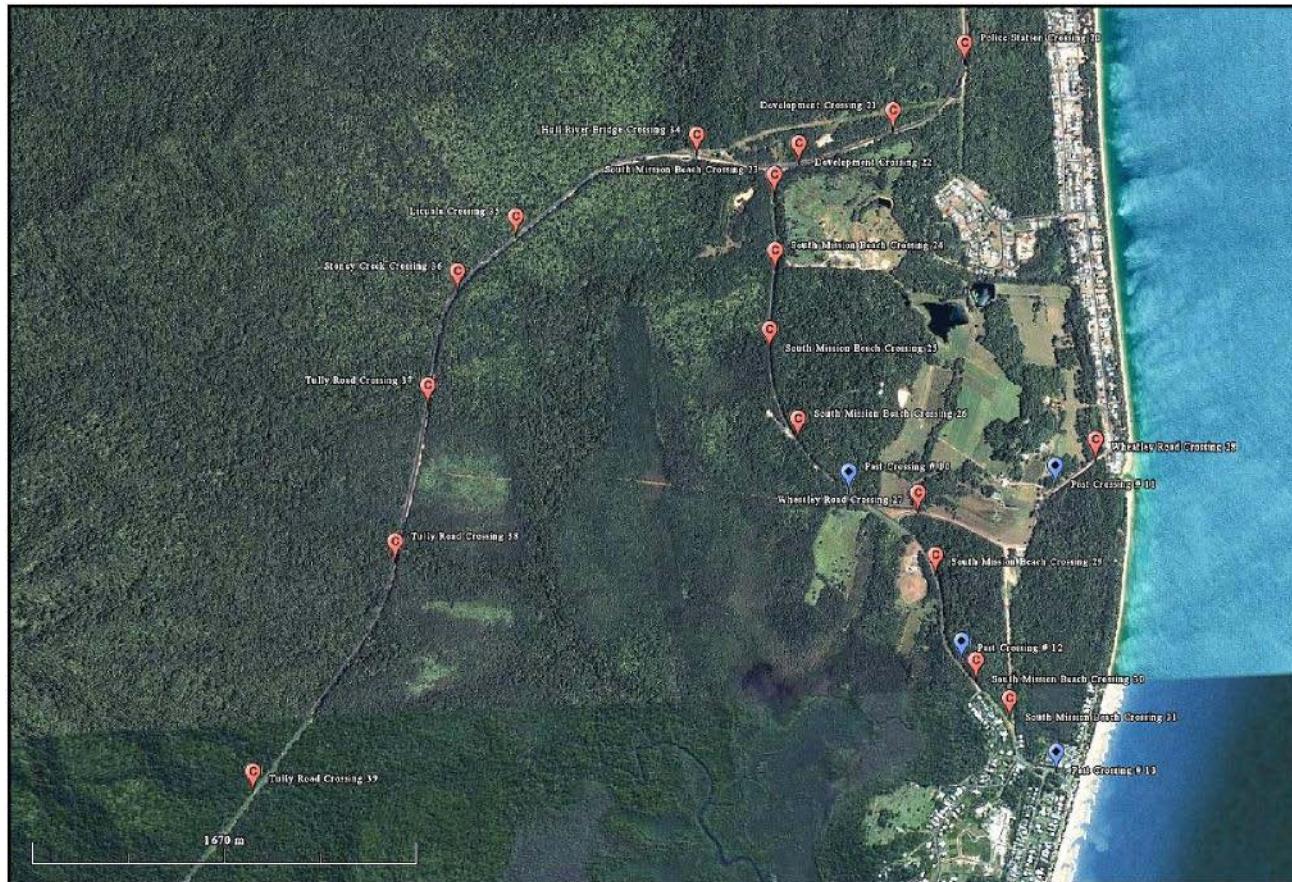
Figure 2.10

An example of the detailed mapping of crossing locations (South Mission Beach Road and Licuala).

Red icons = active crossings Blue icons = past crossings from previous studies
Icons generally represent a zone of crossings rather than exact points

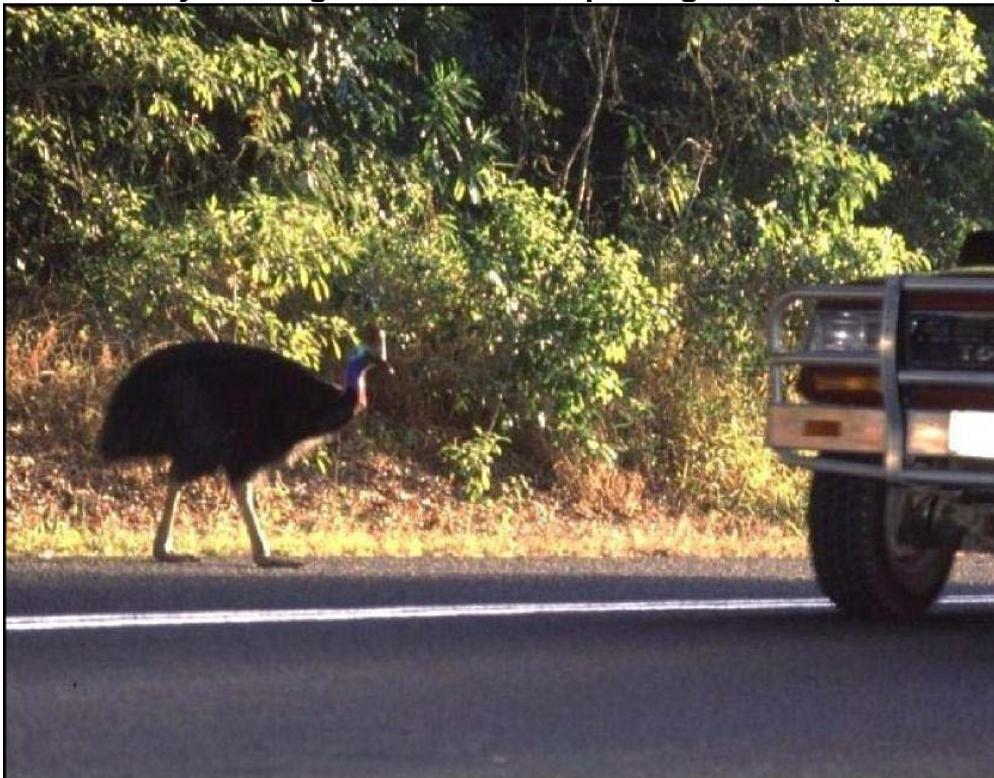
Figure 2.21

Adult cassowary crossing the road between passing vehicles (Photo: M. Prociv)

Some cassowaries become habituated to roads and will calmly attempt to cross between passing vehicles (Figure 2.21). If sighted early, most drivers will slow or stop to let the bird cross safely. However, a crossing cassowary can be easily concealed from view by a first vehicle, subsequently colliding with the following vehicle that was unsighted.

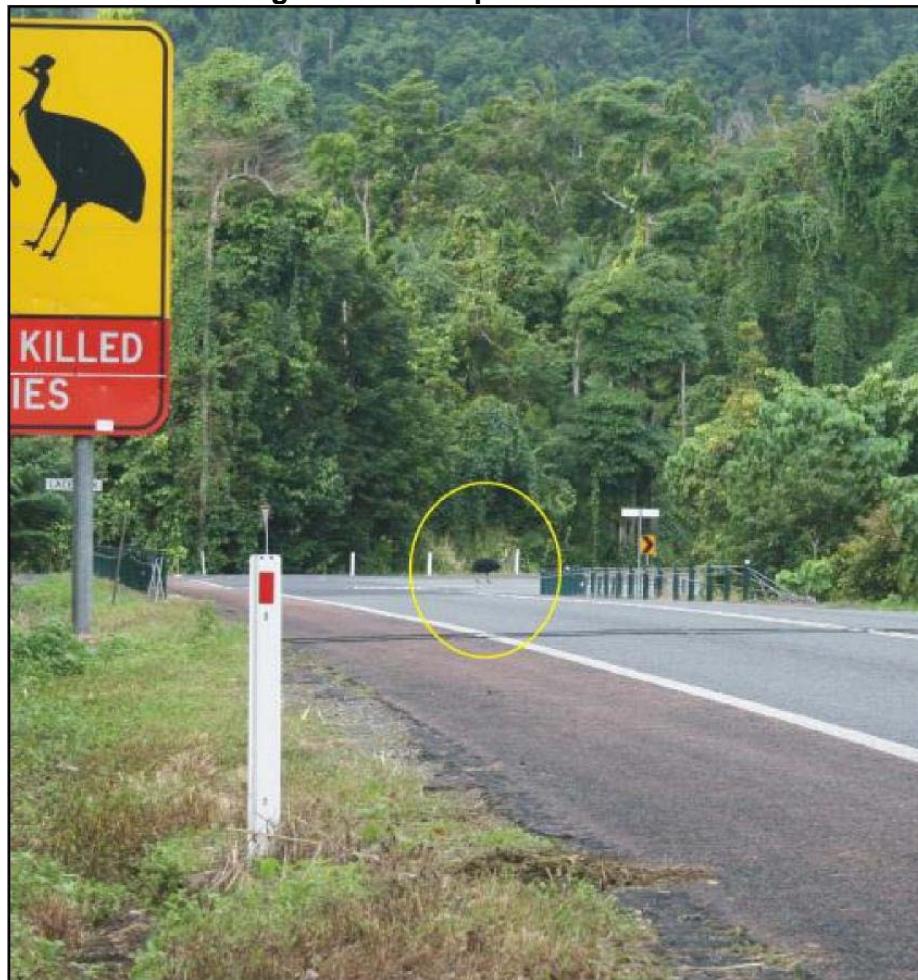
Figure 2.22

Cassowaries crossing the road in open areas can be difficult to detect

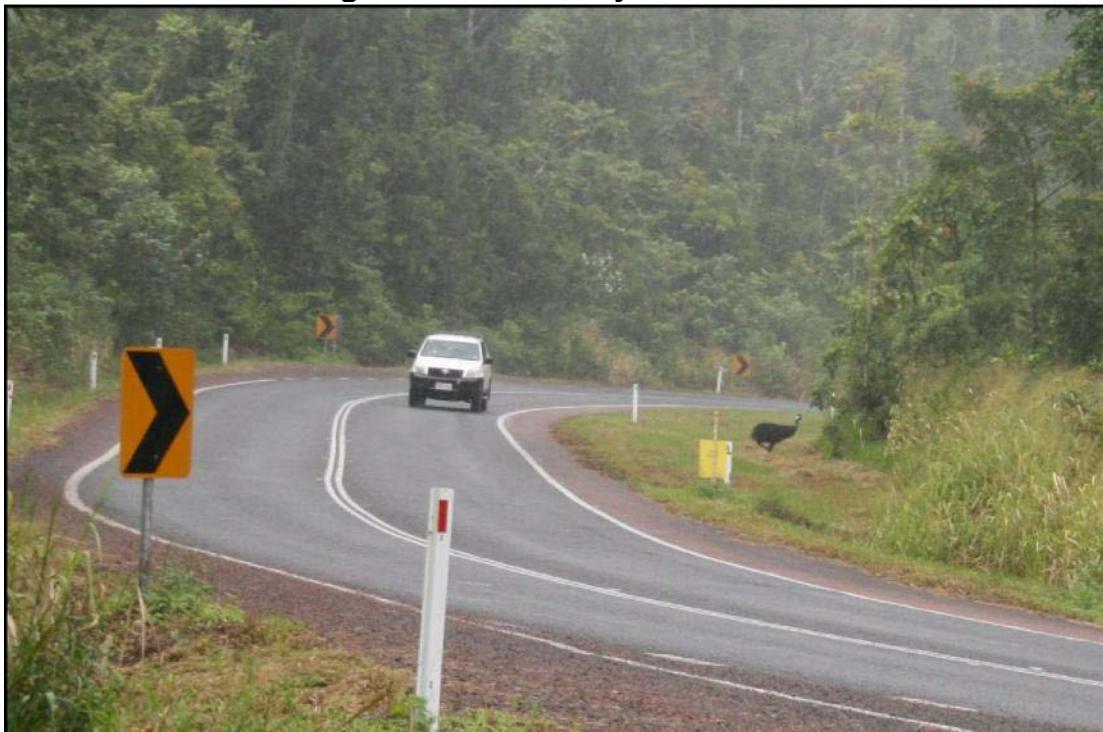
Figure 2.23
Vehicles travelling fast are more likely to collide with cassowaries

Figure 2.23 shows the adult female cassowary had just crossed the road when a vehicle travelling in excess of 100 kph passed. This cassowary, which had been identified ten years ago in the 1998 field survey, was subsequently killed at this location in September 2008.

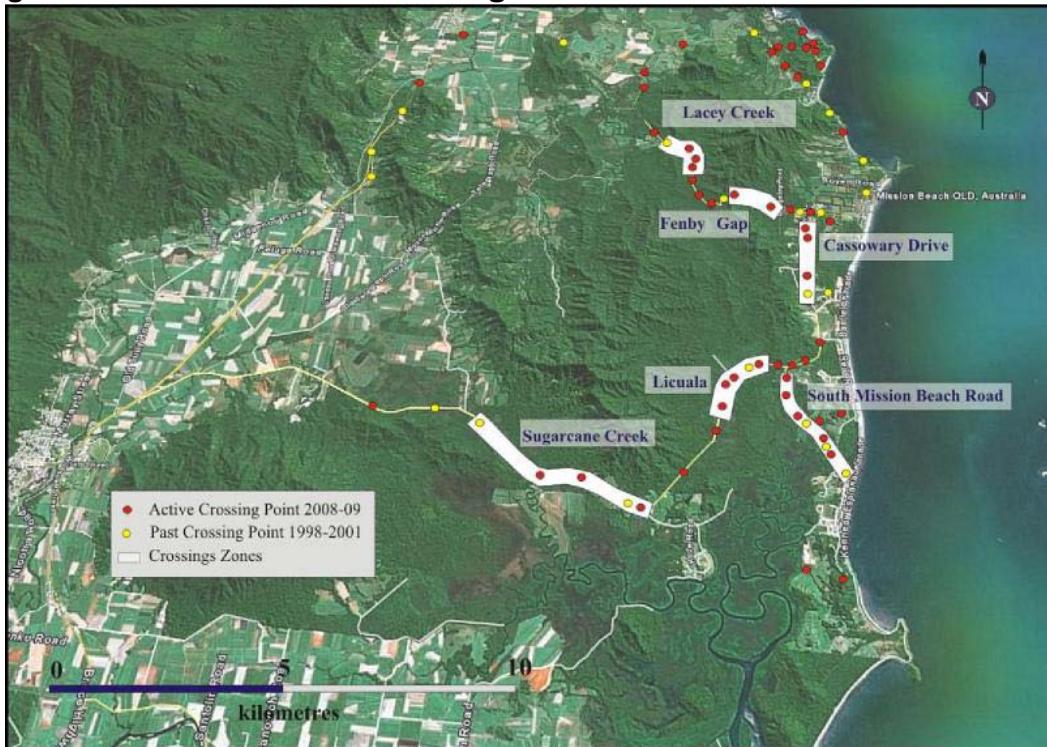
Figure 2.26 Location of road crossing zones at Mission Beach

Road crossings made prior to March 2006 were analysed for pre-cyclone patterns. Where data were sufficient, similar analyses were applied to the three years of post-cyclone data and an evaluation made of changes in crossing use by cassowaries.

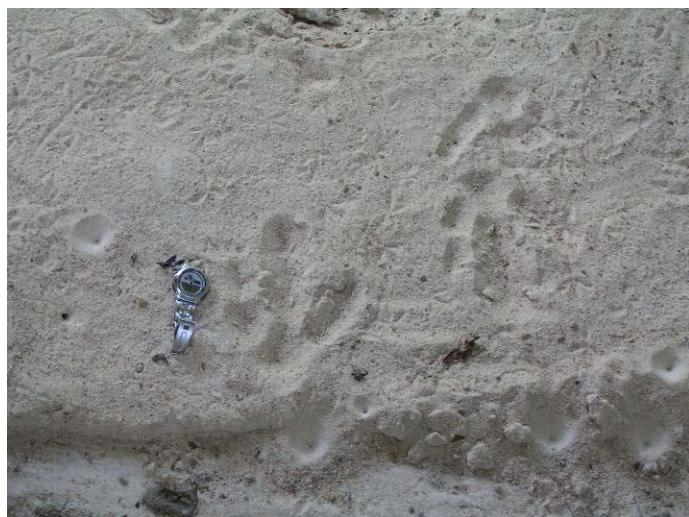
Figure 3.6 Variety of tracks including Southern Cassowary found in the sand trap under North Hull River bridge on 25/09/2008.

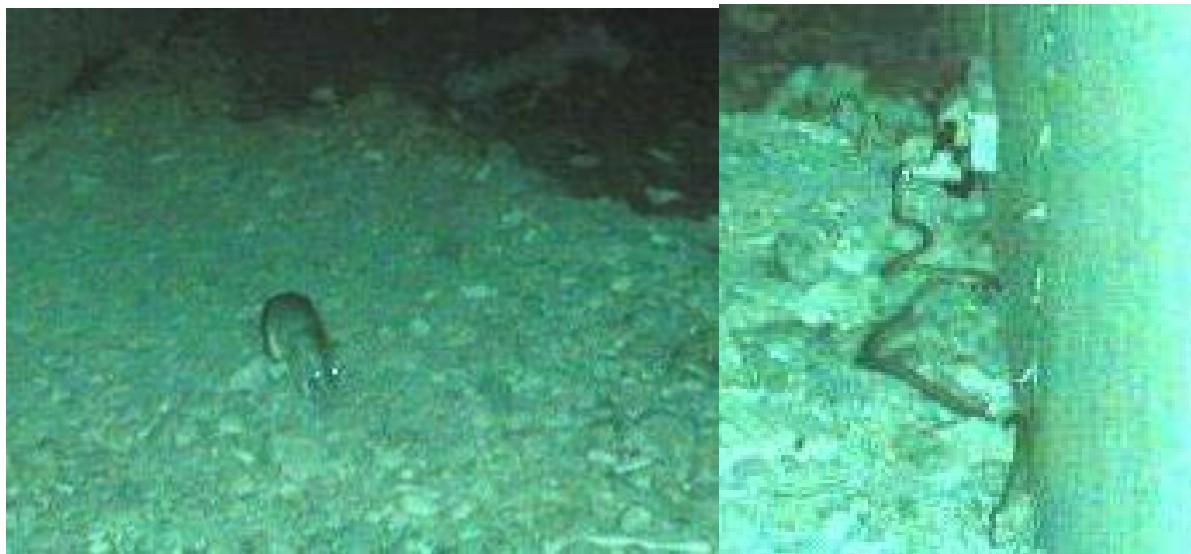
Figure 3.8 Long-nosed Bandicoot and Snake photographed inside the Lacey Creek culvert.

Additionally, several photographs were obtained using infra-red triggered wildlife cameras of animals using the Lacey Creek underpass. Unfortunately, cameras in the Stoney Creek underpass were not successfully deployed prior to flooding, when sensors were washed away and it was not possible to install cameras safely that would cover the large area under the Hull River bridge (Figure 3.8).

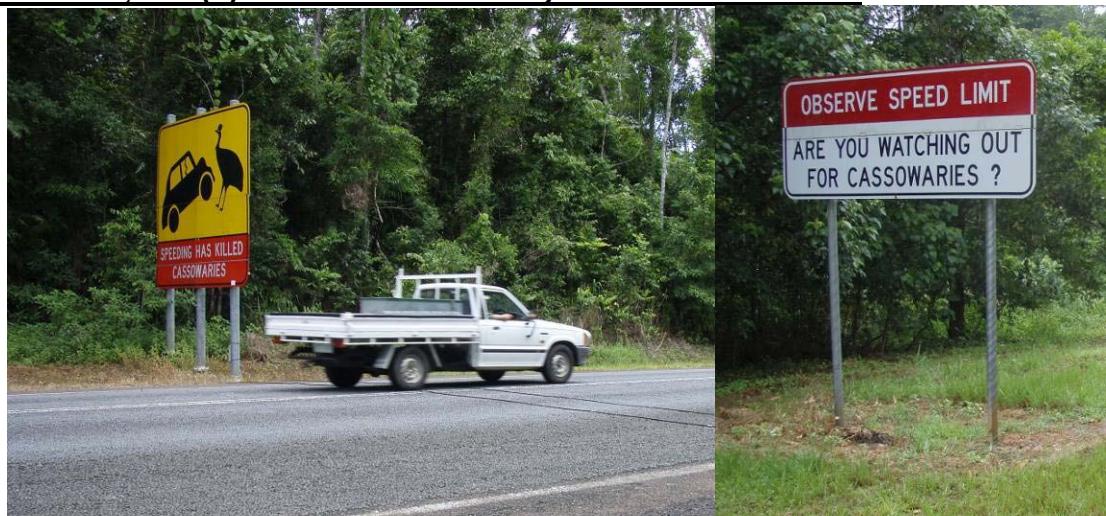
Figure 4.20.

Signs warning of the risk to cassowaries at (a) Lacey's Creek on the El Arish Mission Beach Road, and (b) Hull River on the Tully Mission Beach Road.

Traffic calming at Lacey's Creek (signage and rumble strips) may be effective to some extent, as evidenced by the mean speed at this site being significantly lower than either of the other two sites on the El Arish Mission Beach Road for both the small and larger vehicle classes (Figures 4.14 and 4.18). However, the road surrounds at this site probably also exert an effect on speed. The site is located to the west of Lacey's Creek picnic area and walking tracks, to which there is an entry from the main road causing people to slow if they wish to pull off when coming from El Arish. When re-joining the road from the picnic area to travel in a westerly direction, some vehicles may also take a while to increase speed and therefore be recorded at a slower speed. Vehicles entering the picnic area and leaving it will also exert a slowing effect on through traffic. Additionally, a large curve occurs to the east of the picnic area entrance and this is likely to cause some vehicles to reduce speed in the vicinity of the traffic counter location. The presence of the signage at Lacey's Creek may also cause lowered speeds, at least for tourists, many of whom slow or stop to look at or take photographs of the sign. Therefore, the effectiveness of the traffic calming implemented at this site is difficult to assess, although the mean speed for small vehicles and buses and medium-sized trucks was 6 km/h below the posted legal speed limit (80 km/h).

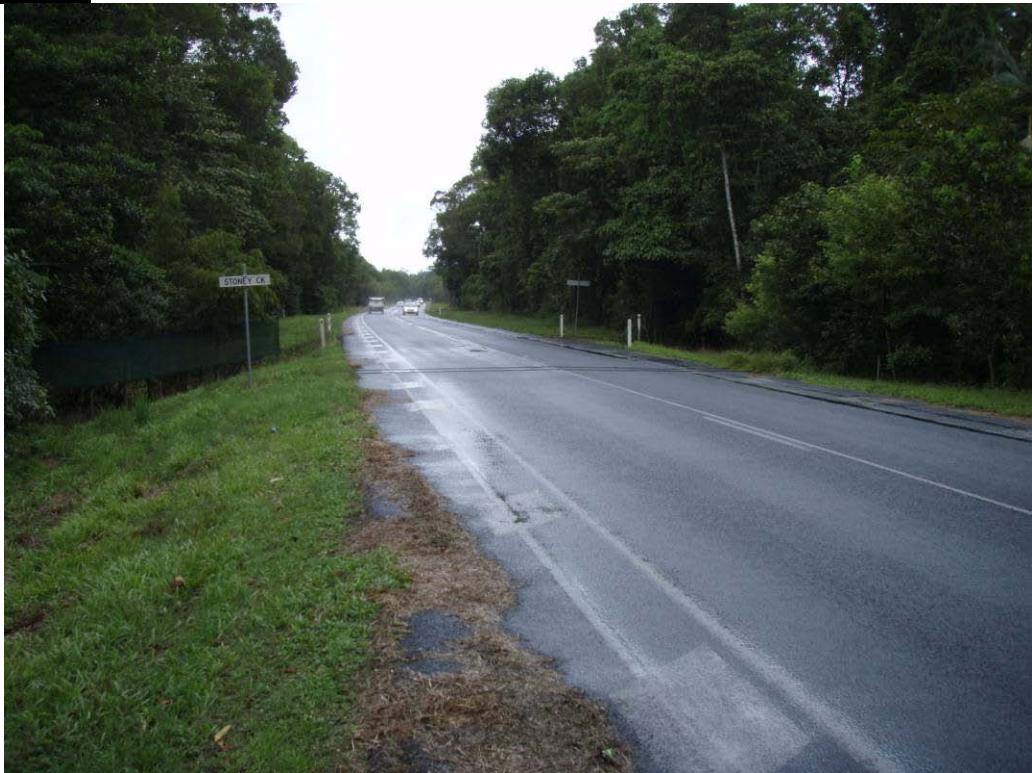
Figure 4.21.

Traffic calming lines on the edge of the road at Stoney Creek on the Tully Mission Beach Road.

The potential effectiveness of traffic calming at Stoney Creek (lines on road) on the Tully Mission Beach Road is not likely to be confounded by other aspects of road design as there are no roads turning off from this section and the site is located on a long, straight stretch of road. There are no reasons for vehicles to slow down, aside from the traffic calming. Vehicle speeds, for all classes tested, were 2-3 kph lower at Stoney Creek than at the other two sites on the Tully Mission Beach Road, suggesting that there may be an advantage accruing from this traffic calming. The effectiveness is negligible, however, when the mean recorded speeds are considered: both small and larger vehicle speeds were above the posted speed limit on this section of road (80 km/h). Maximum recorded speeds at this site were at least twice the legal speed limit.

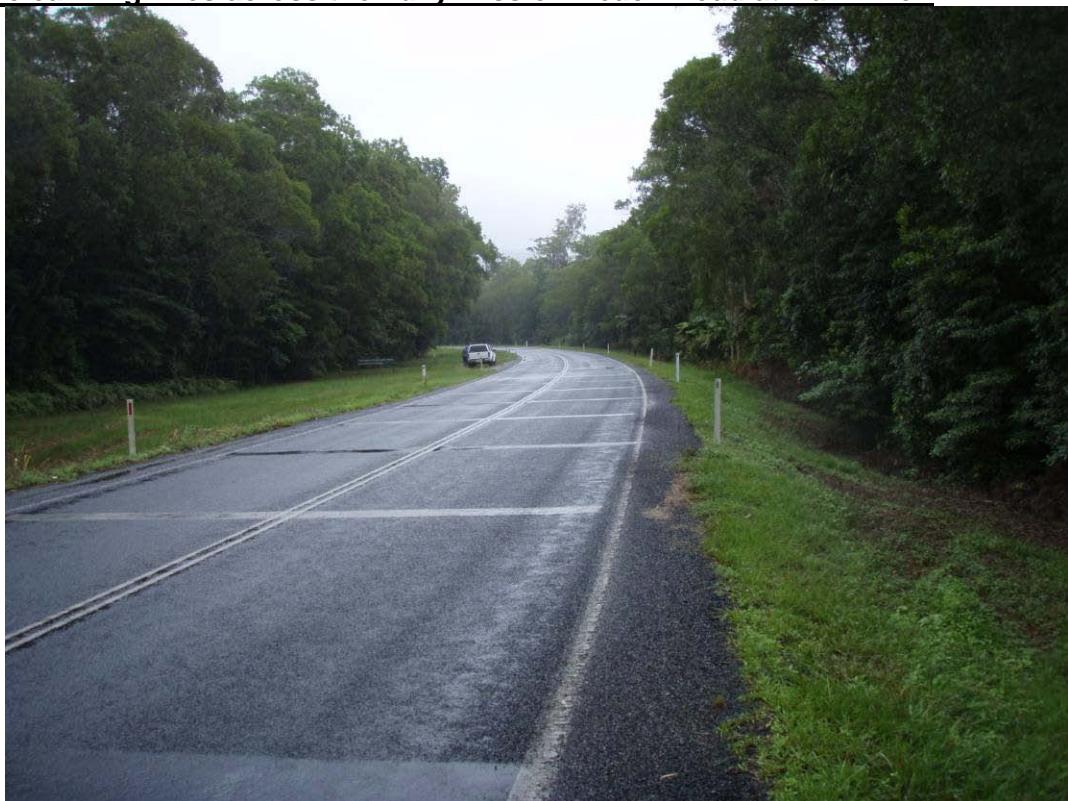
Figure 4.22.

Traffic calming lines across the Tully Mission Beach Road at Hull River.

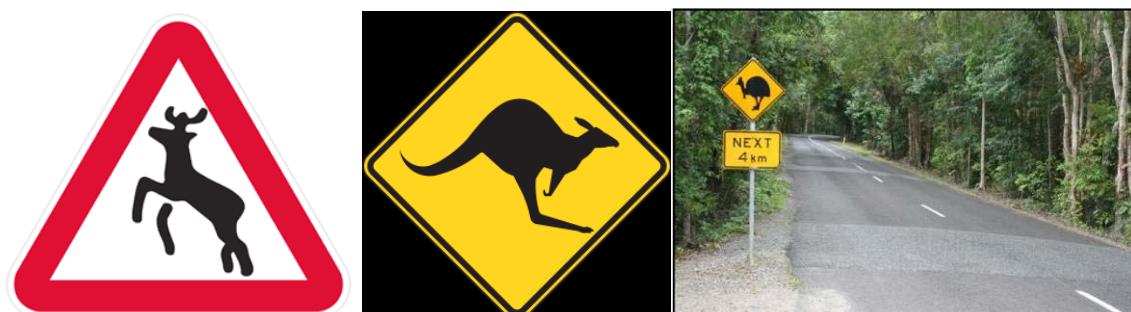
Figure 5.1 Permanently visible signs in fixed locations with static messages

a) European deer b) Kangaroo c) Cassowary crossing teamed with speed hump, Cape Tribulation Road

Standard black on yellow or black and red wildlife warning signs are probably the most widespread roadside road mortality mitigation measure used throughout the world (Bank *et al.* 2002; Huijser and McGowen 2010; Figure 5.1a,b), due to being economical (Magnus *et al.* 2004). These are also the most common signs warning of the potential for cassowary crossings (Figure 5.1c). Warning signs tend to be installed when thresholds of wildlife-vehicle collisions are reached (Knapp and Witte 2006). However, permanently visible signs that remain in the same location and show the same message in words or pictures at all times and in all seasons do not appear to be effective in reducing mortality, even when road, traffic and landscape factors are accounted for (Rogers 2004; Meyer 2006; Huijser *et al.* 2010). Aberg (1981) investigated whether a standard moose warning sign helped Swedish drivers detect a dummy moose placed within 5 metres of the road, finding no change in either rates of detection or driving speeds. We found no further scientific evaluations of whether such passive signs are effective in either increasing driver awareness of large animals or in reducing driving speeds and thus the likelihood of animal-vehicle collisions (Hedlund *et al.* 2004). There appears to be a general consensus that drivers ignore permanently visible standard signs (Aberg 1981; Putman 1997; Sullivan *et al.* 2004; Rogers 2004; Meyer 2006; Huijser *et al.* 2007; Huijser and McGowen 2010), particularly when they are placed in areas where animals are only occasional road crossers. Signs such as these are likely to be most useful in public education rather than increasing driver alertness and reducing **cassowary** mortality.

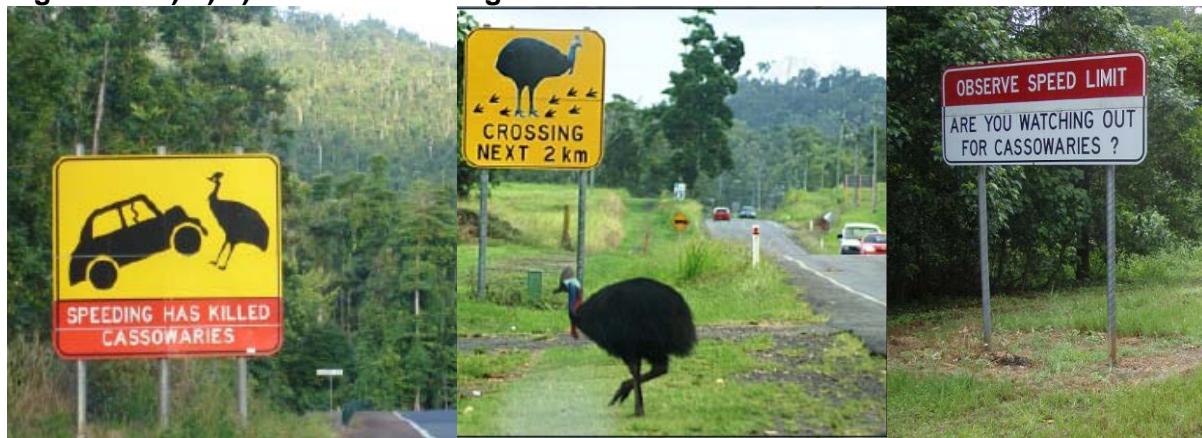
Figure 5.2 a) b) c) Non-standard signs on Mission Beach roads

It is possible that more unusual permanent signs, such as those showing a cassowary-vehicle collision (Figure 5.2) may be more effective than standard signs, at least for visitors who are not habituated to the signs, rather than the local community. However, there is little scientific data about unusual permanent signs with static messages. Knapp *et al.* (2004) concluded that all passive deer crossing signs had limited effectiveness. Enhanced black on yellow deer warning signs showing a deer and a car combined with a black on orange sign stating HIGH CRASH AREA did not reduce collisions (Rogers 2004). Some visitors have been observed to slow down at **Lacey's Creek** near the sign in Figure 5.2a. However, unless they stop completely to take photographs of the sign, it is impossible to determine whether the speed reduction is due to the sign, the presence of the picnic ground or the likelihood of vehicles entering the roadway from the picnic ground (see Chapter 4). Although numbers have not been quantified, the majority of vehicles passing through the area did not slow down.

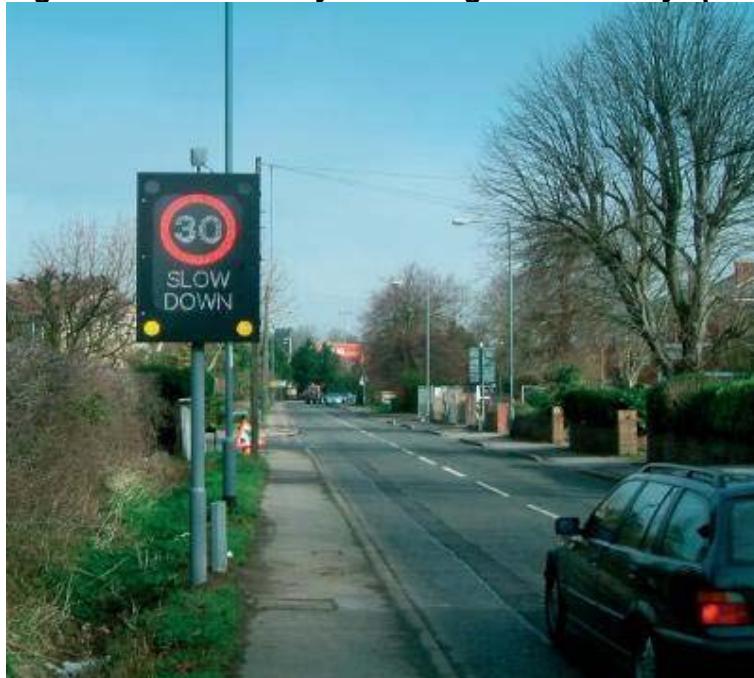
Figure 5.3 Permanently visible sign activated by speeding vehicle.

Figure 5.3 shows permanently visible signs which are blank until activated by a speeding vehicle moving along the roadway. The message shows the driver either vehicle speed, registration number or a message of slow down combined with the speed limit. Data can be collected remotely. The distributor claims that Department of Transport studies have proved this device has a dramatic and instant impact in reducing traffic speeds and accident occurrence rates, although no details are given. These are commonly used in Brazilian towns (pers. obs.). Again there appears to be no scientific evaluation of whether this type of sign would be effective in reducing animal-vehicle collisions when remote from enforcement, so trials are required. A trial of signs such as these along the **entry roads to Mission Beach** would determine whether these would be likely to have a long-term effect on drivers and whether enforcement could be linked to the signs.

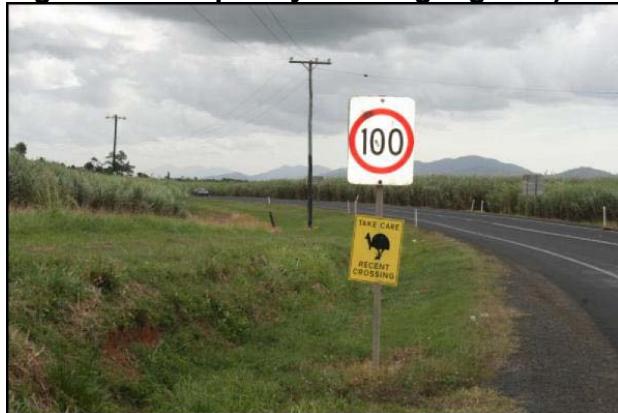
Figure 5.4 Temporary Warning Signs a) for cassowary crossing at Mission Beach

Temporary warning signs (Figure 5.4) are placed out only when animals have been observed in an area or alternatively at certain times of the year such as seasonal migrations. Therefore they are a much more specific warning signal to drivers compared with permanent signage. Messmer *et al.* (2000) found a 13 kph drop in vehicle speeds and a 50-70% decrease in mule deer-vehicle collisions during seasonal migrations when large warning signs with flashing amber lights were placed on roads only at migration times. This was a one year trial compared with three previous years of migration death rates. Similar signs produced similar results for Sullivan *et al.* (2004) when dealing with migrations of the same species. They saw collision reductions of 51% (ranging between 41.5 and 58.6% in different areas) compared with areas without signs. Speeding vehicles were reduced from 19 to 8% in the first year of operation but the effect was less pronounced in the second season the signs operated, suggesting driver habituation and the possibility that over time these types of signs may become far less effective (Huijser and McGowen 2010). In contrast, Rogers (2004) did not find a reduction in deer-vehicle collisions using a sign with flashing lights that was deployed in the season of peak collisions. This is the type of sign currently used at Mission Beach when **cassowary** crossings are reported (Figure 5.4)

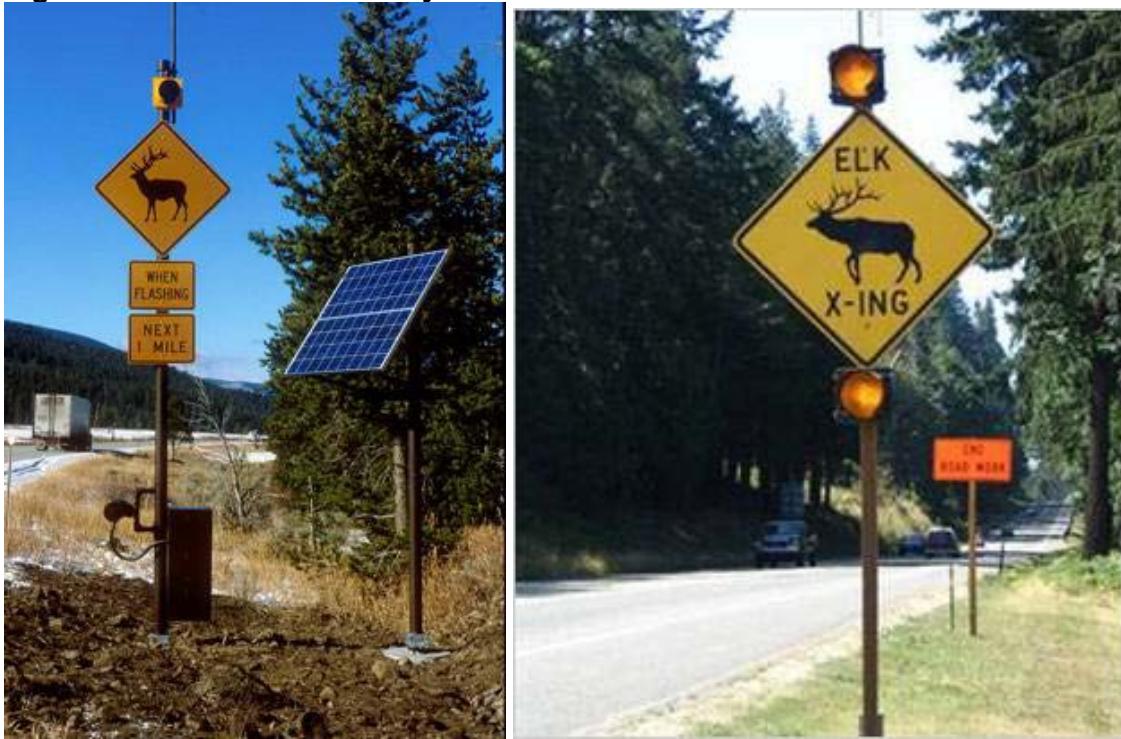
Figure 5.5 Wildlife detection systems

Photo: a) copyright Marcel Huijser, Montana State University b) An animal detection system is combined with signage and lights to warn drivers that animals may be in or near the roadway (Wildlife Crossings Toolkit)

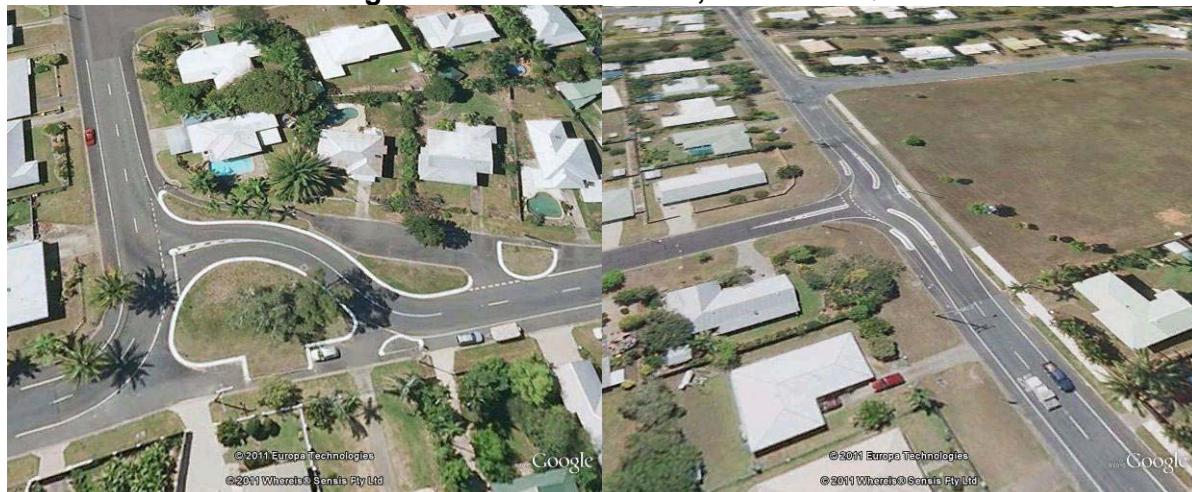
Figure 5.6

Chicanes used for slowing urban traffic in Cairns, Far North Queensland

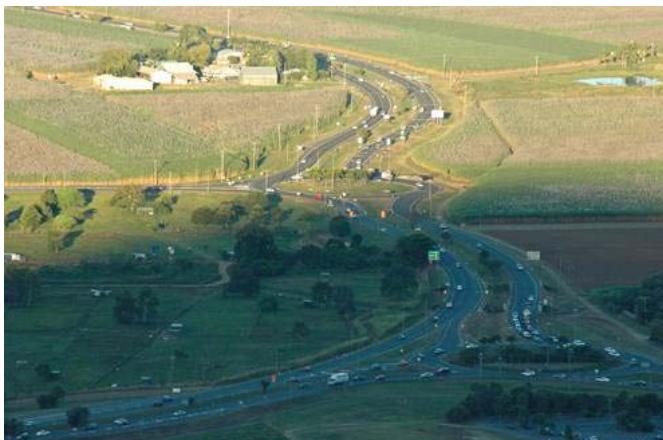
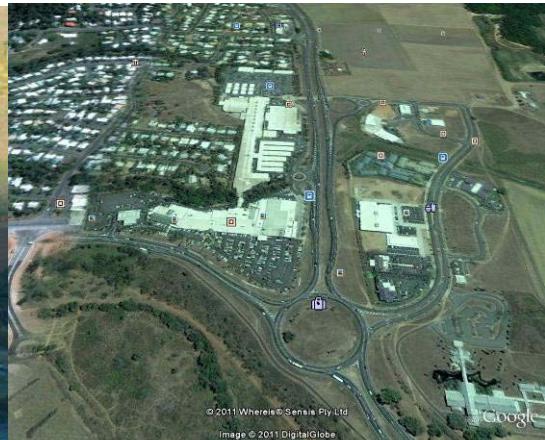
Figure 5.8

Roundabouts used to reduce traffic speed at important intersections on major roads and smaller intersections on minor roads.

Traffic calming is used to reduce traffic speed through careful road design. In urban areas it is generally accepted by the majority of the community that speeds should be reduced on sections of urban access roads where the community wishes safety to be paramount (van Langevelde and Jaarsma 2009). For example the inclusion of roundabouts at intersections and/or chicanes along straight or curved sections of the road is a common feature of urban areas designed to slow traffic (Figure 5.6). The objectives are to ensure safety for residents, particularly children, and to reduce the tendency for through traffic to speed along suburban roads when trying to avoid traffic jams on main roads. Similarly, traffic calming is used to create a low speed environment in areas where the aims of local government are for drivers to enjoy the environment rather than rush through an area (Figure 5.7). This requires careful design to ensure that areas where people cross are not obscured from drivers ignoring warning signage (Cairns Regional Council personnel, pers. comm.). Roundabouts can also be used to reduce speeds on high speed roads, particularly at important intersections (Figure 5.8).

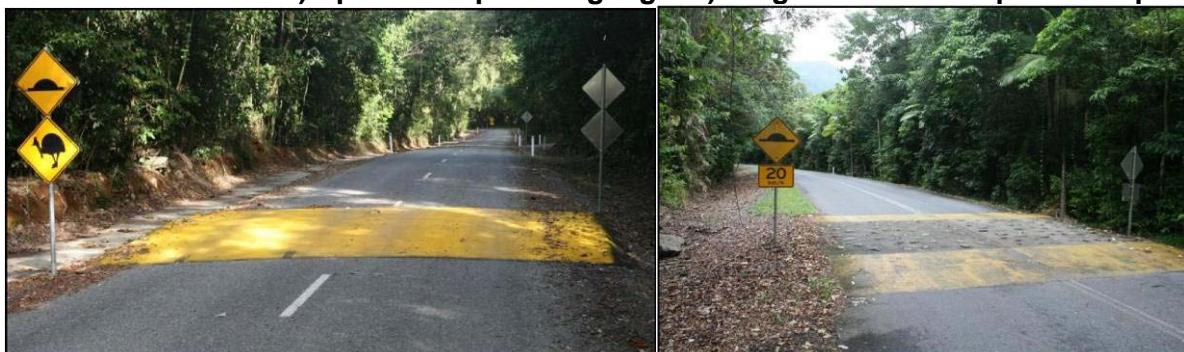
Figure 5.10 Speed humps along the Cape Tribulation Road, Daintree National Park, north Queensland. a) Speed hump and signage b) Large stone-lined speed hump

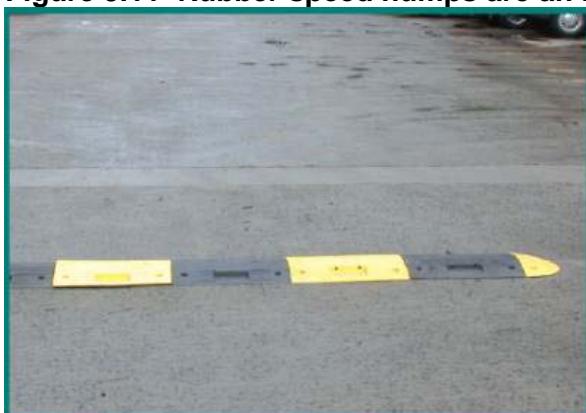
Figure 5.11 Rubber speed humps are an innovation that are claimed to reduce noise

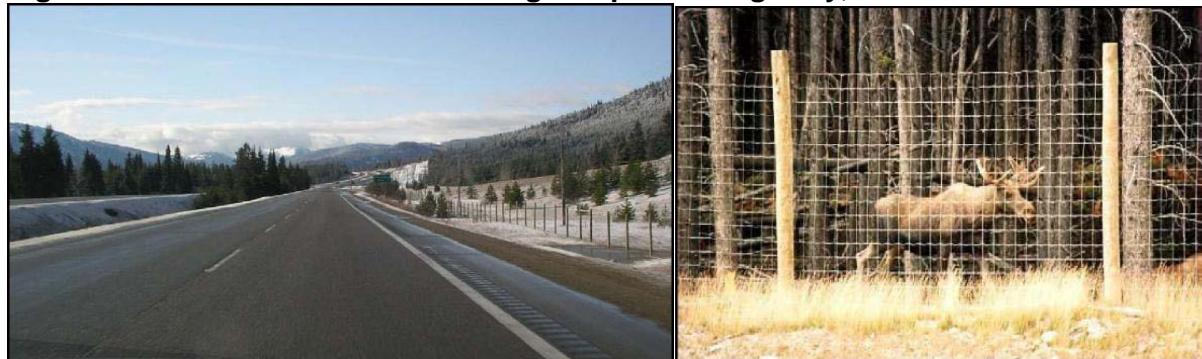
Figure 5.15 Wildlife exclusion fencing: Coquihalla Highway, British Columbia

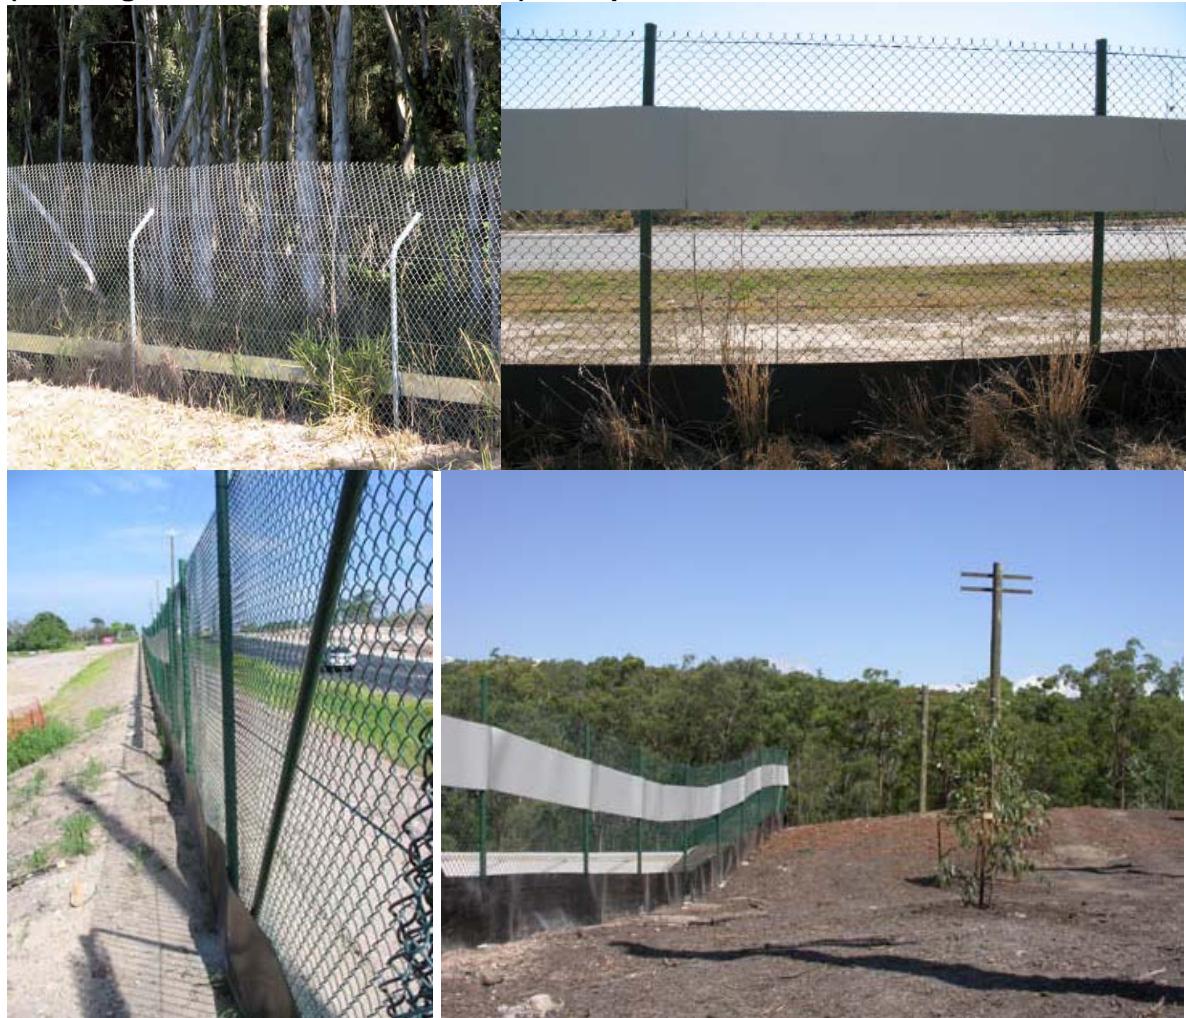
Figure 5.16 Wildlife exclusion fencing a) Koala exclusion fencing b),c),d) Exclusion fencing for variety of species to deter climbing over (0.5m PVC sheeting at base and 0.6m metal sheeting 1.4m above ground) and burrowing under (below- ground fence extends 50mm), Compton Road, Brisbane.

suggests that guide fencing has significantly reduced fauna-vehicle collisions (Gooseem *et al.* 2004); however this may come at the cost of population fragmentation if insufficient crossing the underpasses. Guide fencing is different for each target species or group (Figure 5.16). For example, when frogs are the primary concern the fence is low and constructed to prevent hopping, whereas escape poles from the road side of the fence might be provided for climbing animals (Gooseem 2003). Slippery sheeting can be installed to prevent climbing animals reaching easily-climbed fence materials (Gooseem 2003; Caneris and Jones 2004). Whichever is used, fencing can be an expensive option in terms of maintenance because vegetation must be kept clear of the fence and holes in the fence must be mended immediately.

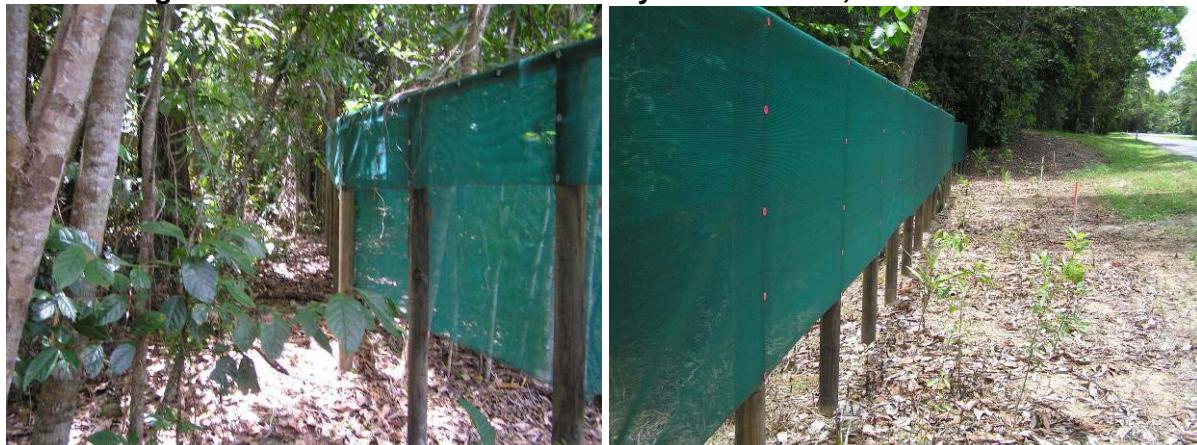
Figure 5.17 Fencing using shade cloth to prevent cassowaries easily seeing habitat on the other side of the road. Unfortunately the installation did not take the shade cloth close enough to the ground to prevent cassowary chicks from moving underneath. The fencing also did not conform to variability of the terrain,

Fencing specifically for **cassowaries** has been constructed at one site on the Tully Mission Beach Road (Figure 5.17), and another in habitat adjacent to the El Arish Mission Beach Road (Chapter 3). The experience of cassowary researchers and the community indicates that fencing for cassowaries must not be constructed of wire mesh because birds will continue to attempt to move through it and thereby injure themselves (Bentrüpperbaumer and Goosem 2005). Instead shade cloth should prevent cassowaries observing habitat on the other side of the road and guide them to safer crossing areas (Goosem *et al.* 2004). Unfortunately the lengths of fencing erected so far and monitoring data available do not provide sufficient evidence as to the effectiveness of this design. Construction of the fence did not translate the design completely, leaving too much height at the base of the shadecloth, especially in dips in the terrain, allowing cassowary chicks to move under the fence. This could be easily adjusted to allow further trials.

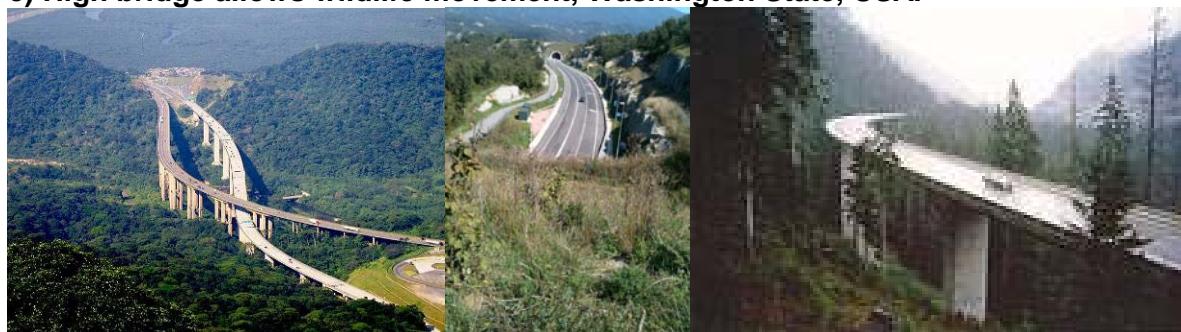
Figure 5.19 Long bridges and tunnels

- a) Highway over rainforest near Sao Paolo, Brazil
- b) Tunnels for the road in Catalonia, Spain
- c) High bridge allows wildlife movement, Washington State, USA.

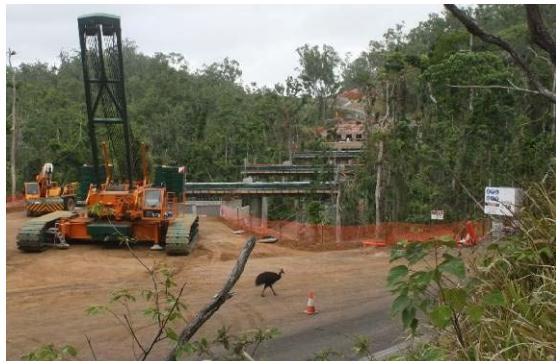
Figure 5.20 When completed the viaduct at Cardwell Range will provide connectivity for cassowaries

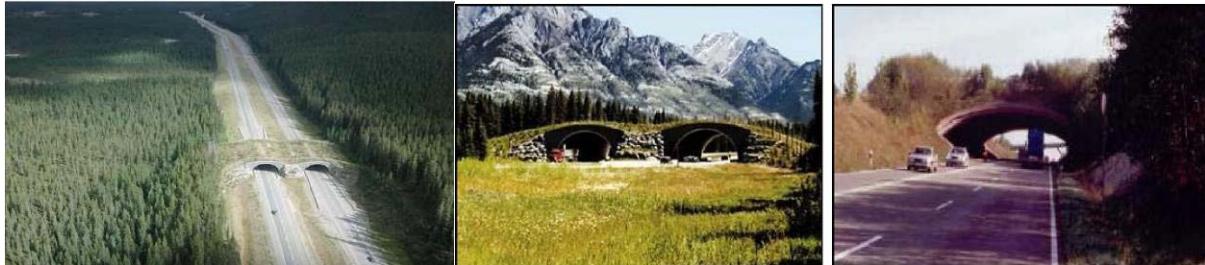
Figure 5.22 Overpasses in North America

- a) Red Earth overpass (50m wide x 70m long) in Banff National Park, Canada**
- b) Overpass in Banff National Park, Canada**
- c) Example from Deer-Vehicle Crash Information and Research Centre**

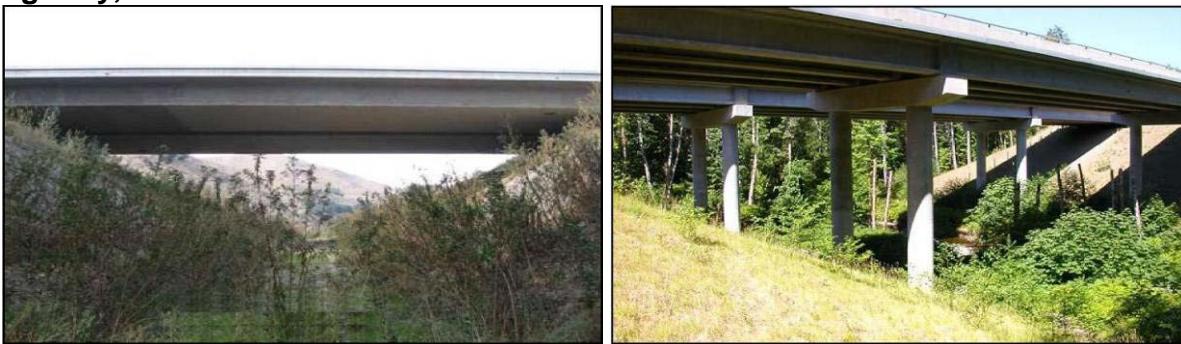
Photo: a) From Wildlife and Roads (2005). The original box culvert at this site was removed and a bridge installed to create an effective passage for bobcat and coyote. b) from Sielecki (2005)

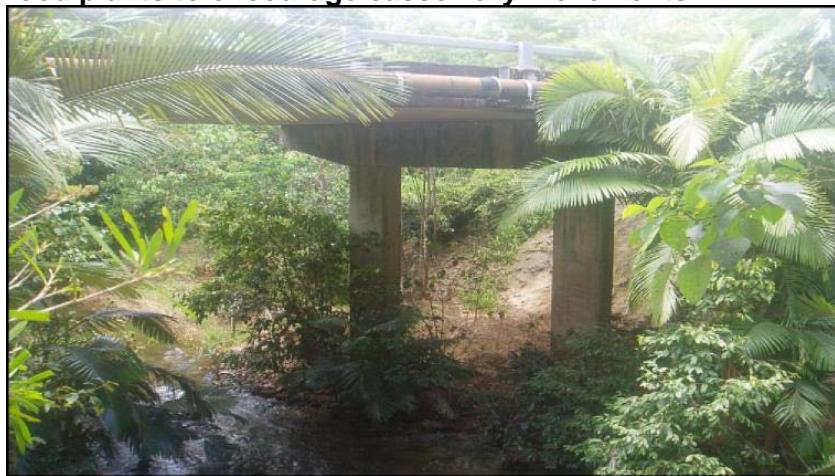
Figure 5.25 Passage under the North Hull River bridge, showing revegetation with food plants to encourage cassowary movements

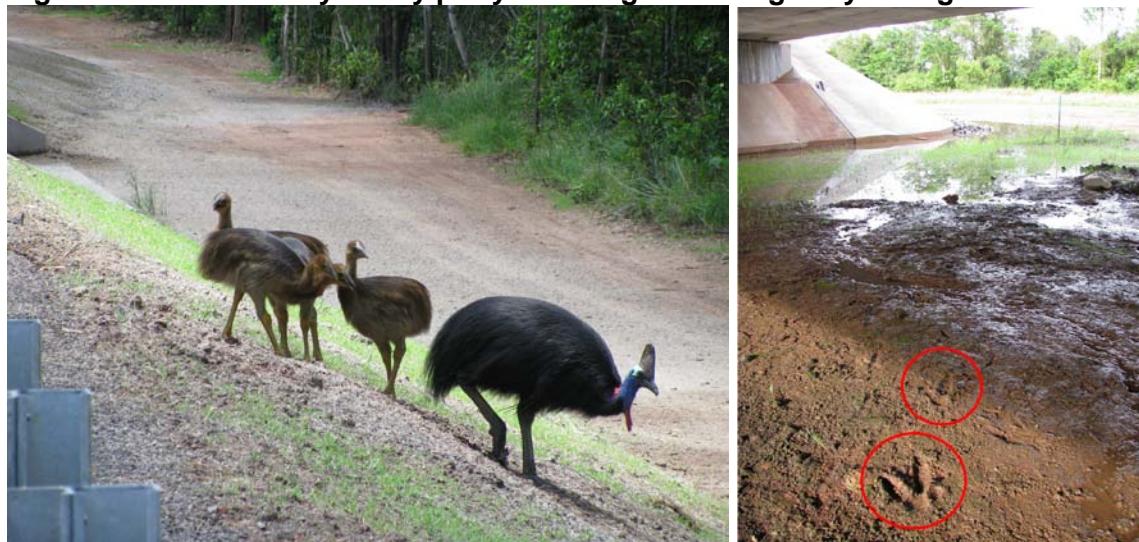
Figure 5.26 Cassowary family party crossing Bruce Highway at Lagoon South bridge

Similarly, although crossings are rare, cassowaries have been known to cross under the Bruce Highway at Lagoon South bridge (Figure 5.26; Tully Alliance, pers. comm.). Cassowary traces have also been recorded under the Maria Creek bridge on the Bruce Highway near Smith's Gap (Les Moore, pers. obs.).

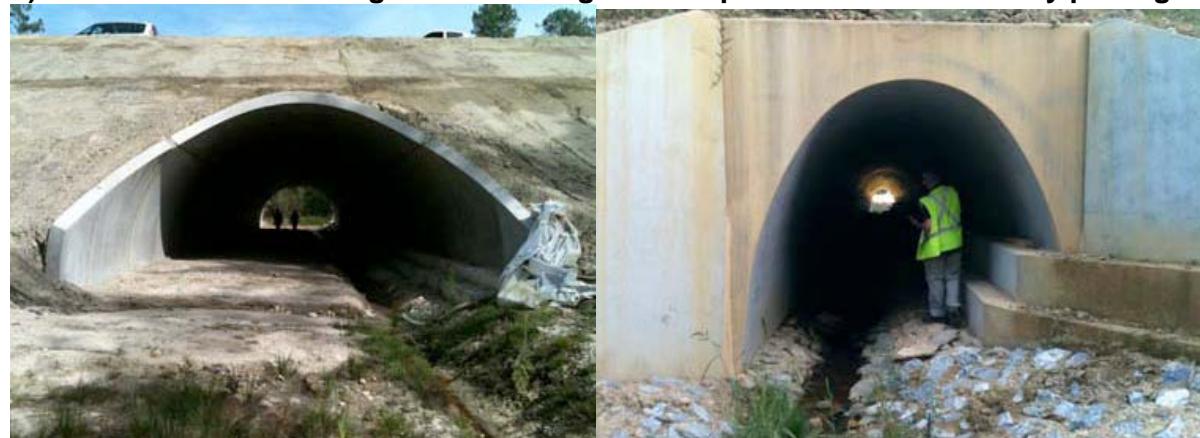
a) designed for roe deer in southern France

b) modified to include ledges to encourage small species to cross via a dry passage.

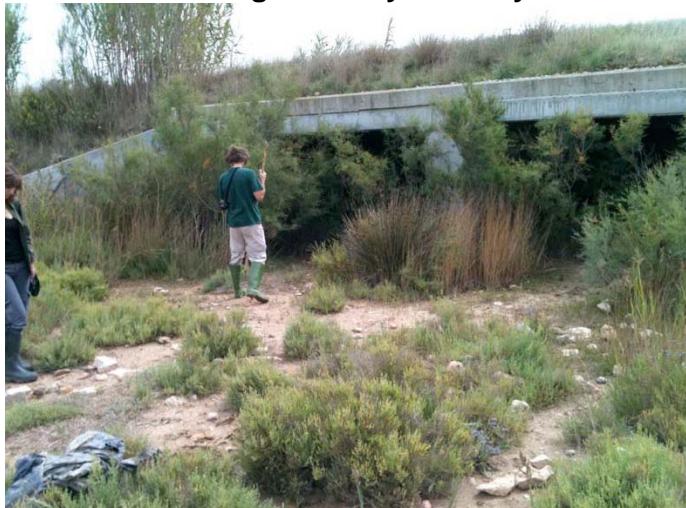
Figure 5.28 Large multiple box culvert, Spain. Natural vegetation continues to entrance encourages use by a variety of mammals (Jones 2010).

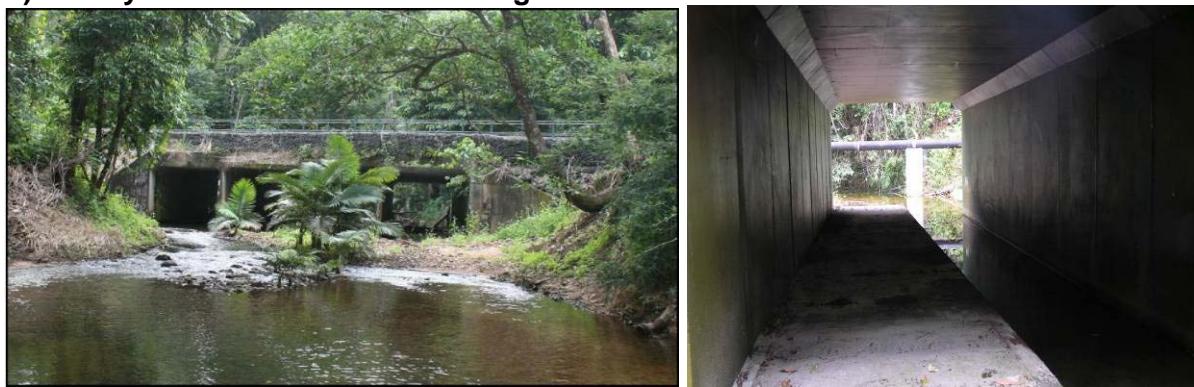
**Figure 5.29 a) Lacey Creek multiple box culvert
b) Stoney Creek box culvert with ledge**

The culverts at Lacey Creek and Stoney Creek (Figure 5.29) are 'box culverts' as they have 'four sides, including bottom' (USDA 2005). Stoney Creek culvert was retro-fitted with a ledge, together with sand track areas for monitoring and (at one stage) a camera, which unfortunately was not reliable. There has been evidence in the form of tracks in 2006 and a dropping that a **cassowary** or a family party has used the Stoney Creek culvert on at least one or two occasions in the past (DERM personnel, pers. comm.). However, monitoring undertaken in this study (Chapter 3) found no evidence that any individuals were using the culvert, so it appears that use is extremely occasional and is not occurring at all currently. Similarly there is one record of a family party approaching the Lacey Creek culverts but not crossing (DERM personnel, pers. comm.). Again, monitoring of that structure found no evidence of cassowary use (Chapter 3). There is also evidence that a family party crossed under the Bruce Highway in a 2 metre high culvert near Lagoon Creek (Tully Alliance, pers. comm.). However, again the family party appeared to prefer crossing at a higher bridge structure (Figure 5.26), as the larger structure was used multiple times. Therefore, it appears that even larger box culverts do not provide ideal conditions for cassowary crossings and are very seldom used, but that larger structures such as bridges are far more favourable options in terms of cassowary crossing opportunities.
