FINAL REPORT

MISSION BEACH ROAD RESEARCH: TRAFFIC IMPACTS ON CASSOWARIES AND OTHER FAUNA AND STRATEGIES FOR MITIGATION

Miriam Goosem, Leslie Moore, Peter Byrnes,
Marina Gibson

School of Earth and Environmental Sciences
James Cook University, Cairns

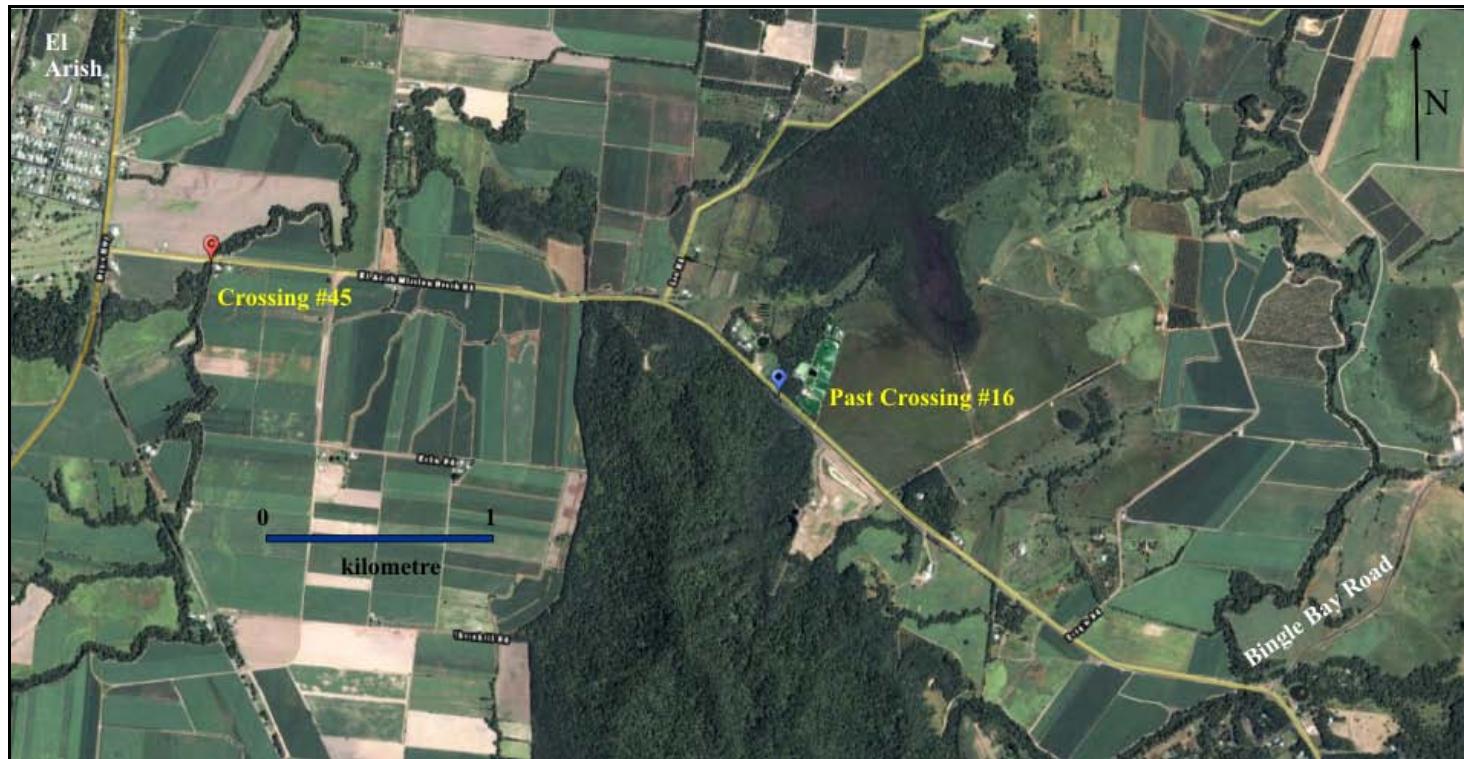
Figure 6.4
Road Section 1 – Bruce Highway to Bingil Bay Road

Red icons = active crossings

Blue icons = past crossings

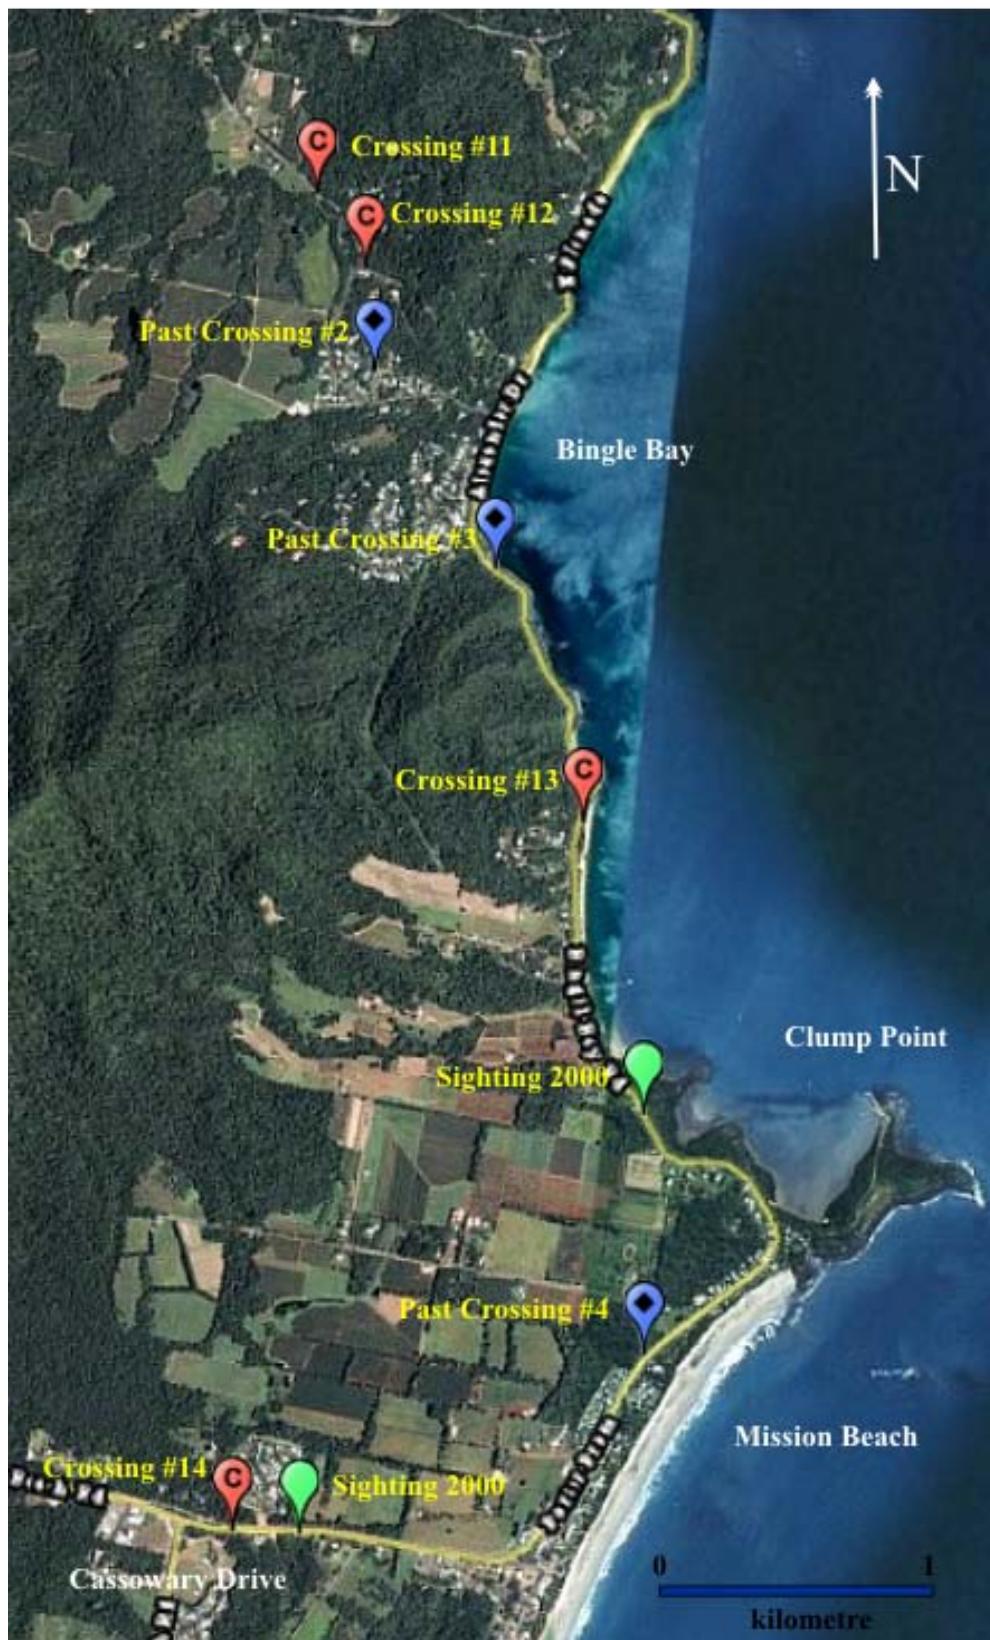
Figure 6.7
Road Section 4 – Bingil Bay Road and Alexander Drive:
Garners Beach Road to Mission Beach

Red icons = active crossings Blue icons = past crossings
Green icons = past sighting

Road Section	Crossing Number	Comments	General Risk Analysis	Mitigation Options
4. Bingil Bay Road and Alexander Drive: Garners Beach Road to Mission Beach and beyond to Cassowary Drive turnoff	11 Bingil Bay Road 11.1	<ul style="list-style-type: none"> Riparian corridor Connects Garners Beach National Park with Clump Mt & Tam O-Shanter NPs Cassowaries known to move from Double Mt across into Garners Beach NP (Moore 2003) There are 5 crossings recorded in this area in the visitor database Comments from C4 describe another crossing zone approaching the Bingil Bay shop, 10 crossings in the zone including the shop and beach in the visitor database 	<ul style="list-style-type: none"> Medium speed road Currently low traffic volume Private property, residences Fences Proximity of dogs Frequent crossings Council-controlled road 	<ul style="list-style-type: none"> Road-based traffic calming (speed humps, combined with rumble strips, painted road surface) Standard warning signage OR Flashing warning signs that react to vehicle presence when recent crossings are recorded Non-standard warning signage Temporary passive signage when animals are sighted crossing the road Speed reduction on CCRC road Speed limit enforcement

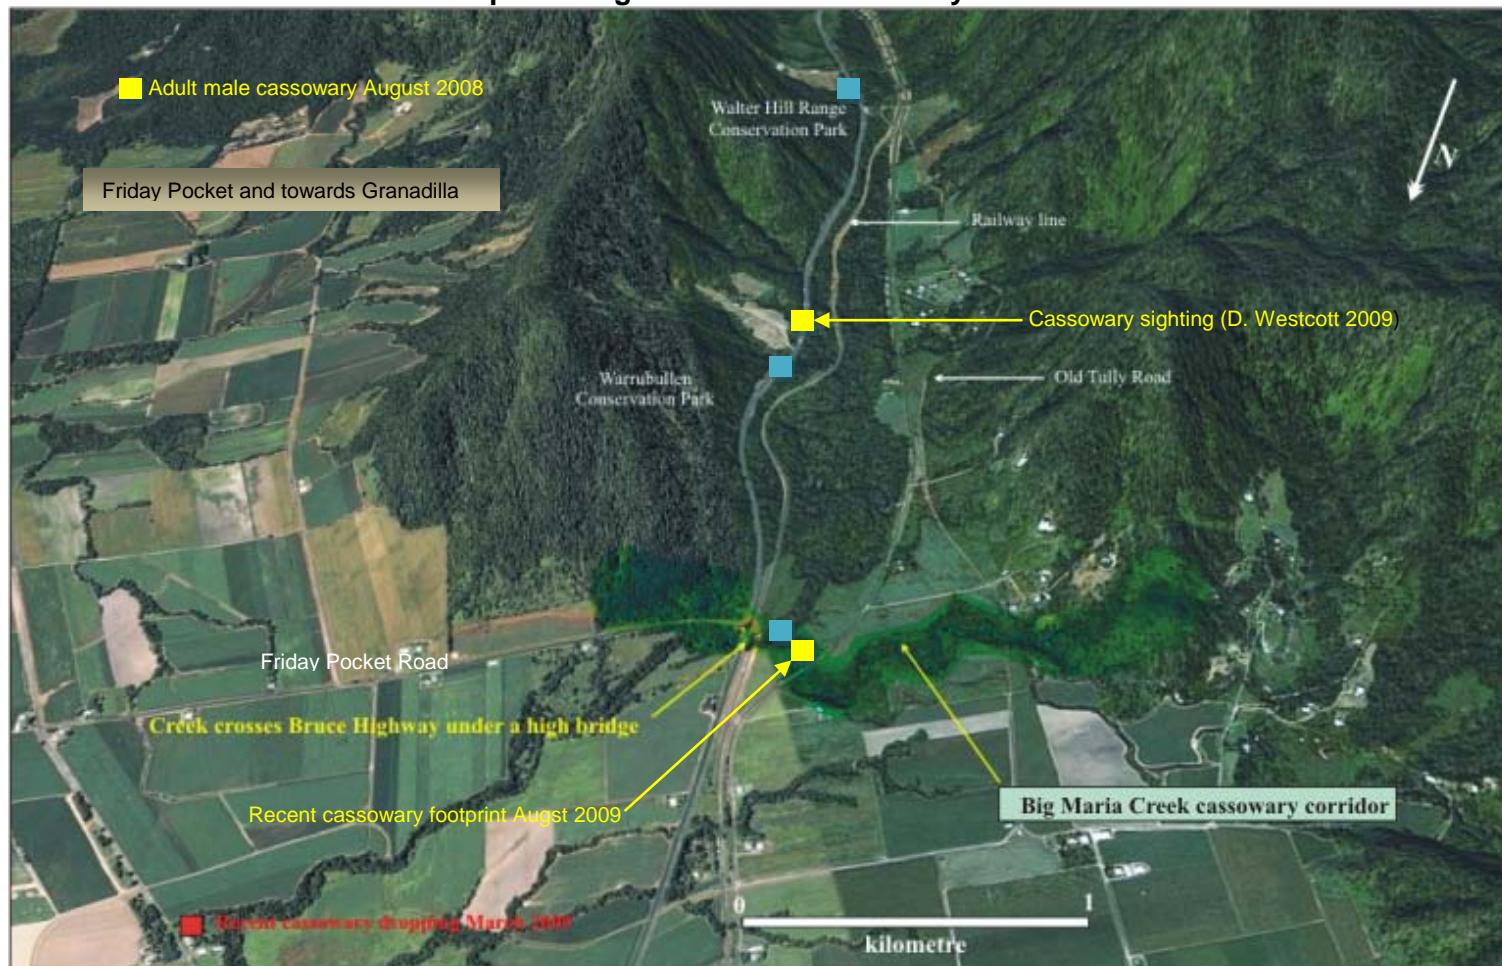
Figure 6.14
Proposed Big Maria Creek cassowary corridor

Blue squares = past crossing observations

The Walter Hill Conservation Park, Warrubullen Conservation Park, and the railway reserve east of the Bruce Highway in the Smiths Gap area were surveyed for cassowaries in 2008-2009 as part of the Mission Beach cassowary road project. The objective of the survey was to establish whether the area was currently being used by cassowaries, and to locate any active cassowary crossing points across the Bruce Highway. Cassowary use of vegetation surrounding the Smiths Gap area appeared to be low, probably due to a combination of the steep terrain and highly disturbed vegetation along much of the Walter Hill Range and its lower slopes. The cleared areas along Old Tully Road may discourage cassowaries moving into the Hogan Creek forest from the west. When approached in 2008, most landowners along the Bruce Highway and the Old Tully Road had never seen cassowaries on their properties or observed them crossing the Bruce Highway. Apart from fresh cassowary footprints found along Big Maria Creek in July 2008, no cassowary activity was observed in the immediate area of Smiths Gap. Birds were located, however, along Telegraph Road (three kilometres east of Smiths Gap) and near Banfield Road approximately four kilometres east of the Bruce Highway (Figure 6.14). Recent droppings were also found along a narrow section of Big Maria Creek which traversed cleared agricultural land two kilometres north of Friday Pocket Road (Figure 6.14).

The most promising location for a faunal movement corridor across the Bruce Highway is the riparian corridor of Big Maria Creek, at the north end of Smiths Gap (Figures 6.14, 6.15 and 6.16). Cassowary footprints were found along the creek near the Old Tully Road Bridge on 12 July 2008 and birds are known to have crossed the road in the past using the riparian corridor (Moore *pers. obs.* 1988-1998). The highway bridge area has been the site of Department of Environment and Resource Management and community rehabilitation efforts in the past. Big Maria Creek is permanent and connects to the uplands of the Walter Hill Range to the west; it is fed by the smaller tributary of Hogan Creek. Flooding occurs during the wet season and access under the bridge for cassowaries may be compromised at this time. This obstacle could be ameliorated by rehabilitation to widen the riparian strip allowing cassowaries to move along the creek banks as well as within the stream itself. Landholders who contribute to the corridor should be offered incentives to retain and enhance habitat such as through voluntary covenants and revegetation. Department of Transport and Main Roads should plan for upgrading the bridge to greater height for a more effective fauna crossing in future major works in the area. Implementation of those plans should form an essential part of any upgrade.

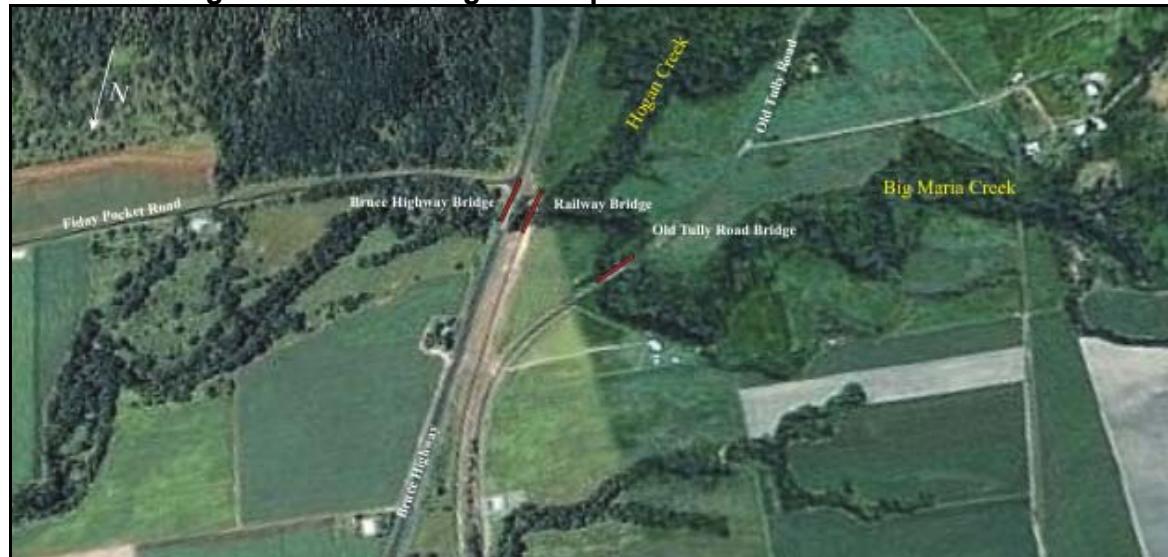
Figure 6.16

Location of Big Maria Creek bridges with place names discussed in the text

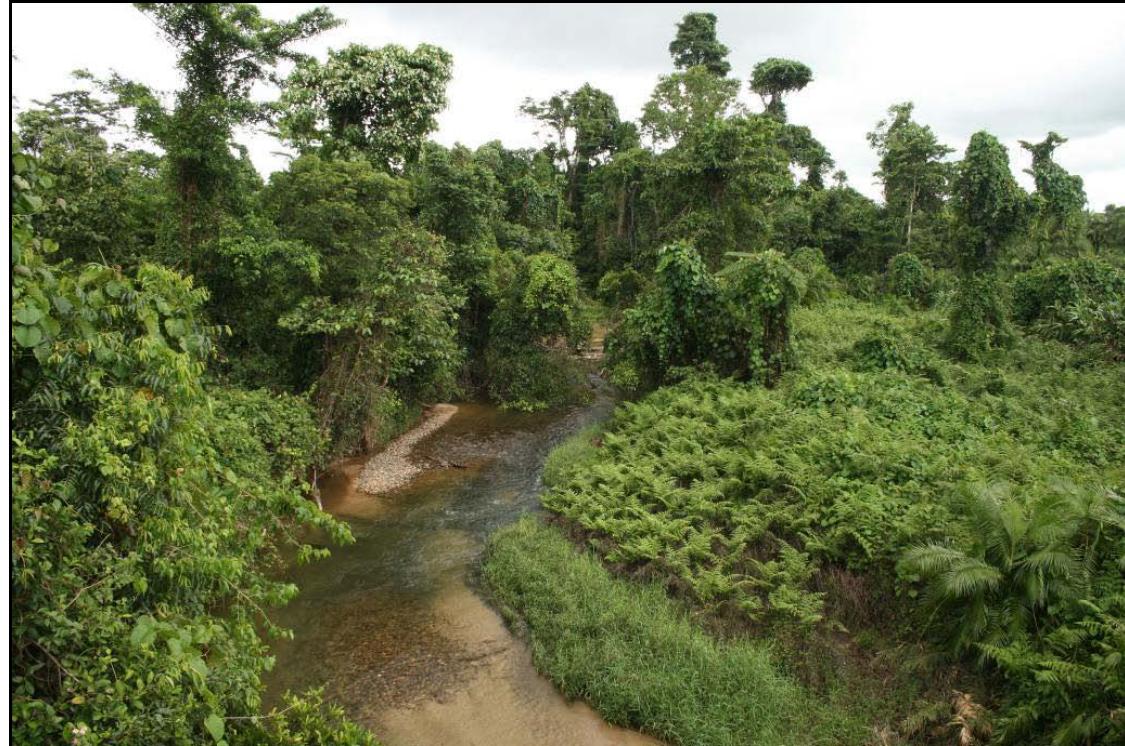
Figure 6.17
Big Maria Creek at the Old Tully Road Bridge - looking west

The following photographs (Figures 6.17 – 6.21) show the general state of the riparian corridor and its location in the landscape. They clearly illustrate the

requirement for rehabilitation particularly under the Bruce Highway bridge and railway bridge, and along the creek bank near the Old Tully Road bridge and railway bridge

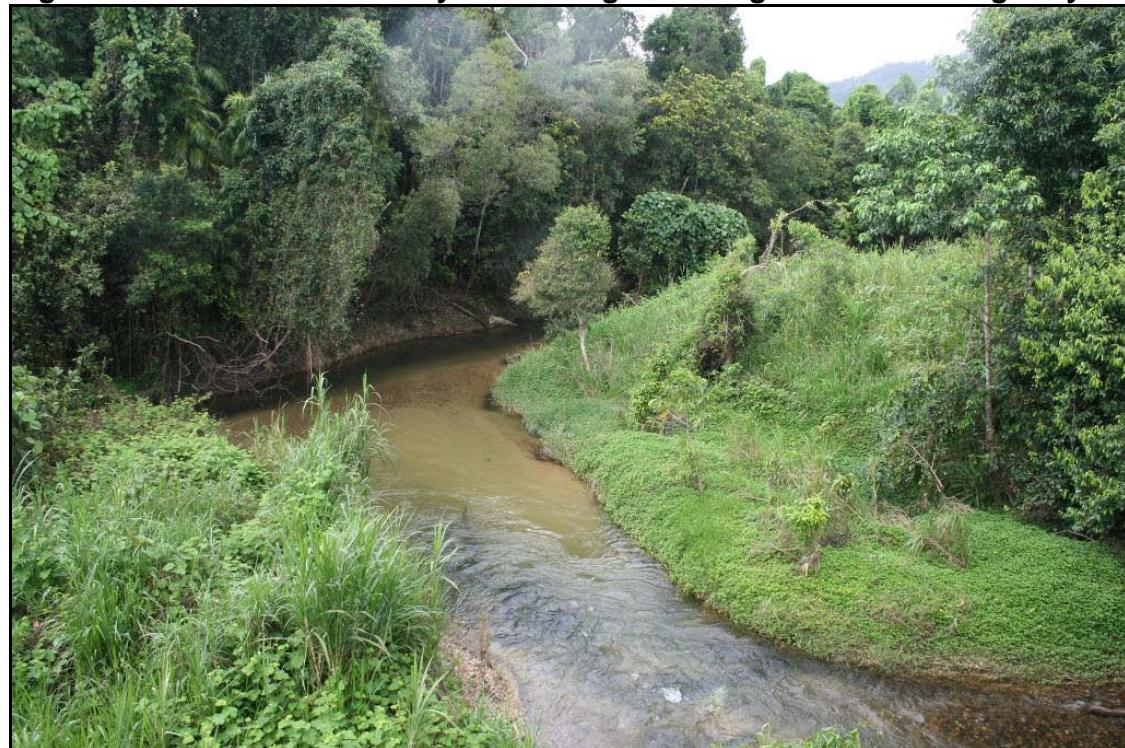
Figure 6.18
Big Maria Creek at the Old Tully Road Bridge - looking east towards highway

Given the support of local landowners and adequate funding, it is highly probable that effective connectivity can be achieved for cassowaries (and other species) between Walter Hill Range and the major sections of the Wet Tropics World Heritage Area west of the Bruce Highway using the riparian corridor of Big Maria Creek. The total length of this riparian corridor is approximately 1400 metres. Cassowaries have historically used the creek to cross the highway, both across the road and under the bridges, and evidence of recent usage was found in this study. The three bridges along Big Maria Creek are all suitable underpasses for cassowaries, being high structures with a relatively narrow width and bright visual profile. There are extensive opportunities for rehabilitation in the area surrounding the bridges (refer to Figures 6.17-6.21) and vehicle access is reliable for most of the year. The width of the riparian corridor varies from approximately 30 m at its narrowest point at Old Tully Bridge to approximately 170 m at the western end of the corridor. There is potential to widen the riparian corridor considerably at the Old Tully Bridge (Figure 6.18).

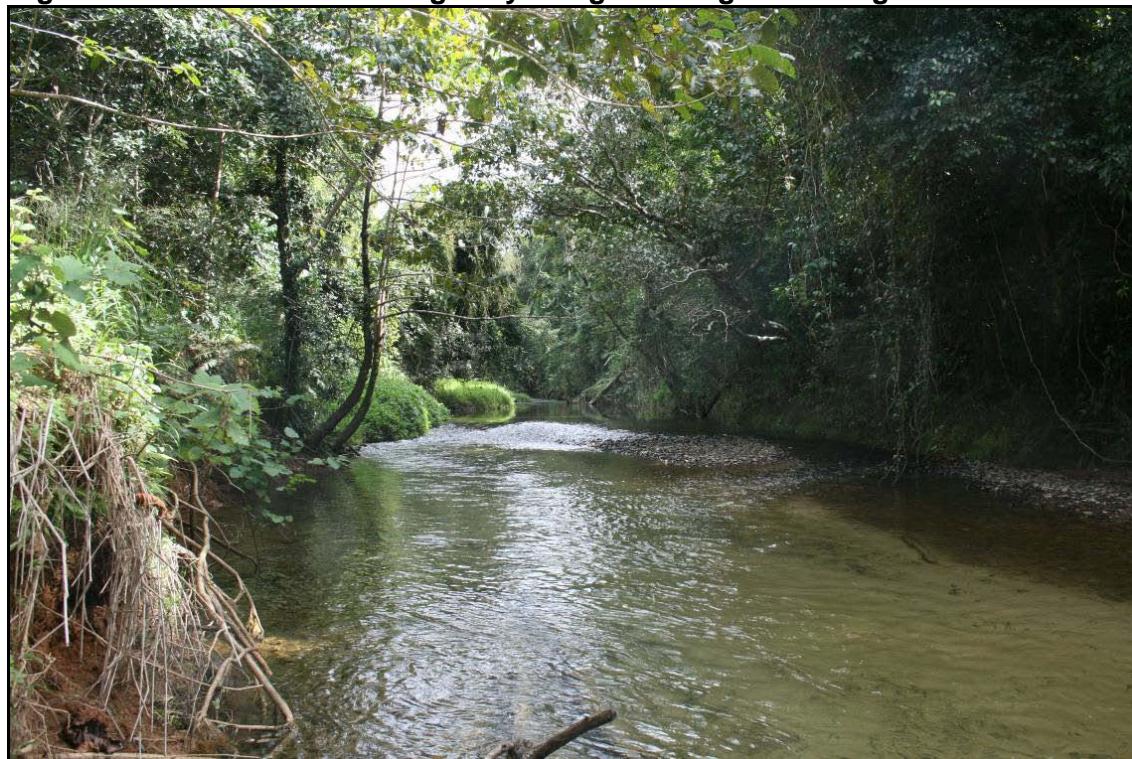
Figure 6.19

Big Maria Creek near Bruce Highway Bridge looking east along the creek

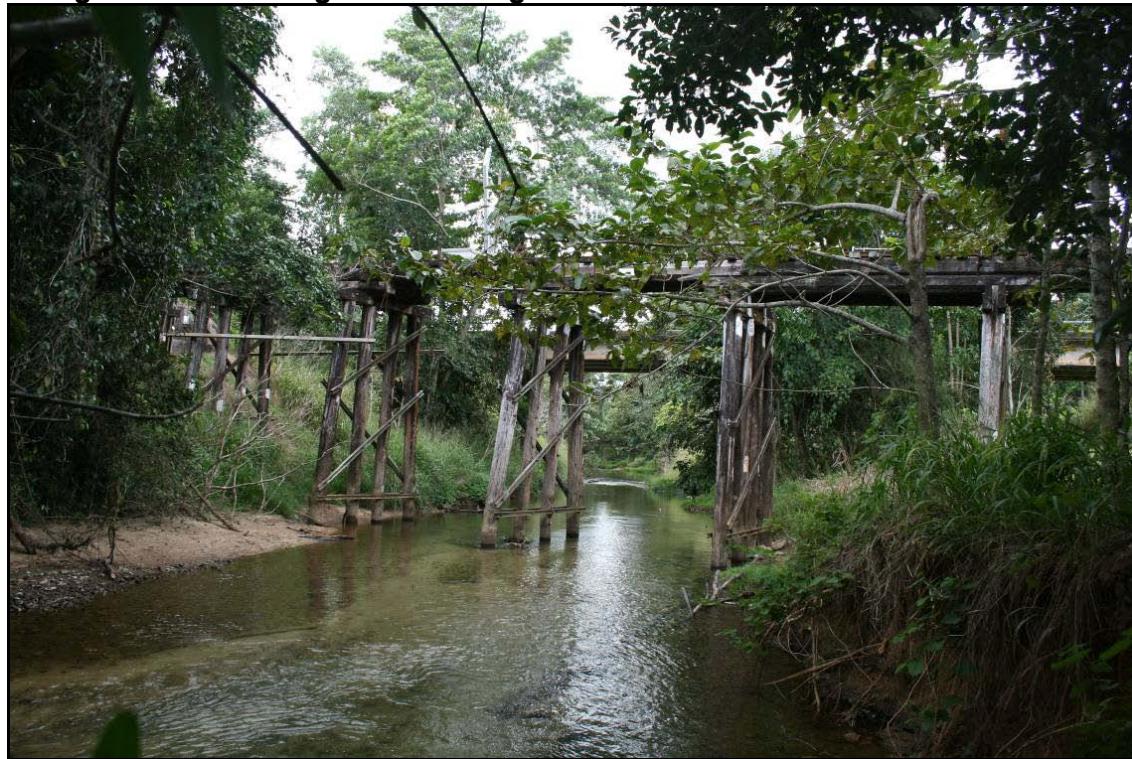
Figure 6.20

Big Maria Creek near Bruce Highway Bridge 2 looking west from same location as Figure 6.19 showing the two bridges

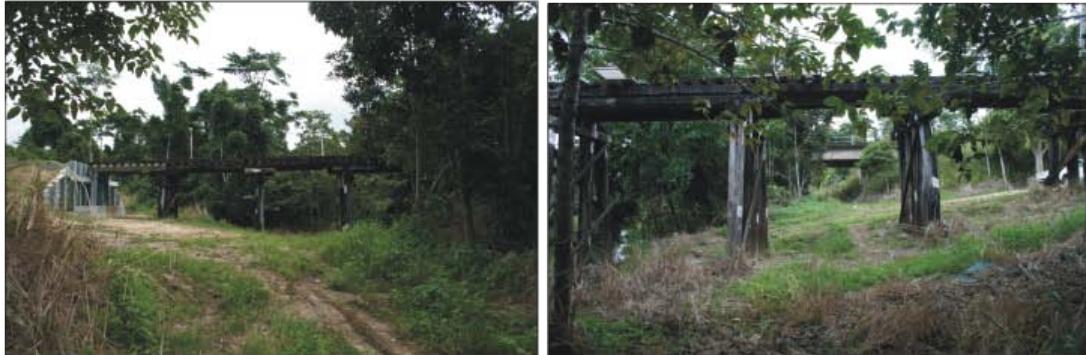
Figure 6.21
Views of Rail Line Bridge and Bruce Highway Bridge areas

Railway bridge on Big Maria Creek looking west

Railway bridge looking east with Bruce Highway bridge in background

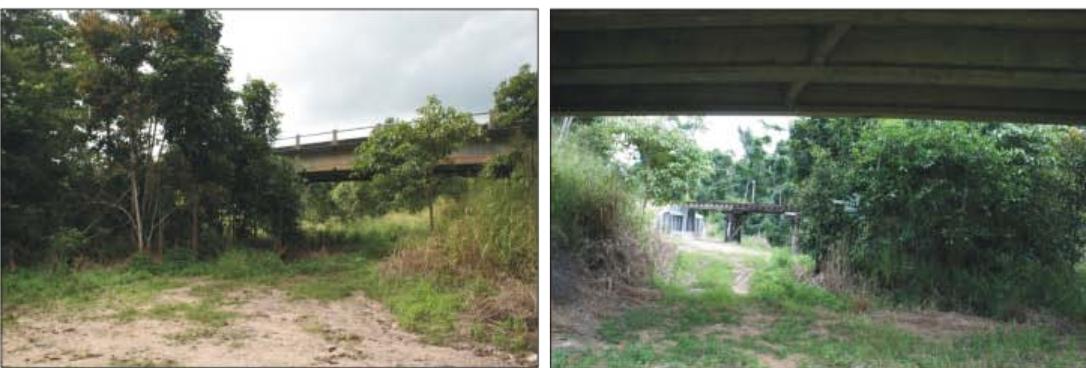
Bruce Highway bridge looking east

Bruce Highway bridge looking west with railway bridge in background

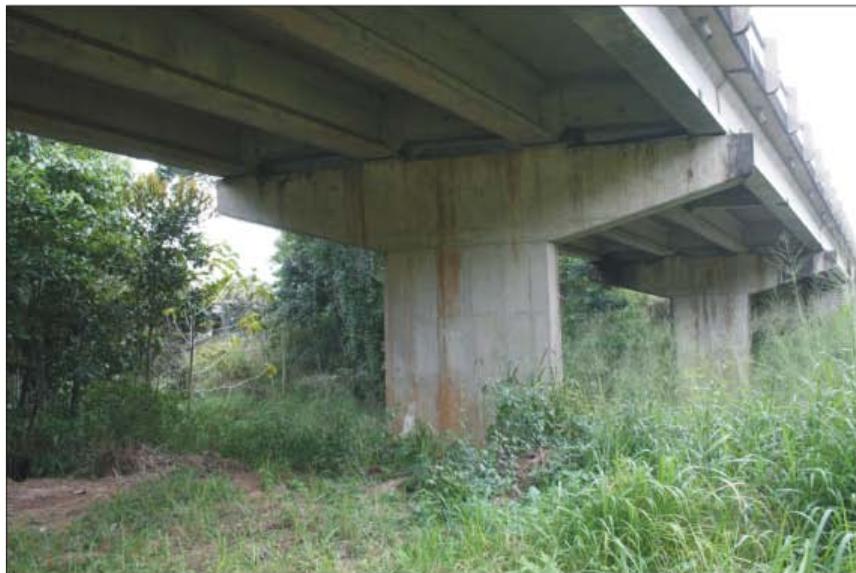
Bruce Highway bridge showing the height above ground and large area for rehabilitation

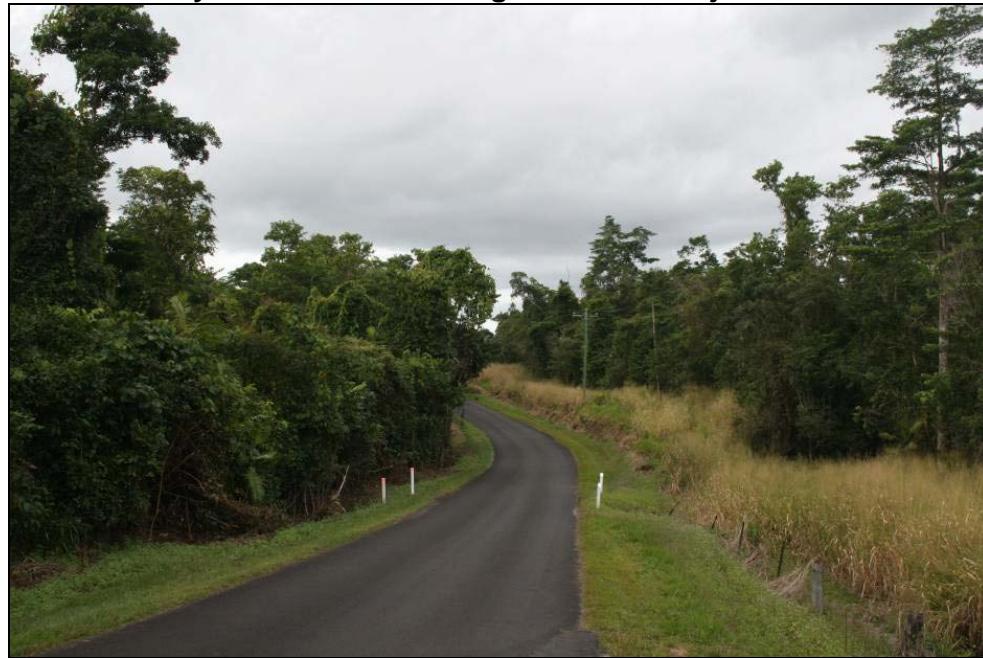
Figure 6.22

View of Friday Pocket Road looking east from the junction with Bruce Highway

As cassowaries using Big Maria Creek would have to cross Friday Pocket Road to enter the Warrubullen Conservation Park, road mitigation will be required to get them across the road safely. Figures 6.22 and 6.23 show the vegetation adjoining the road at the probable crossing area. Currently the Big Maria Creek option represents the

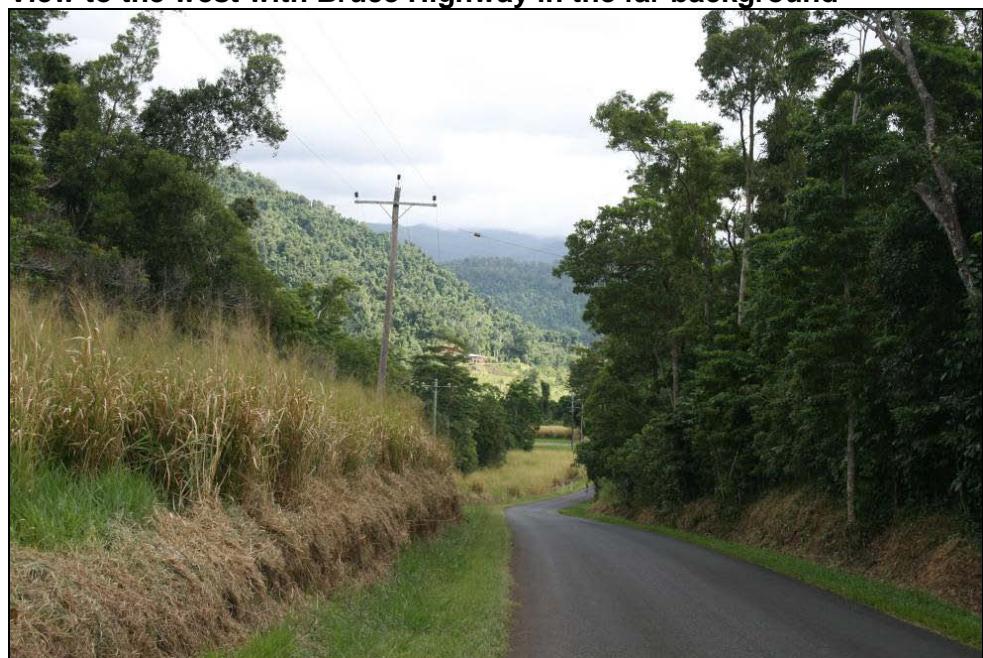
Figure 6.23

View to the west with Bruce Highway in the far background

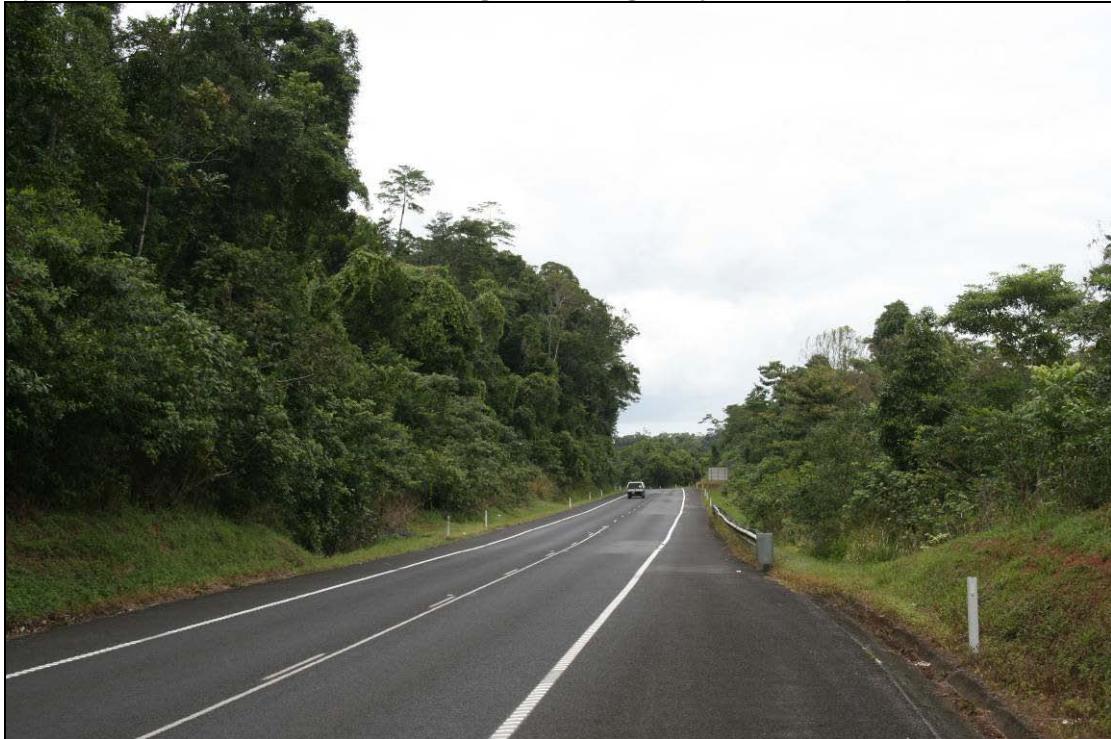
Figure 6.24

Typical view of road corridor along Bruce Highway in Smiths Gap area

The Bruce Highway is a major highway with high traffic volumes and a posted road speed of 100kph. The width of the road corridor varies along its length through Smiths Gap but generally approximates 40-50 metres from canopy to canopy (Figure 6.24).
