**Investigation of Potential Barriers  
Restricting Fish Passage into Horseshoe  
Lagoon, Burdekin-Haughton  
Floodplain, North Queensland**

**Report No. 07/16**

**June 2007**

Prepared for  
Great Barrier Reef Coastal Wetlands Protection Program  
Department of Environment & Water  
Canberra

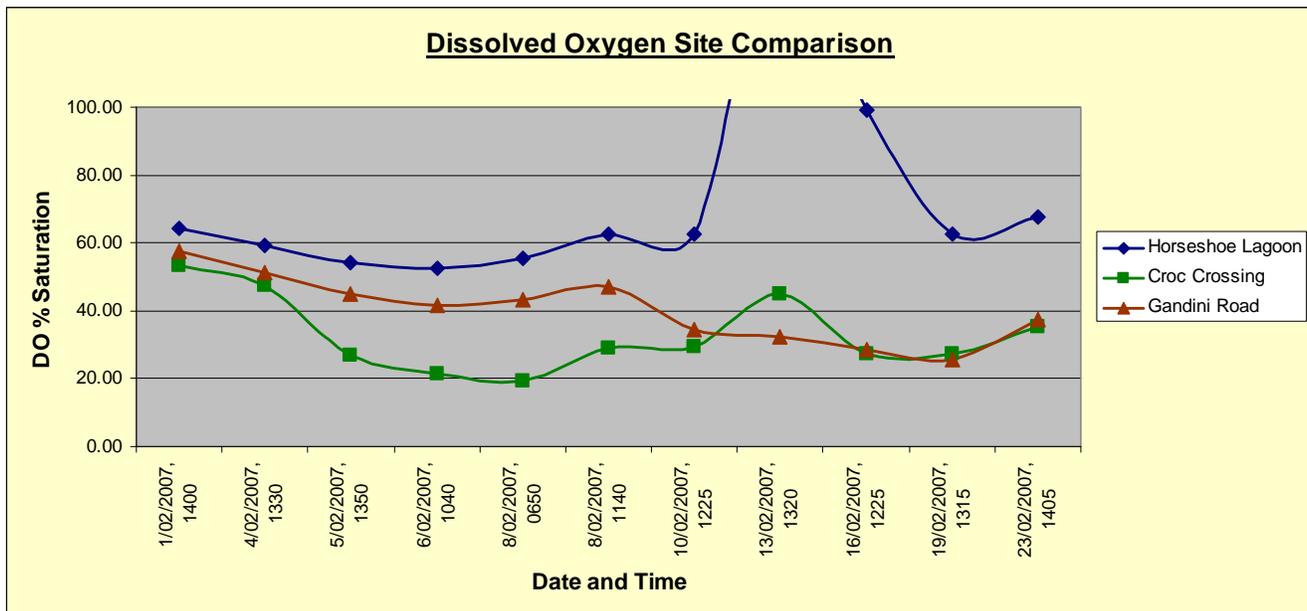
**Figure 2** Water Quality Data from Horseshoe Lagoon, Croc Crossing and Gandini Road during February 2007.

The graph at Figure 2 shows an important trend in DO levels from Horseshoe Lagoon to Gandini Road regardless of the background reading. Generally, DO levels are moderate to high in Horseshoe Lagoon but drop significantly above Croc Crossing before showing some recovery by the time they reach Gandini Road where the waterway is narrow but heavily shaded. The only exception to this strong trend was on 13 February where water flow from a small rain event following the flood was sufficient to hide the effect due to increased velocity along the length of the stream. Between Croc Crossing and Gandini Road, there is more turbulence in the now deeper and more channelised flow path to oxygenate the water.

Site 1 = Horseshoe Lagoon adjacent to Hodel Road

Site 2 = Croc Crossing at culvert access to cane farm

Site 3 = Shaded reach opposite Gandini Road/Hodel Road intersection

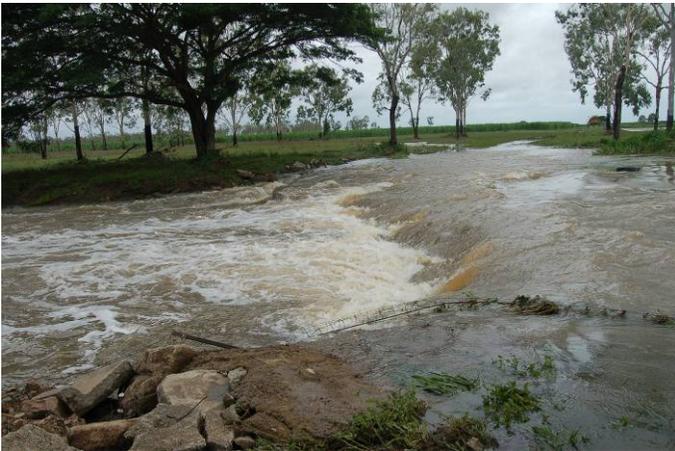
**Figure A9:** Croc Crossing almost flooded out on 4 Feb 2007.

The culvert on the cane farm access road is estimated to be about 2.5 m high and creates a large head loss at all but the highest flows when it temporarily drowns out (Figure A9 taken on 4 Feb 2007). Thus opportunities for fish passage are limited to a brief window of opportunity.

Restoration of good fish passage requires that pathways for fish passage remain viable more frequently and for longer periods. One means of achieving this in the current situation would be to construct a causeway with a downstream rock ramp at Croc Crossing to enhance fish migration. A rock ramp will allow fish to migrate in low flows at the start and finish of a flood event rather than the peak. A funding application to construct a fish ramp at Croc Crossing, in conjunction with the Burdekin Shire Council, has been submitted to the Australian Government's Recreational Fishing Grants Fund. The design of this rock ramp was investigated via a site visit with Tim Marsden, a fish biologist with experience in fishway design, from the Queensland Department of Primary Industries and Fisheries on 4 May 2007. Additional funding should be sought to ensure ongoing management of weeds along the stream joining Horseshoe Lagoon to the estuarine environment and undertake monitoring of water quality and fish passage resulting from improved management of the stream. Due to the extent of the connectivity problem that is often not easily apparent, information from this project should be important to other floodplain projects in the Queensland Dry Tropics region.

Overall, it is clear that estuarine-breeding fish species are able to negotiate their way up to Croc Crossing during flood events, but not into Horseshoe Lagoon itself. The road culvert at Croc Crossing appears to be a fish passage barrier. This culvert drowns out at the peak of medium-large floods, but this is apparently insufficient to allow for any significant fish passage. Although control of aquatic weeds within the system is also recommended, reinstating passage over this physical barrier is the highest priority.

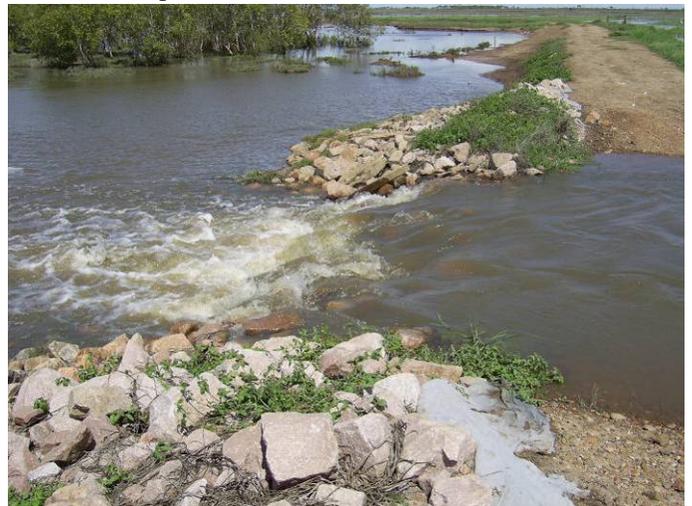
**Figure A12 :** Tidal Barrier in low flow conditions. This barrier floods out in moderate flows.

The bund wall is very low and has a breach that makes passage over this structure even easier (Figure A12-A13). The bund wall and the whole area either side of the bund wall readily drowns out during flow events and for extended periods. Thus, we did not consider this to be creating any fish passage problems during elevated flows. Additionally, sampling upstream of this site at the rail bridge showed that fish are migrating up from tidal areas, at least to that point, during flow events.
