Wind Loading Effects on Roof to Wall Connection in a Timber Frame Structure

ABSTRACT: Load sharing and structural response of contemporary representative houses to loading are investigated using numerical model analysis and full scale test in this study. The structural system of the contemporary representative house is obtained from a field survey by Cyclone Testing Station, James Cook University. In Australia, Contemporary houses are generally brick veneer structures with metal or tile clad roofs. Previous studies on damage to timber framed houses show that the roof structure of a house is vulnerable to windstorms. This indicates the need to study their structural response to mitigate their failures in windstorms. The roof to wall connection is an important inter-component connection for the structural stability of a house during strong winds, by providing a continuous load path from the roof to the foundation. The aim of this study is to assess the loading effects on roof to wall connection of a typical brick veneer contemporary house. A numerical model of the contemporary representative house was developed which provides load sharing and the structural response. This result als

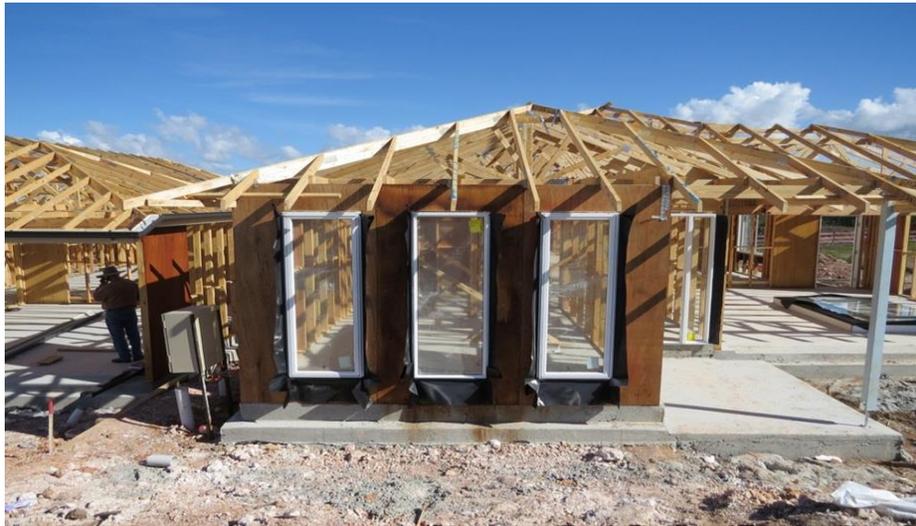
Figure 1. Contemporary house under construction.

A field survey of contemporary houses under construction as shown in Figure 1 near Brisbane, Australia was conducted by a team from the Cyclone Testing Station to determine their structural system. The survey features were the overall dimensions of house, roof slope, shape, type of connections and type of construction. In addition construction defects were also recorded in this field survey. Contemporary houses in many parts of Australia are brick veneer structures with metal or tile clad roofs that are built by trained builders using skilled labourers working to engineering design specifications. The metal cladding is fixed to metal top-hat battens, which are attached to timber trusses that are spaced at regular intervals along the walls. The roof trusses are fixed to the wall top plate using various methods, depending on wind loading and building regulations. The schematic diagram of a brick veneer contemporary house structural system is shown in Figure 2.

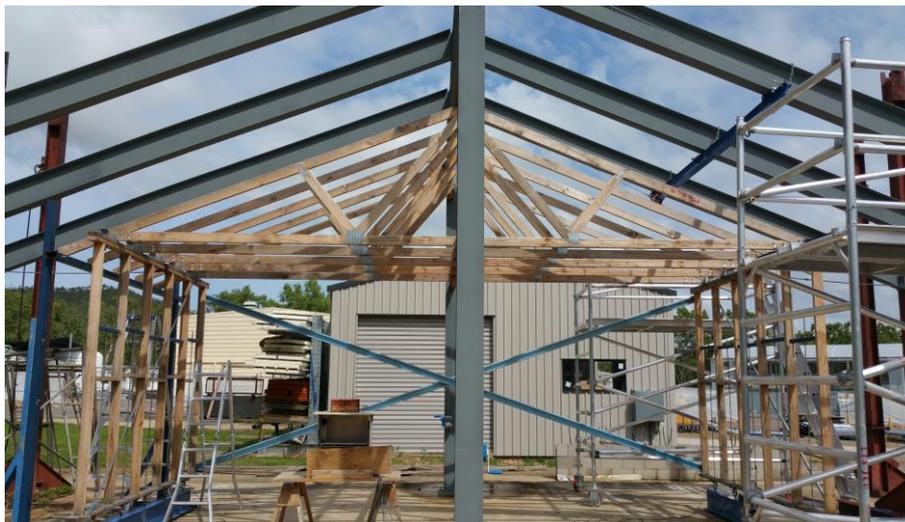
A full scale test house has been built (Figure 12) to validate the numerical model. “S type” load cells were used to measure the applied and reaction forces and LVDT’s were used to measure the roof to wall connections displacements. The entire house structural system is sitting on the load cells located under the bottom plates at the locations of the roof to wall connections, as shown in Figure 13a. Steel rods were used to connect the load cell and the top plate, as described in Figure 13b, to transfer the vertical reaction force from roof to wall connection to load cell. Test will be carried out for all seven cases as described in Table 2 and the results will be compared to the numerical model results.

Figure 12. Full scale test house
