Wind Load Sharing and Vertical Load Transfer from Roof to Wall in a Timber-Framed House

DOCTORAL THESIS

Doctor of Philosophy (Civil Engineering)

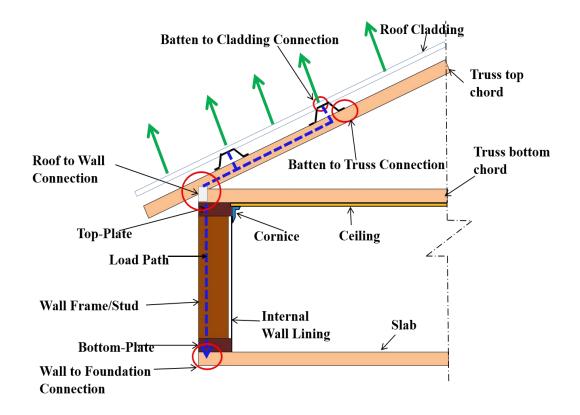
Figure 1.3. Schematic diagram of the vertical load path of the timber-framed house

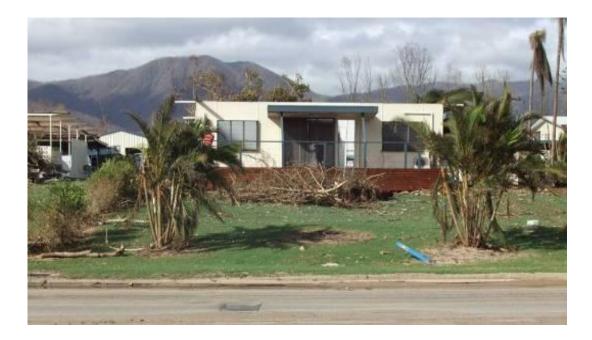
Figure 2.2. Roof loss after failure of door on the windward wall (Boughton et al., 2011)

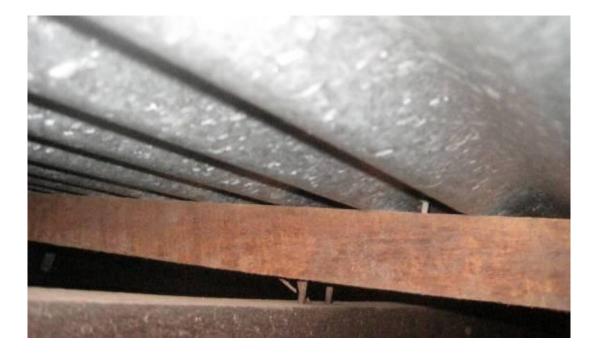
Figure 2.3. Partial withdrawal of nails in batten to rafter connection (Boughton et al., 2011)

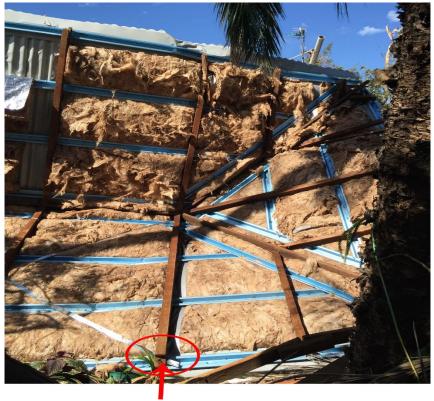
Figure 2.7 shows the whole roof loss of a house during Cyclone Marcia. This is an old house where the roof structure's cladding, battens, batten to truss connections and batten to cladding connections were replaced recently. The RWCs were not replaced or repaired and that resulted in the whole roof failure during Cyclone Marcia. These failures indicate poor construction practice and high gust wind speed increase the probability of these RWCs failures.

Figure 2.7. Roof loss due to the RWCs failure (Photo courtesy of CTS)

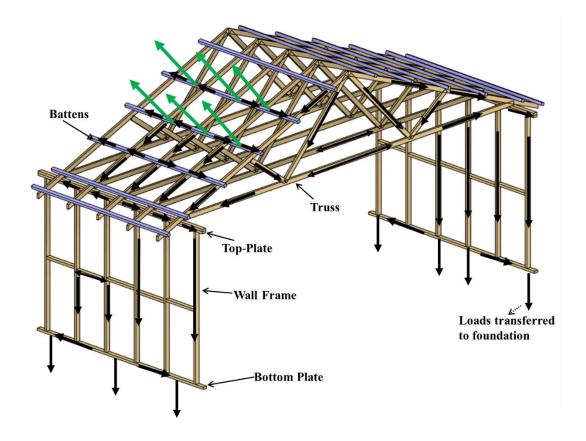
Figure 2.8. Schematic diagram of wind load transmission from roof to foundation in a timber-framed structure

sheathing type and orientation, etc. (Henderson et al., 2013). Figure 2.8 shows the complex ways of the wind load transmission from roof to foundation in a timber-framed structure. The typical idealised vertical load path layout in a low rise light framed structure is shown in Figure 2.9.

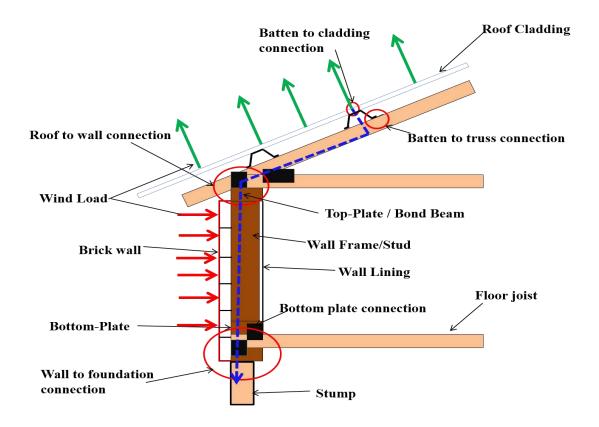
Figure 2.9. Schematic diagram of idealised vertical load path of low rise timber-framed structure (highlighted in blue dash line)

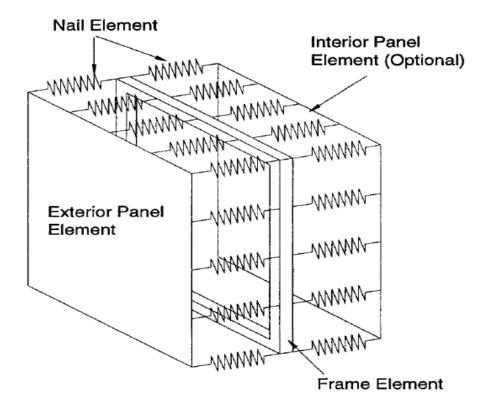
Figure 2.14. Basic Element Unit in He et al (2001) model analysis

He et al (2001) investigated the performance of three-dimensional timber light-frame buildings under static loading conditions. In this model, shown in Figure 2.14, there was an assembly of three types of elements: panel element, frame element, and connection element. Panel elements are approximated as thin plate elements and a frame element modeled as a 3D beam element with inelastic material properties. The connection element consisted of a nail, the surrounding area on the panel, and frame members contacting with the nail, which is represented by non-linear spring elements. This numerical model produced an effective prediction of load sharing among structural components and load paths within the entire wood-frame structural system. The uniqueness of this model was that a mechanics-based nail model was implemented by using basic material properties of the nail connector and the embedment characteristics of the surrounding wood medium. This approach has led to easily modeled structures with varied connections in timber-framed house structural systems.

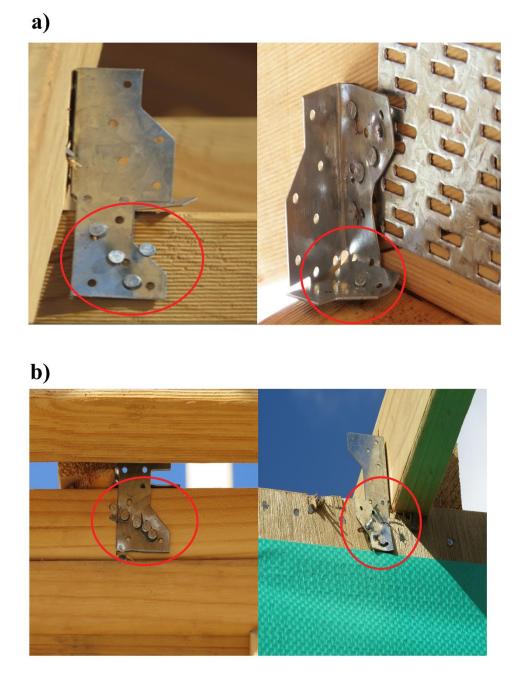
Based on the standard AS 1684.2 (2010) and the manufacturer's specifications, ten nails (i.e. four nails on the vertical side of truss chord, two nails on the top-plate top surface and four nails on the side surface of the top-plate) should be used in this roof to wall triple grip connection. The field survey data analysis also showed common construction defects on the RWCs, such as missing nails, grouping nails, bending framing anchors, and partially driven nails and nail teeth, as shown in Figure 3.6. These types of construction defects were observed in every surveyed house. The house survey data also showed that the roof structure of the contemporary house was constructed with at least a six general trusses and four truncated trusses. In every surveyed house, at least three of these general trusses RWCs had some common construction defect. Missing nails were the most common construction defect.

Figure 3.6. Common construction defects on the roof to wall triple grip connection: a) Missing nail and triple grip bending, and b) Grouping nails and nail bending

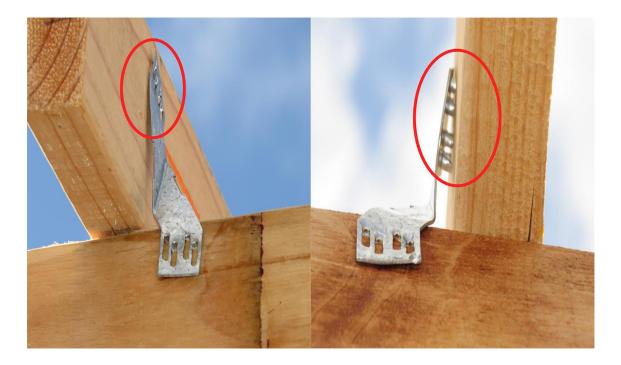
Figure 3.7 illustrates the common construction defect on the truss grip type roof to wall connection in the houses in Melbourne. Partially driven nail teeth were commonly observed as a construction defect on this type of connection.

Figure 3.7. Common construction defects on the roof to wall truss grip connection

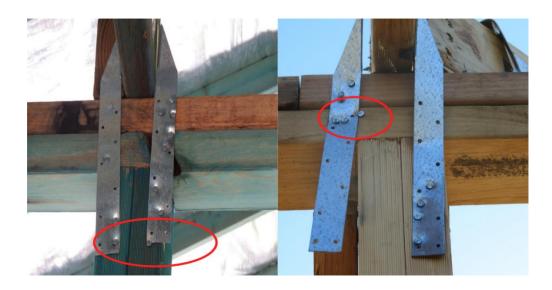
The common construction defects on the roof to wall strap connection were missing nails, grouping nails together and pre-punched nail hole, as shown in Figure 3.8. These grouped nails and pre-punched holes caused tearing of the strap, especially at the location of the grouped nails.

Figure 3.8. Common construction defects on the roof to wall strap connection

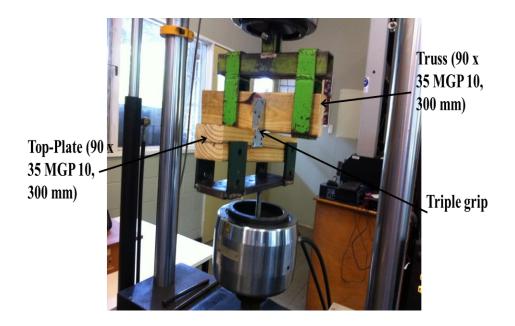
Experimental tests were carried out to assess the strength and stiffness of RWCs with and without construction defects. Truss grip and triple grip connections were tested in an Instron testing machine. The specimens were stored at 25°C and 65% relative humidity for 24-hours prior to testing. Figure 4.1 illustrates the test set-up for a triple grip connection. The resultant forces and vertical displacements (i.e. the relative displacement of the crosshead of Intron machine) were measured.

Figure 4.1. Triple grip connection test arrangements

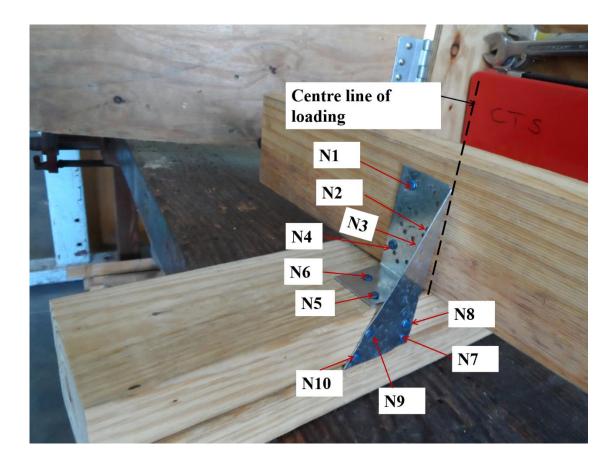
Figure 4.4. Test specimen Type A -showing Nails N1 to N10

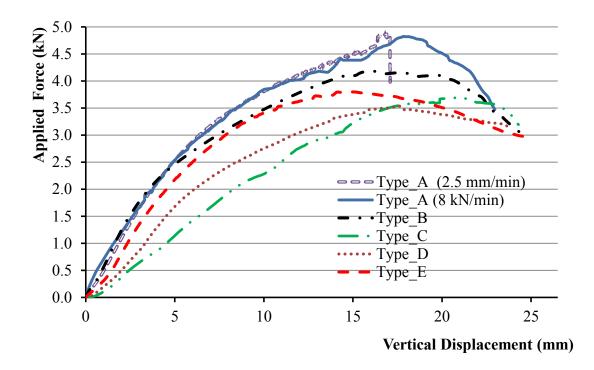
The average force-displacement behaviour of connection Types A, B and E are similar, while that of Types C and D are similar. This shows that differences in the framing anchor do not cause significant differences in peak loads of the RWC. However, the material variability in timber does change the peak load of the RWC (Types A and C). Changing the timber material from MGP10 Australian radiata pine to spruce pine in the connection gives about 25% reduction in peak load. Figure 4.6 also shows that the different types of nails in the connections (Types A and E) also create variations in the peak load. The variation of peak load between the hand nailed and the gun nailed connection is about 25%. The average applied force versus displacement of the "Ideal" triple grip connections show that the stiffness of the hand nailed connection (i.e. Types A, B and C) is higher than the gun nailed connection (i.e. Types D and E). Eight of the 10 nails (i.e. N1, N2, N3, N4, N7, N8, N9 and N10) in the triple grip connection experience lateral (i.e. shear) load when the connection was subjected to uplift load. Under this condition, the lateral strength of the nail joint is mainly dependent on the nail diameter rather than the nail mechanical properties, as shown by Chui et al (2000). The hand nail diameter (2.8 mm) is higher than that of the gun nail (2.5 mm), and this could reason for the stiffness difference between the hand and gun nailed connections.

Figure 4.6. Average applied force-displacement relationships for "Ideal" Triple Grip connections

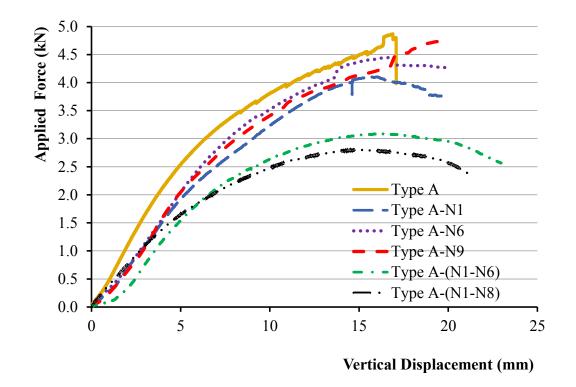
Figure 4.7 shows the comparison of the average applied force-displacement curves of the defective hand nailed connections, listed in Table 4.2a (Types A-N1, A-N6, A-N9, A-(N1-N6) and A-(N1-N8)), with the force-displacement curve of "Ideal" Type A (Figure 4.4). This figure and Table 4.3 illustrate that the average peak loads of the Types A-(N1-N6) and A-(N1-N8) of 3.10 kN and 2.78 kN respectively, are less than the "Ideal" connection Type A. This clearly indicates that when a nail is missing on both the truss and top-plate (i.e. Types A-(N1-N6) and A-(N1-N8)), the strength of the "Ideal" connection triple grip connection is significantly reduced by about 40%. Table 4.3 shows that the connection Type A). This indicates that missing either nail N6 or N9 has a lesser impact on the strength of the triple grip connection. The nails (N6 and N9) were located away from the lone of loading action compared to other nails, which is the reason for these nails to have less influence on the strength of the triple grip connection.

Figure 4.7. Average applied force-displacement relationships for triple grip connection Type A with construction defects

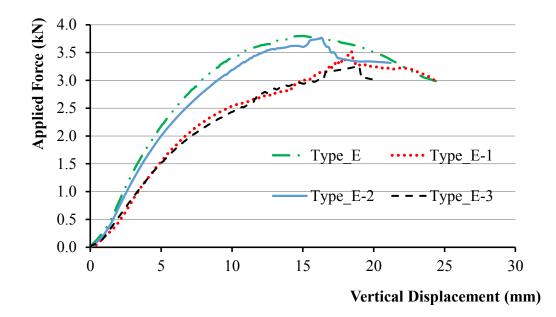
Figure 4.8 presents the comparison of the average applied force variation with a displacement for the defective gun nailed connection Types E-1, E-2 and E-3 with the "Ideal" connection Type E. This figure shows that the peak load of the connection Type E-3 is less than the other defective connections (i.e. Types E-1 and E-2), indicating that the grouping of nails together on the top-plate will reduce the connection strength and stiffness. This figure also shows that the stiffness of the connection Types E-1 and E-3 are similar and less than the connection Types E and E-2.

Figure 4.8. Comparison of the force-displacement relationships for the triple grip connection Type E with construction defects

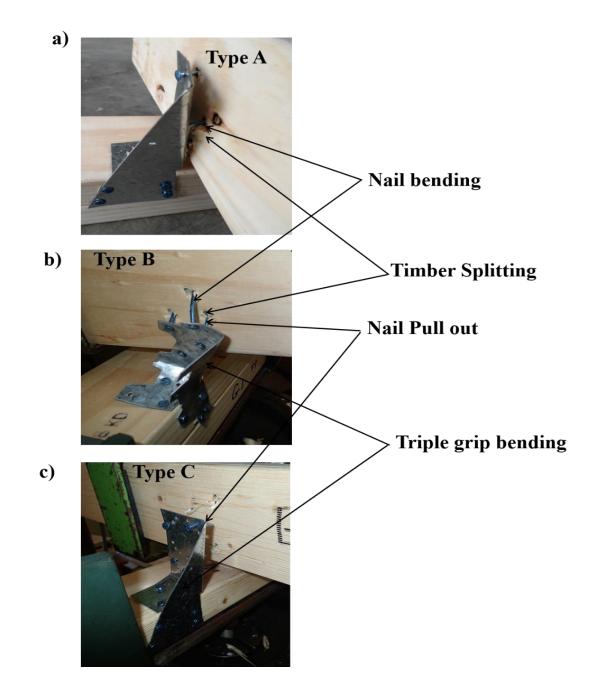
A comparison of the tested specimens revealed that failures of hand-nailed connections eventuate on the part connected to the truss, whereas failures of gun-nailed connections eventuate on the part fixed to the top-plate. The length of the gun nail is almost equal to the width of the truss (Truss 35 mm and Gun nail 32 mm) and the nails on the truss are perpendicular to imposed load, consequently, these nails have more grip than other nails on the gun nailed triple grip connection. This could be contributing to the failure mode variation between the gun and hand nailed triple grip connections.

Figure 4.9. Most common failure modes of hand nailed "Ideal" triple grip connections: a) Type A, b) Type B, and c) Type C

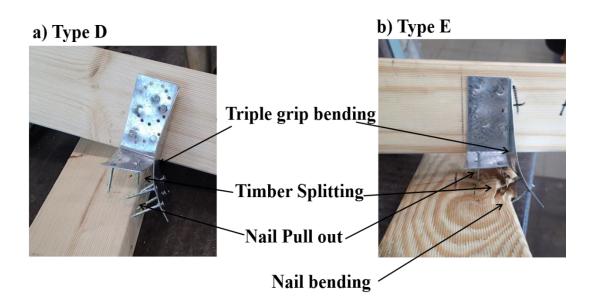
Figure 4.10. Failure modes of gun nailed "Ideal" triple grip connections: a) Type D, and b) Type E

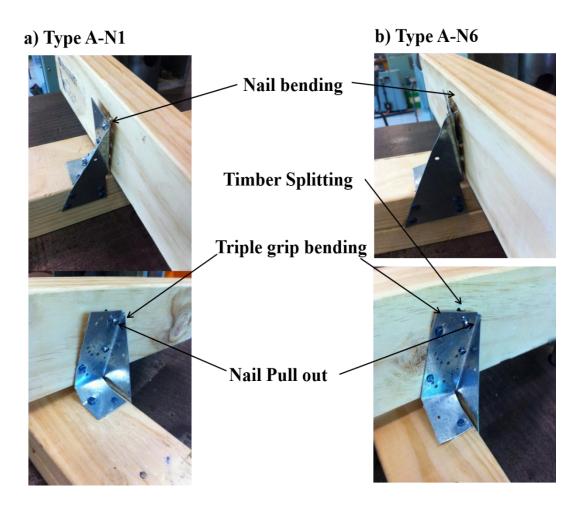
Figures 4.11 and 4.12 illustrate the most common failure modes of defective hand nailed triple grip connection Types A-N1, A-N6, A-N9, A-(N1-N6) and A-(N1-N8). Compared to the failures of the "Ideal" connection Type A, the triple grips in these defective connections were more severely deformed, and nails N2, N3, N7, and N8 experienced more severe pull out and bending, mainly due to increased loads as a result of missing nearby nails. This indicates missing nails closer to the centre line of the loading will change the failure mode and reduce the strength of the connection; consequently, this will affect the load sharing and transfer of the timber-framed house to wind loads.

Figure 4.11. The most common failure modes of defective hand nailed triple grip connections: a) Type A-N1, and b) Type A-N6

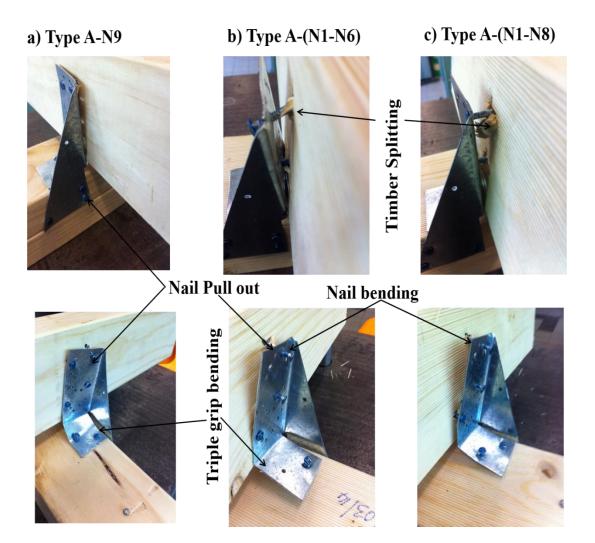
Figure 4.12. Most common failure modes of defective hand nailed triple grip connections: a) Type A-N9, b) Type A-(N1-N6), and c) Type A-(N1-N8)

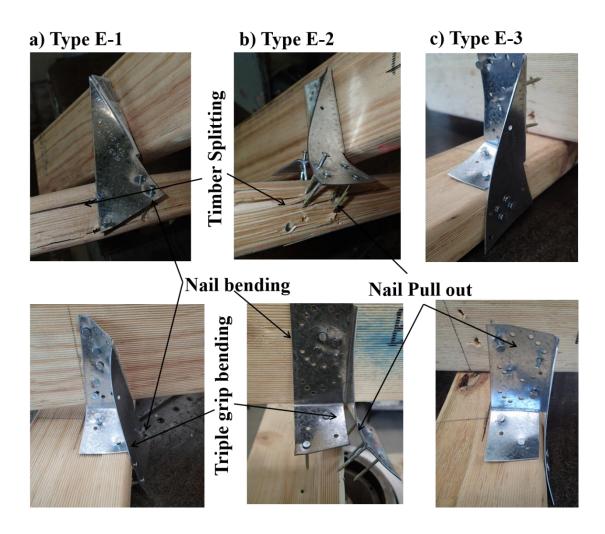
Figure 4.13. Common failure modes of defective gun nailed triple grip connections: a) Type E-1, b) Type E-2, and c) Type E-3

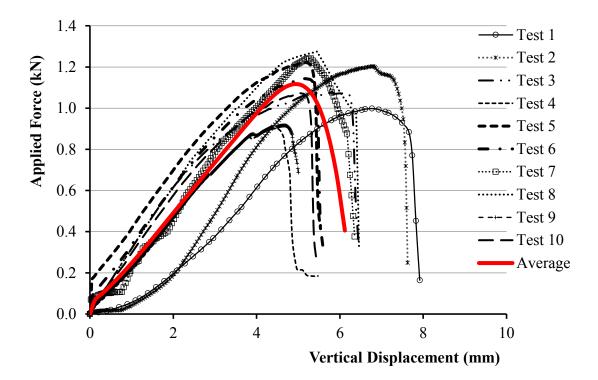
Figure 4.15. Applied force-displacement relationship for the Truss grip connection

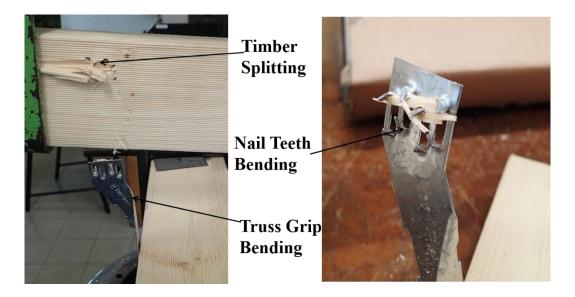
Figure 4.16. Common failure modes of truss grip connection

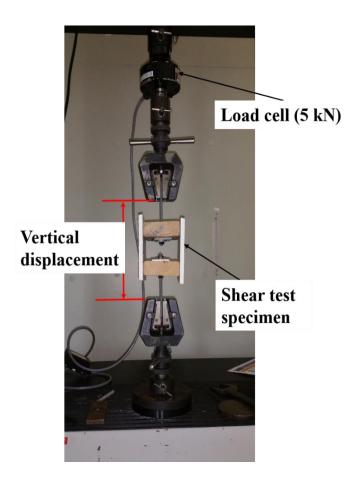
Figure 4.17. Timber to plasterboard shear joint test arrangements

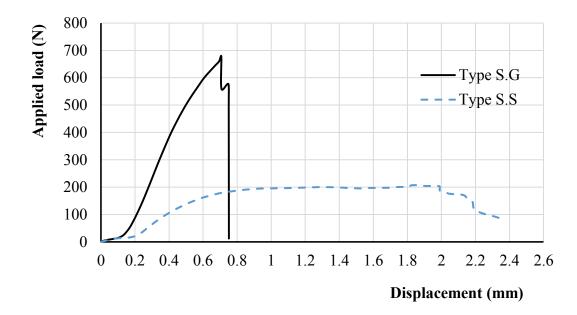
Figure 4.20. The applied load versus vertical displacement for Types S.G and S.S

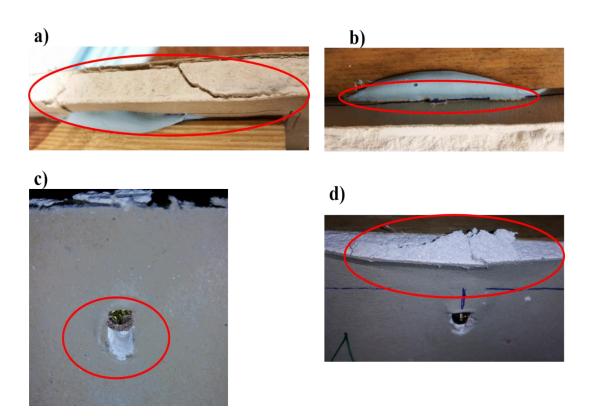
Figure 4.21. Most common failure modes of the shear load test specimens: a) Type S.G, b) Type S.G, c) Type S.S, and d) Type S.S

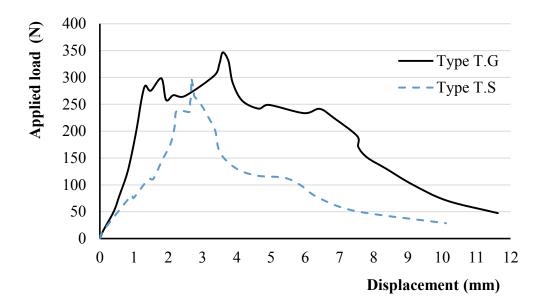
Figure 4.22. Applied load versus vertical displacement for Types T.G and T.S

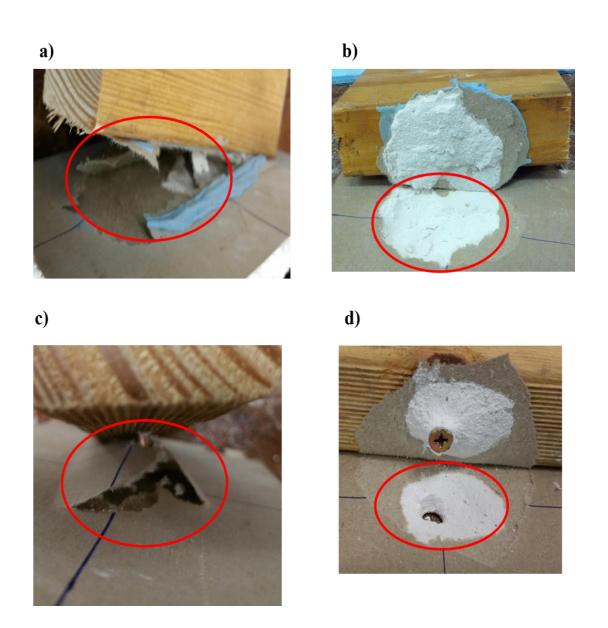
Figure 4.23. Common failure mode of the tension load test specimens: a) Type T.G, b) Type T.G, c) Type T.S, and d) Type T.S

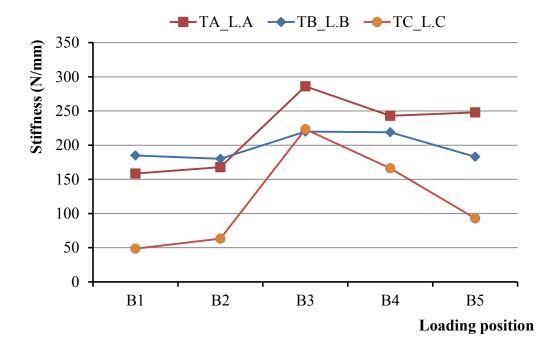
Figure 5.23. RWC stiffness variation at Trusses A (i.e. TA), B (i.e. TB) and C (i.e. TC), supports L.A, L.B and L.C at Stage S1

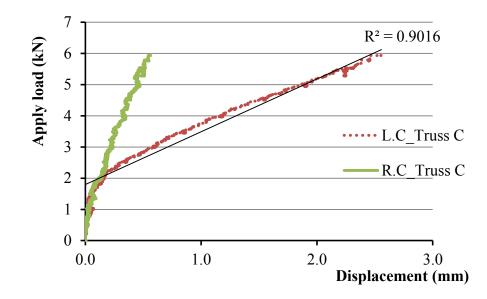
Figure 5.43. Lateral displacement of RWC versus applied load at Truss C (i.e. L.C and R.C)

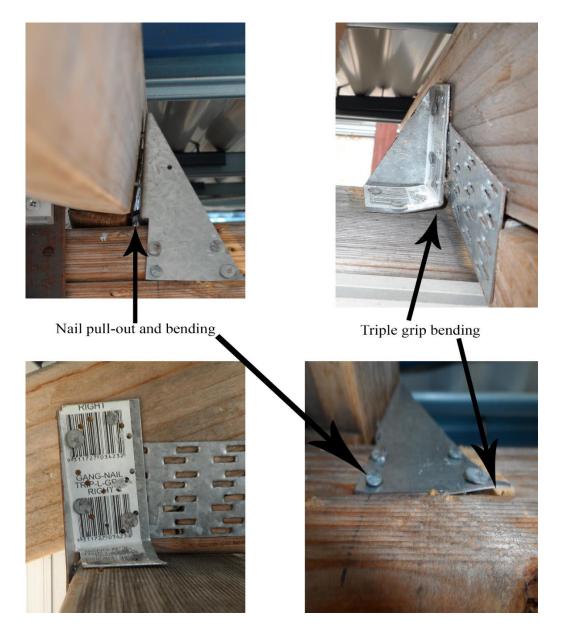
Figure 5.44. The failure modes of the roof to wall triple grip connection of Truss C, at loading side during line load test

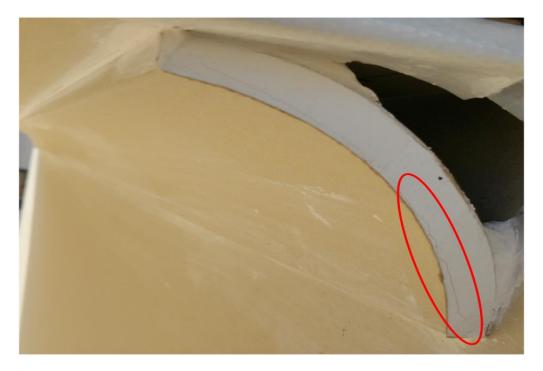
Figure 5.46. Hair-line crack on loading side ceiling cornice

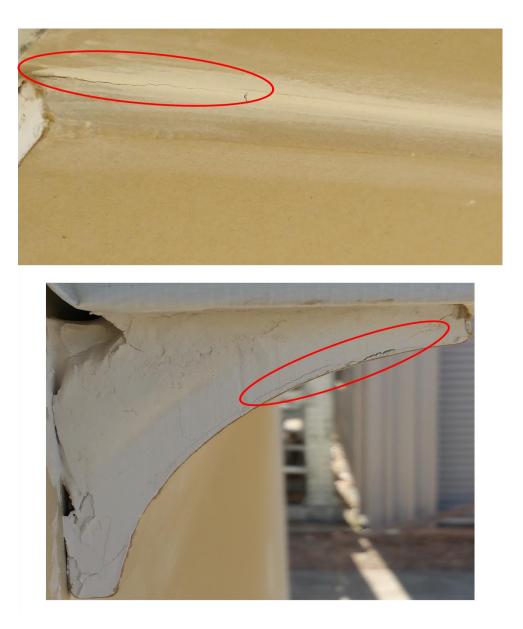
Figure 5.47. Hair-line crack on non-loading side ceiling cornice

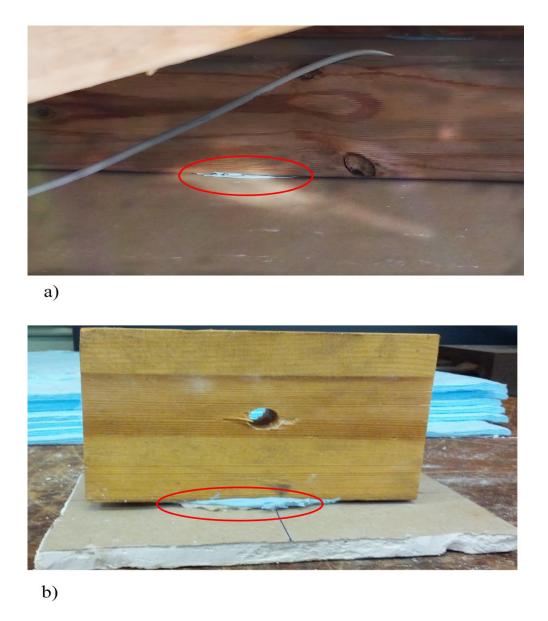
Figure 5.48. Comparison of the ceiling glue joint failure mode between the full-scale test and individual joint test: a) full-scale test, and b) individual joint test

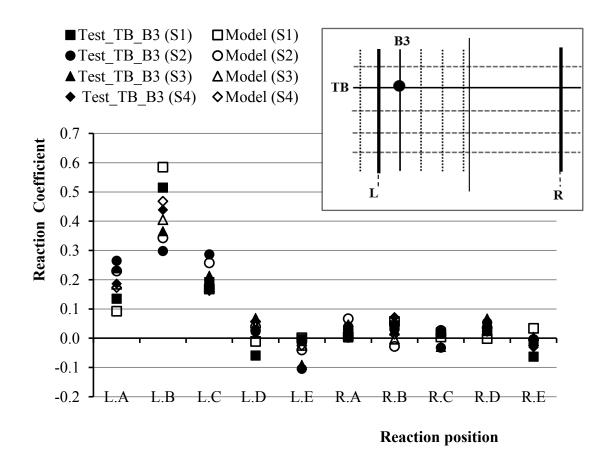
Figure 6.10. Comparison of the VRCs when load was applied at Batten B3 along Truss B at Stage S1, S2, S3 and S4 with full-scale test and the FEM

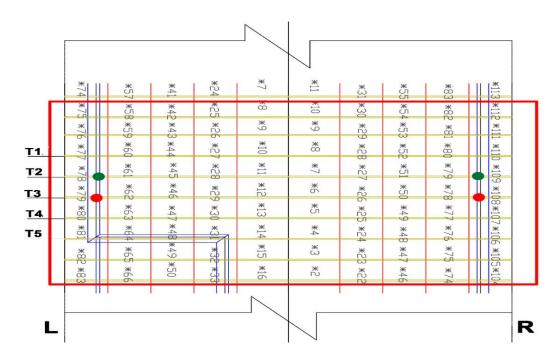
Figure 7.9. General truss region of the contemporary representative house, circles showing the defective RWC locations

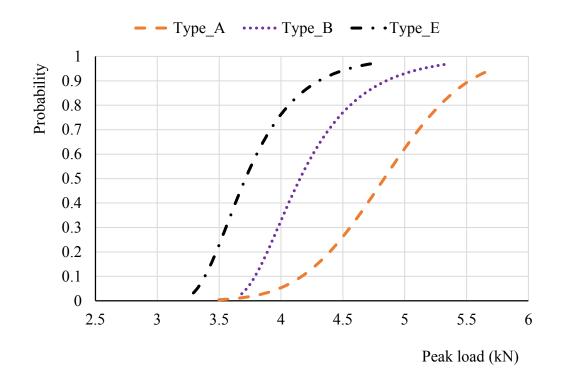
Figure A.1. Probability distribution for the peak load of the triple grip connection Types A, B and E

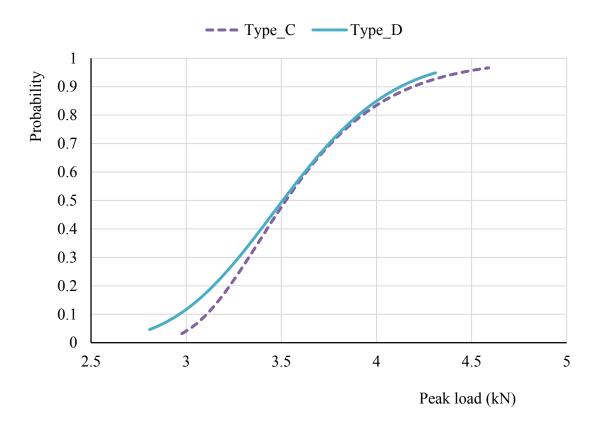
Figure A.2. Probability distribution for the peak load of the triple grip connection Types C and D

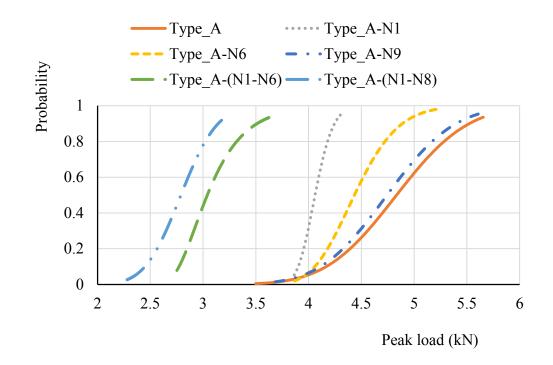
Figure A.3. Probability distribution for the peak load of the defective hand nailed triple grip connections

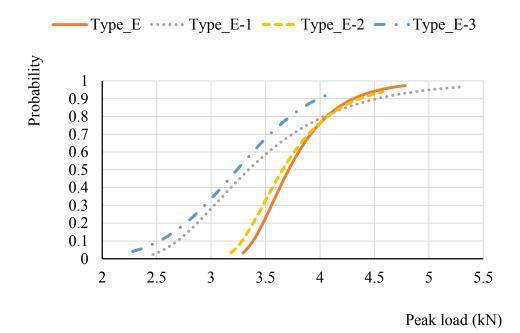
Figure A.4. Probability distribution for the peak load of the defective gun nailed triple grip connections

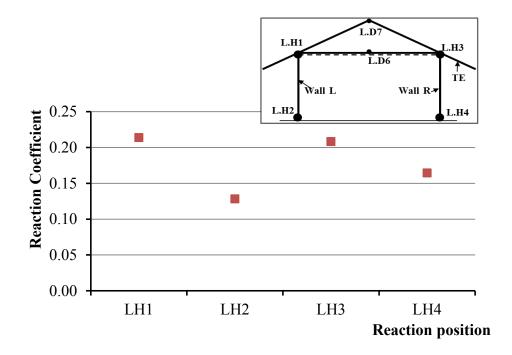
Figure B.14. Horizontal reaction coefficients at the top-plate and the bottom plate horizontal supports

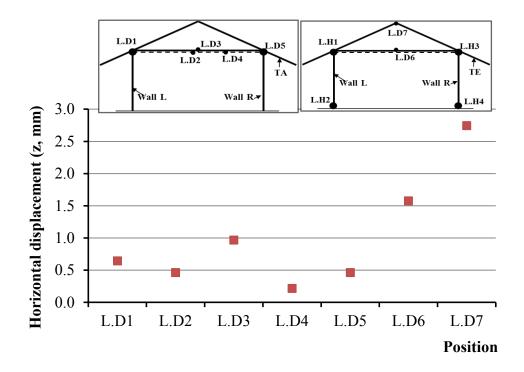
Figure B.15. Horizontal displacement at the top-plate, truss and the ceiling

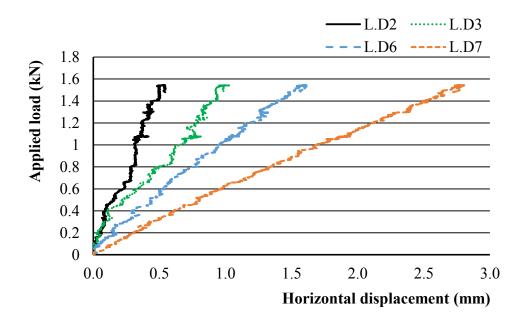
Figure B.16. The horizontal applied load versus displacements at the ceiling and truss bottom chord and apex

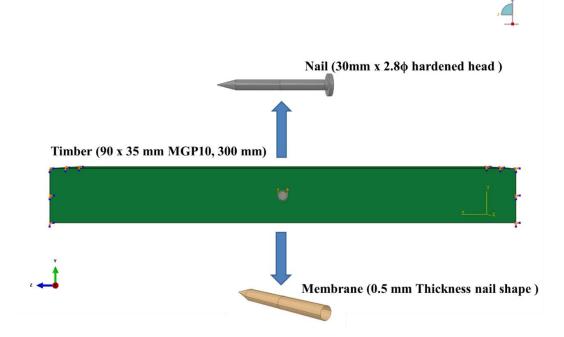
Figure C.7. FEM of single nail joint

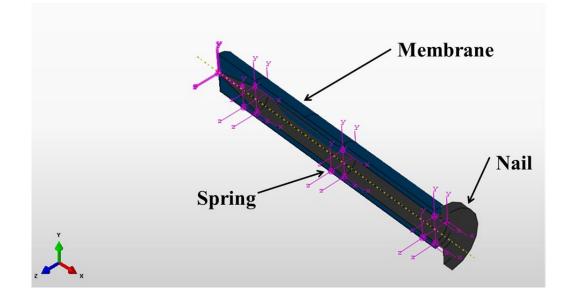
Figure C.8. Nonlinear spring location in the single nail joint model

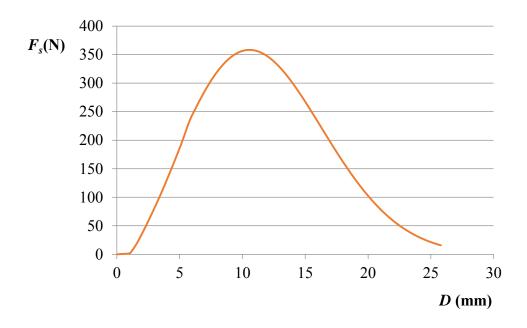
Figure C.9. Input force-displacement relationship for each spring

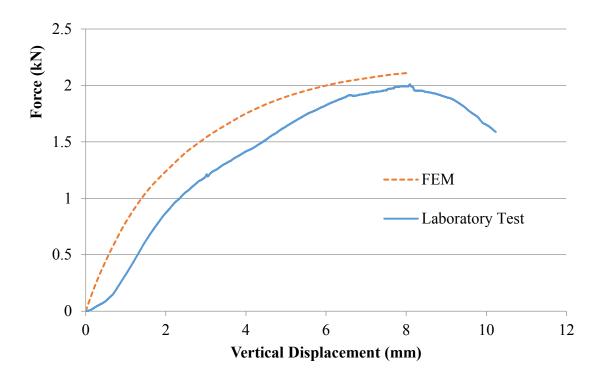
Figure C.10. Comparison of force-displacement relationship for a single nail joint model and experimental test

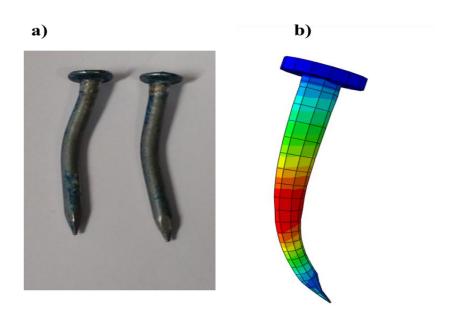
Figure C.11. Deformed shape of nails observed in the laboratory test and the FEM: a) laboratory test; b) FEM analysis

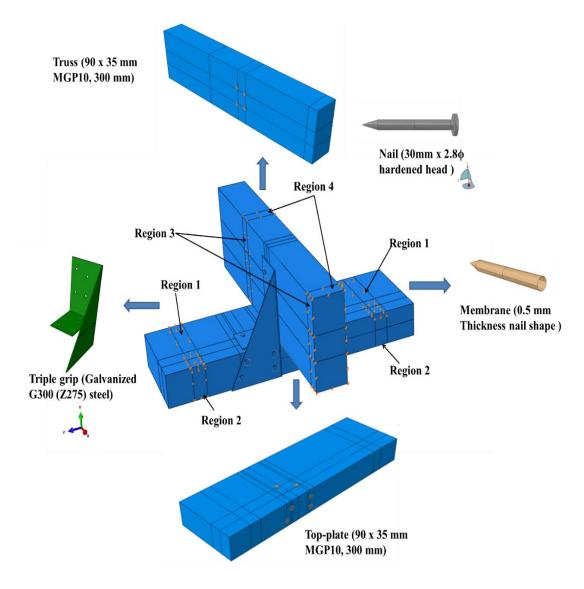
Figure C.12. FEM of triple grip connection

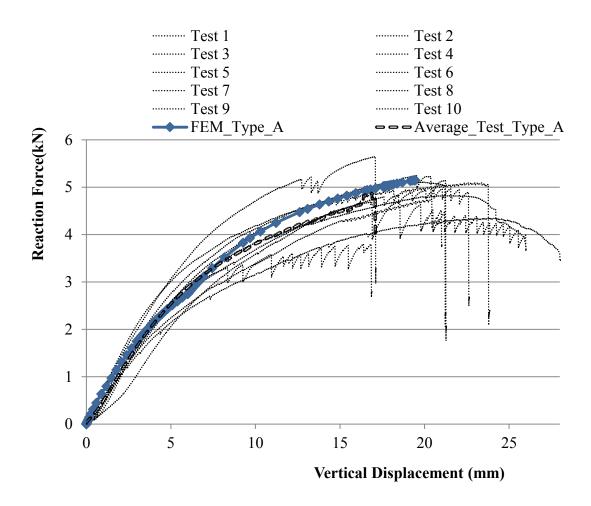
Figure C.13. Comparison of the FEM analysis and the laboratory test forcedisplacement relationships for the triple grip connections Type A

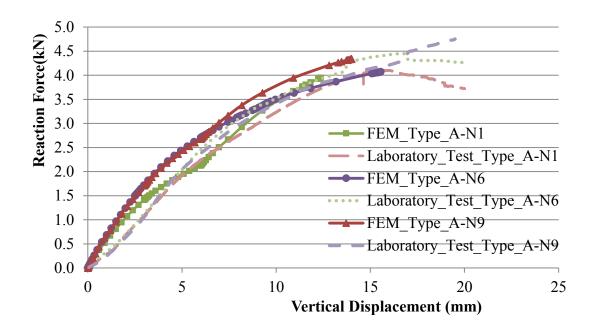
Figure C.14. Comparison of the FEM analysis and laboratory test force- displacement relationships for the triple grip connections Type A-N1, A-N6 and A-N9

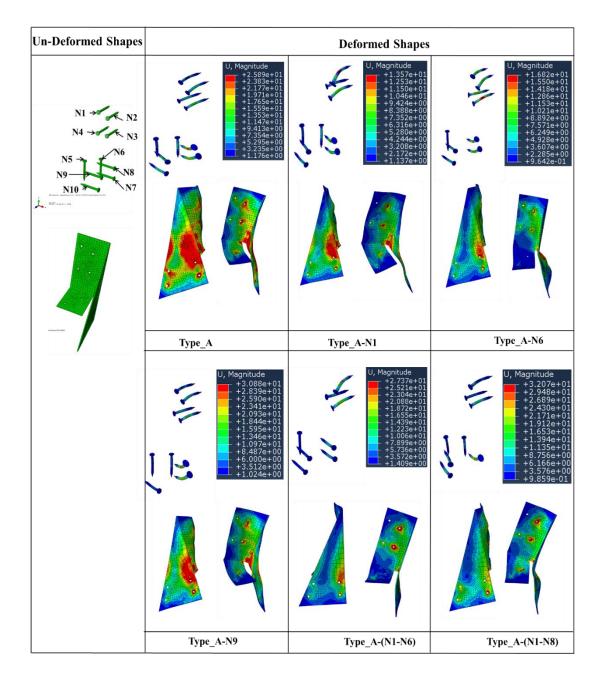
Figure C.16. FEM of triple grip connections: deformed and un-deformed shapes of triple grip and nails

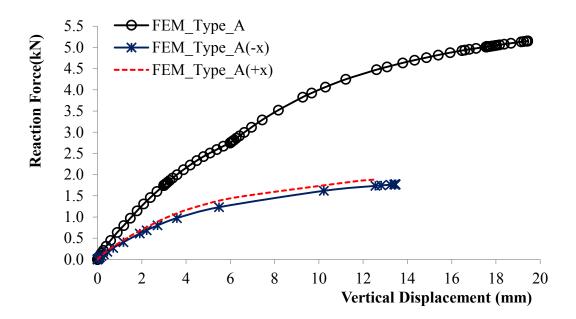
Figure C.19. Comparison of the vertical reaction force displacement relationship for RWCs subjected to vertical and angle loading

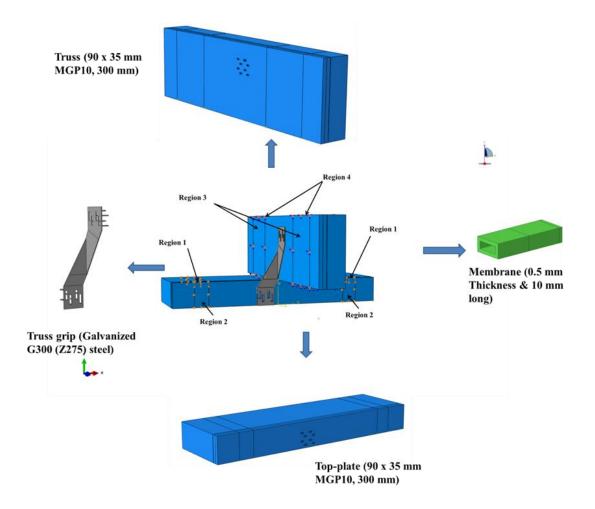
Figure C.22. FEM of truss grip connection

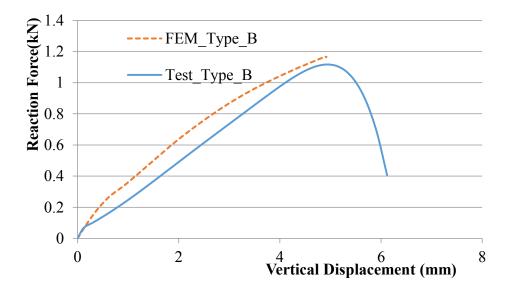
Figure C.23. Comparison of the FEM analysis with the laboratory test forcedisplacement relationships for the truss grip connection Type B

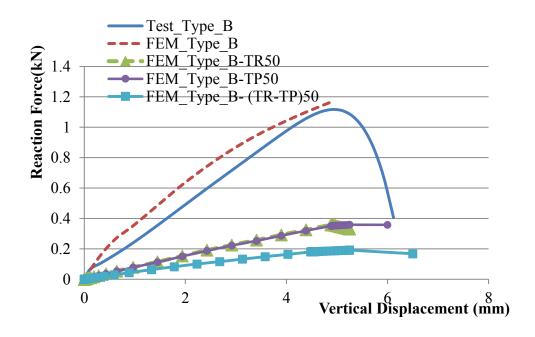
Figure C.25. Force- displacement relationships comparison between the "Ideal" and defective truss grip connections

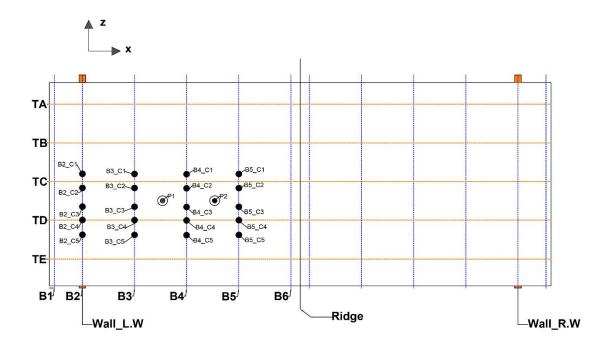
Figure D.7. Cladding to batten connection locations

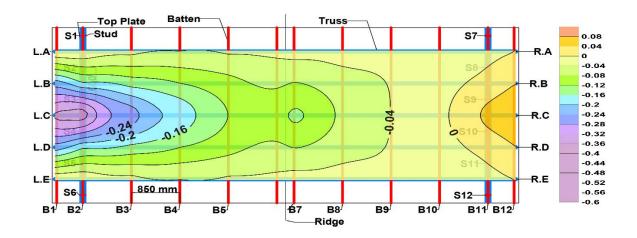
Figure D.9. Vertical reaction influence coefficient for Truss C support L.C obtained from FEM 2 (one defective RWC)

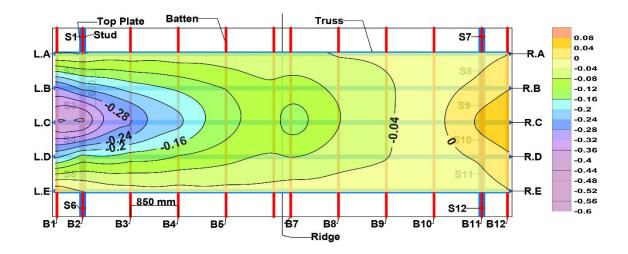
Figure D.10. Vertical reaction influence coefficient for Truss C support L.C obtained from FEM 3 (two defective RWCs)

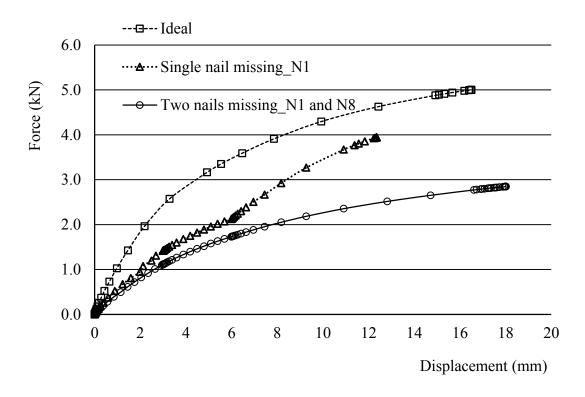
Figure D.11. Vertical force-displacement relationship for the "Ideal" and defective RWCs

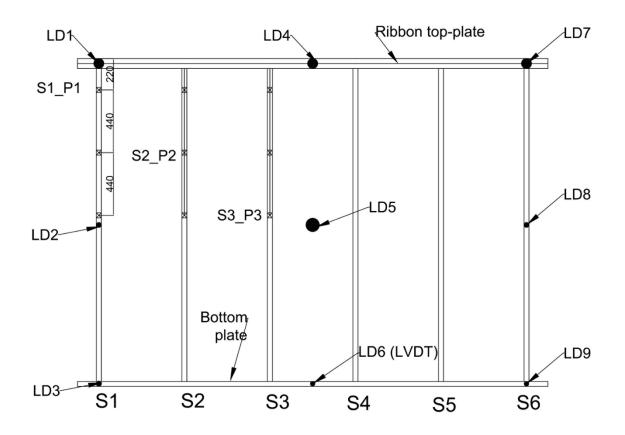
Figure D.12. Lateral loading (i.e. S1_P1, S2_P2 and S3_P3) and displacement measured locations

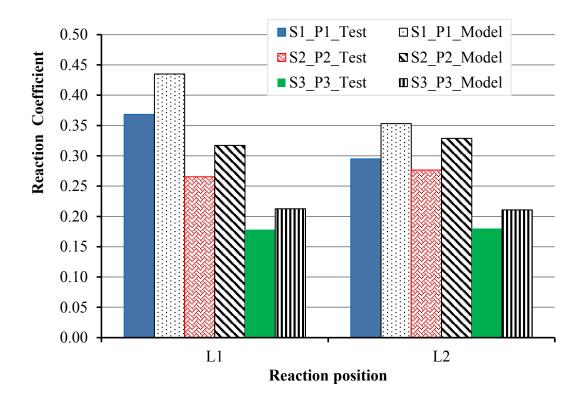
Figure D.14. Comparison of the lateral load reaction coefficients between FEM and full-scale test, when load was applied to the studs at S1_P1, S2_P2 and S3_P3

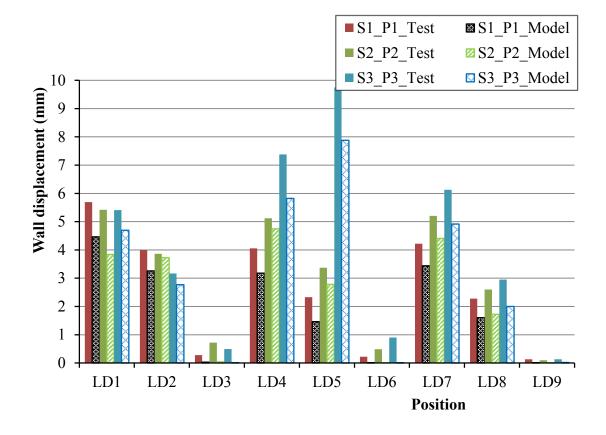
Figure D.15. Comparison of the lateral movement of wall (i.e. Wall L) between FEM and full-scale test, when load was applied to the studs at S1_P1, S2_P2 and S3_P3
