# Development of a Full-Scale Structural Testing Program to Evaluate the Resistance of Australian Houses to Wind Loads

Cyclone Testing Station, James Cook University, Townsville, QLD, Australia

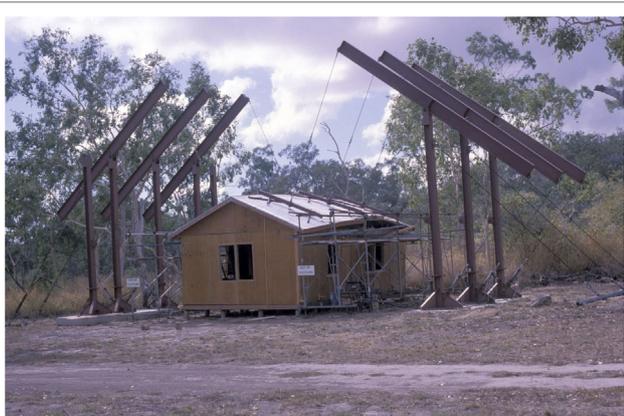
**FIGURE 3 |** Tongan house after low-cycle failure of truss-to-wall connection.

- The “Tongan house”—a house designed for a large scale reconstruction program following Tropical Cyclone Isaac in Tonga (Boughton and Reardon, 1984b) (**Figure 3**) The Tongan house was low-set (single storey with floor level less than 0.9 m above ground), with rectangular floor plan 7.2 m × 4.8 m, a steel sheet roof on softwood trusses with a 26° pitch and gable ends. The house included sawn softwood timber wall and floor framing, plywood floor, 8 mm thick plywood external cladding, and no internal linings. The design wind speed at eaves level was 62 m/s.

- The tests on the Tongan house showed that some straps and truss nail plates were susceptible to fatigue damage. After redesigning those details, the house resisted loads that were 130% of the design lateral and uplift loads.

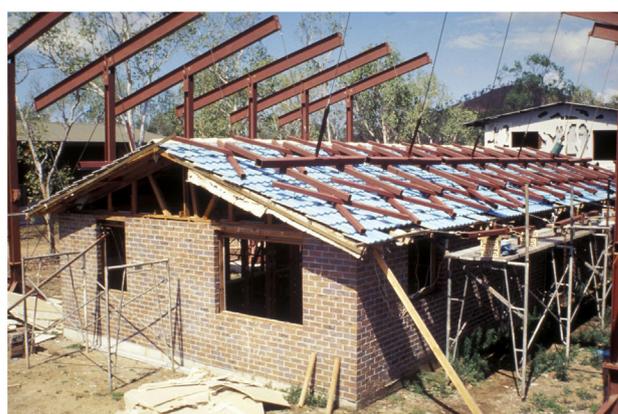
**FIGURE 4 |** Loading trees attached to roof battens of single storey house (the Hyne high-set house in background showing the damage to exterior wall cladding from simulated wind driven debris to evaluate loss of racking resistance in wall lining).

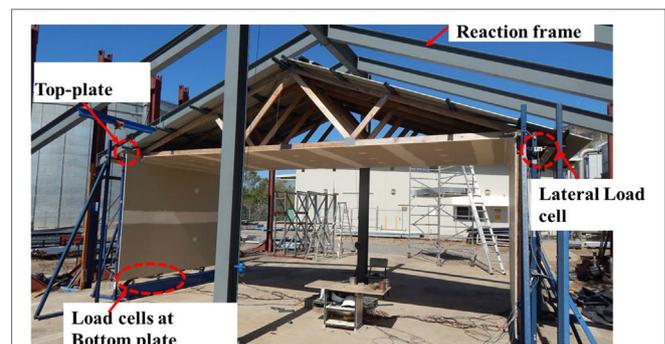
FIGURE 9 | Full-scale tests on house cross-section.

A 3.3 m-long section of house including five 6.6 m-long roof trusses, shown in **Figure 9**, was constructed for full-scale testing to evaluate the capacity of normal house components such as wall linings and cornices to carry loads (Satheeskumar et al., 2016a) around weak truss-to-wall connections. Vertical load transfer through the structural connections was measured at the top plate and the bottom plate. The full-scale test structure included five standard prefabricated nail plate trusses, metal battens, corrugated steel roof cladding, timber wall frames, plasterboard wall and ceiling lining, and cemented ceiling cornices.

Hand-nailed metal framing anchors that complied with recommended construction practices (“ideal”) were initially installed to connect the trusses to the wall frames. Some of the connections were altered (e.g., missing nails) for subsequent tests to reflect poor construction practices observed in some houses as discussed in the Section “Investigation and Testing of Contemporary House Construction.” The results showed that the load distribution of uplift forces was a function of the stiffness of the roof-to-wall connection. The lining elements (i.e., ceiling, ceiling cornice, and wall lining) contributed significantly to vertical load sharing.
