## Load Sharing Between Batten to Rafter Connections under Wind Loading

K.I. Parackal, J.D. Ginger, D.J. Smith and D.J. Henderson

Cyclone Testing Station, College of Science Technology and Engineering,  
James Cook University, Townsville, Queensland 4811, Australia

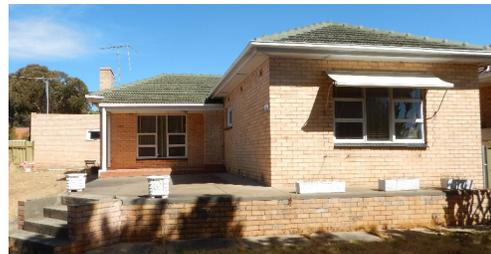
Figure 1 An example of the typical double brick pitched framed construction surveyed

Most of the houses surveyed were single storeyed with double brick walls and pitched frame hip and valley roofs. Figure 1 shows a typical 1960's single storey double brick house with hardwood pitched roof framing and concrete tile cladding that was surveyed.

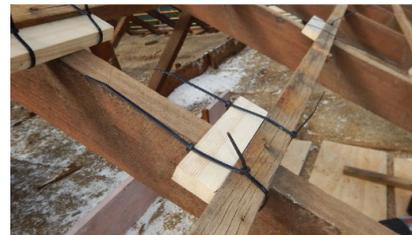
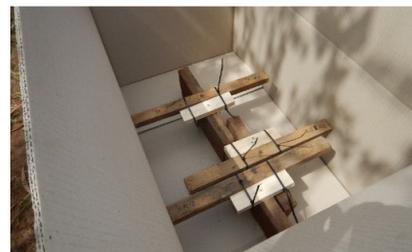
Figure 2 Connections being prepared for extraction (top) and being packed for transit (bottom).

Connections were securely braced (Figure 2) before they were cut away from the roof structure so that they could be interlocked and transported safely via road freight. Rafters and battens were named such that connections on the same rafter and the same batten could be identified. A comparison to moisture contents taken of samples inside the roof spaces of neighbouring houses with the same material indicated that the levels of moisture had not changed significantly during transit.

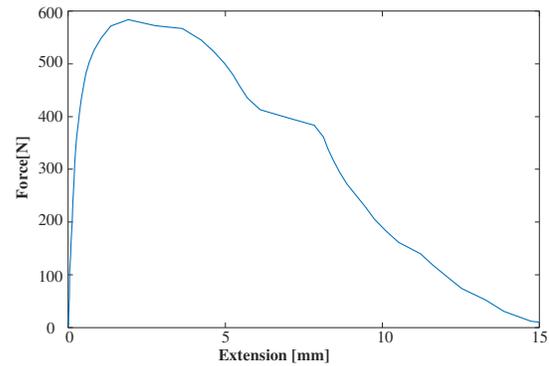
Figure 3 Example of a force vs. displacement curve for static pull-out test of a hardwood batten to rafter connection

Displacement controlled pull-out tests at a rate of 2.5mm/min were conducted to determine the mean strength of the connections under a slow load rate. A representative load vs. extension plot of a hardwood connection with a strength close to the mean strength is shown in Figure 3.

The connection behaves elastically up to a load of approx. 500 N and reaches a maximum load of approx. 600 N. Connections then display a plastic region where the nails withdraw while maintaining the same load for 5 to 10 mm after which the connection quickly loses its strength with further withdrawal of the nail.

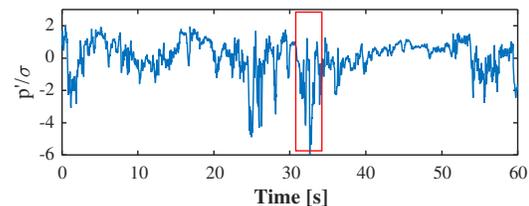
Figure 4 Load time history at a batten to rafter connection showing an intermittent 'peak event'

Batten to rafter connections are subject to fluctuating uplift loads due to turbulence of the atmospheric boundary layer and building induced turbulence from flow separation. A 1/50 scale wind tunnel model test was conducted on a gable roof house with a 22.5° roof pitch as described in [2]. For cornering winds, connections near the ridgeline at the gable end experience especially high uplift loads. Load fluctuations at one of these connections are shown in Figure 4. High loads occur in 'peak events' where the load can be more than 3.5 standard deviations from the mean.

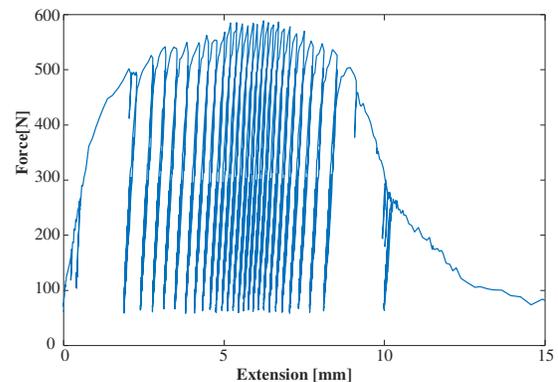
Figure 5 Example of a force vs. displacement behaviour of a hardwood batten to rafter connection under repeated wind uplift peak events

Figure 5 shows an example of connection behaviour under dynamic loading. The vertical bands in this plot indicate the loading and unloading paths during low-level load fluctuations between peak events. During peak events, the nail slips causing a permanent withdrawal of the nail. As the pressure fluctuations do not reverse the direction of the load on the nail, the connection deforms elastically resulting in another vertical band in the plot between each peak event. In this case, there was an increase in performance after a slight withdrawal of the nail as the magnitude

of each slip decreased near the centre of the plot. After about 7mm of nail withdrawal, the connection rapidly lost strength and failed.

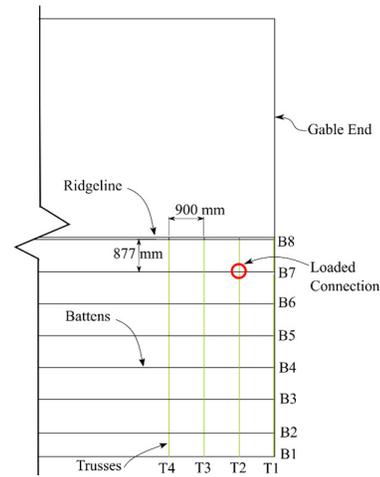
Figure 6 Plan view of batten to rafter/truss connections on the gable roof house modelled in the finite element model. [1]

To determine the characteristics of load redistribution and how a progressive failure may propagate through the roof structure, a non-linear time history analysis using a finite element method structural analysis model was performed. An array of batten to rafter connections representing the connections on a gable roof house were modelled as shown in Figure 6.

As described in [1], non-linear time history analysis was performed with a quasi-static ramp load (1kN/min) applied at the location of connection T2-B7 (Batten 7 fastened to rafter/truss 2 as shown in Figure 6). The ramp load is continued as the first connection fails and loads are redistributed to neighbouring connections. Selected time steps of colour scale plots showing the redistribution of load are shown in Figure 7.

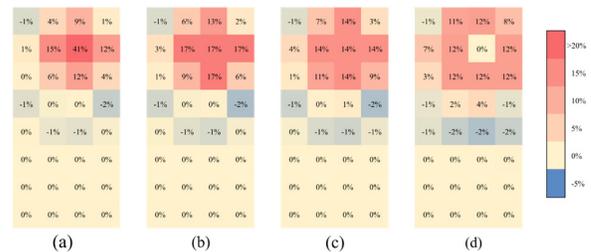
Figure 7 Colour scale plots of batten to rafter connection loads at five time steps showing percentage of the applied load borne by each connection. From left to right: (a) at and before yield of loaded connection, (b) at yield of connections along battens, (c) at yield of connections along cladding corrugations, (d) at failure of loaded connection. [1]

Before connection T2-B7 yields as shown in Figure 7(a), a total of 27% of the load is shared among connections immediately to the left and right on the same batten (T3-B7 and T1-B7). Loads are also resisted along the corrugations of the cladding, with a total of 21% shared with connections T2-B8 and T2-B6. Finally, 15% is shared among connections diagonally away from the loaded connection. These proportions of load sharing continue to the point where connection T2-B7 yields.

After connection T2-B7 yields the proportion of load borne by this connection decreases and the amount of load sharing at all neighbouring connections increases. After connections to the left (T3-B7) and right (T1-B7) yield, shown in Figure 7(b), the loads borne by connections on the same batten reduces and load transferred along corrugations increases. Loads are then redistributed along corrugations to connections T2-B8 and T2-B6.

Once all connections adjacent to the loaded connection yield as shown in Figure 7(c), loads are shared equally among all the adjacent connections including the loaded connection. However, when the loaded connection fails completely as shown in Figure 7(d), loads are redistributed to diagonal connections.

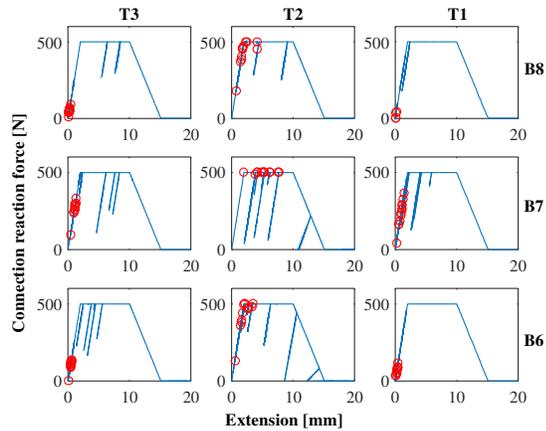
Figure 8 Force-deformation curves of nine connections including the loaded connection showing nail slip behaviour in response to peak events. Time steps encircled indicate instances when connection T2-B7 begins a nail slip, showing that nail slips occur at different times at neighbouring connections.

Incremental failure of nails was observed similar to those of the individual connection tests. Each nail slip results in loads being redistributed to neighbouring connections. Figure 8 shows the force-displacement curves of nine connections including the loaded connection with the nail slip behaviour seen in the repeated diagonal bands. Selected time steps when connection T2-B7 begins to slip are encircled and indicate that nail slips at neighbouring connections occur at different times to that of the loaded connection.

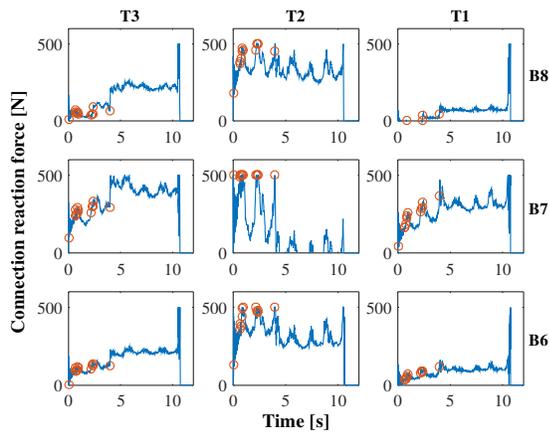
Figure 9 Load time histories at nine connections showing load redistribution during nails slips at the loaded connection. Time steps encircled indicate instances when connection T2-B7 begins a nail slip.

Figure 9 shows load time histories at the nine connections showing the increase in loads at neighbouring connections during nail slips at Connection T2-B7. Loads increase at neighbouring connections with little time delay, indicating that loads are redistributed effectively instantaneously to neighbouring connections during nail slips. Additionally, loads are shared and redistributed in similar directions to the pull-up analysis. In this instance the structure becomes unstable after seven peak events, a cascading failure then commences and propagates in a similar manner to that of the pull-up analysis.
