Smith, Amanda Sharlene Maree (1992) Townsville's old gaol: a study of people and structures. Graduate Diploma thesis, James Cook University of North Queensland.

TOWNSVILLE'S OLD GAOL: A STUDY OF PEOPLE AND STRUCTURES

in partial fulfilment of the requirements for the Graduate Diploma
of Material Anthropology in the Material Culture Unit of James Cook
University of North Queensland.

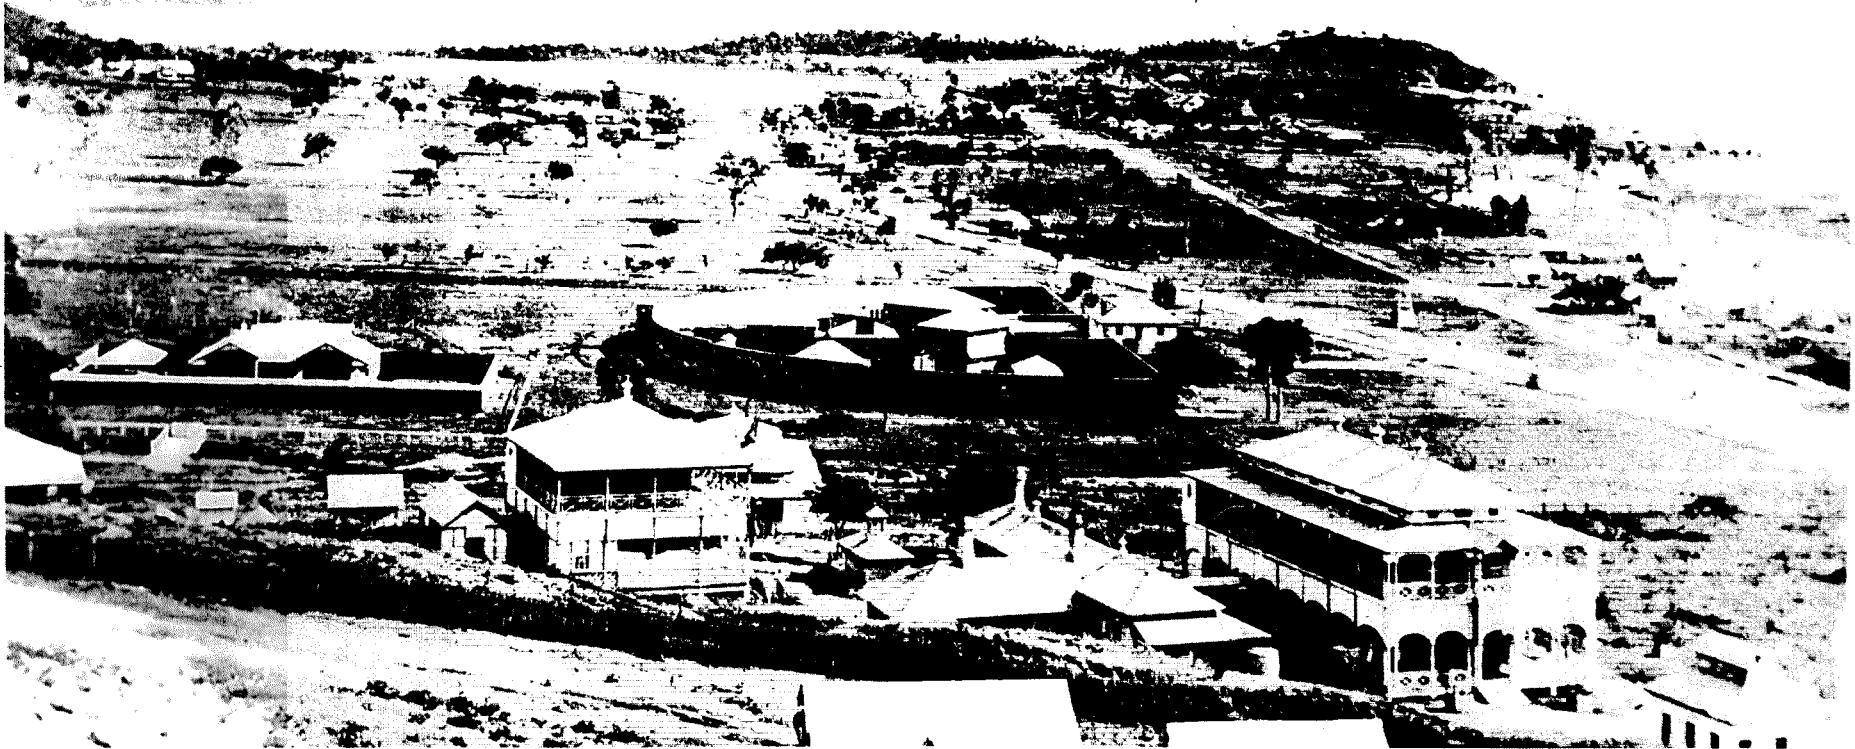
Plate 1: Townsville's Old Gaol, courtesy of Townsville Central State Primary School (c.1885, source unknown).

situated mid-way along the straight margin, and to the exterior of the boundary wall (Figure 1.d). At the centre of this building was a covered court where prisoners (and, for some time, so-called lunatics) were accepted through main entrance gates, into a large circulation and distribution space, called the front circle. A verandah, connected to a 10ft [3048mm] high wall, followed the arc of the front circle from which three main elements radiated (Q V&P 1887:729). These elements were the women's cell block to the left, the men's cell block to the right, with the kitchen and wood shed in the middle. A large water tank was situated in the centre of the front circle, a guard room was located in the southern corner, and a kitchen for the principal gaoler was in the northern corner (loc. cit.).

The women's cell block was a brick and cement structure, 33ft x 26ft [10058mm x 7925mm], with seven single cells on the ground floor, and an associated cell (a dormitory situation) on the upper floor (Q V&P 1887:730). The concrete foundation of this wing remains today, showing 9ft x 7ft [2743mm x 2134mm] outlines of the single cells. Instead of an eighth cell, stairs led to the associated cell. The men's block was similar, yet larger, being 49ft x 26 1/4 ft [14935mm x 8001mm] on the ground floor (Q V&P 1887:730). There were 11 single cells on the ground floor, with the same dimensions as those of the female prisoners' wing. On the ground floor, the twelfth cell space was converted to a stairwell which led to the upper associated cell.

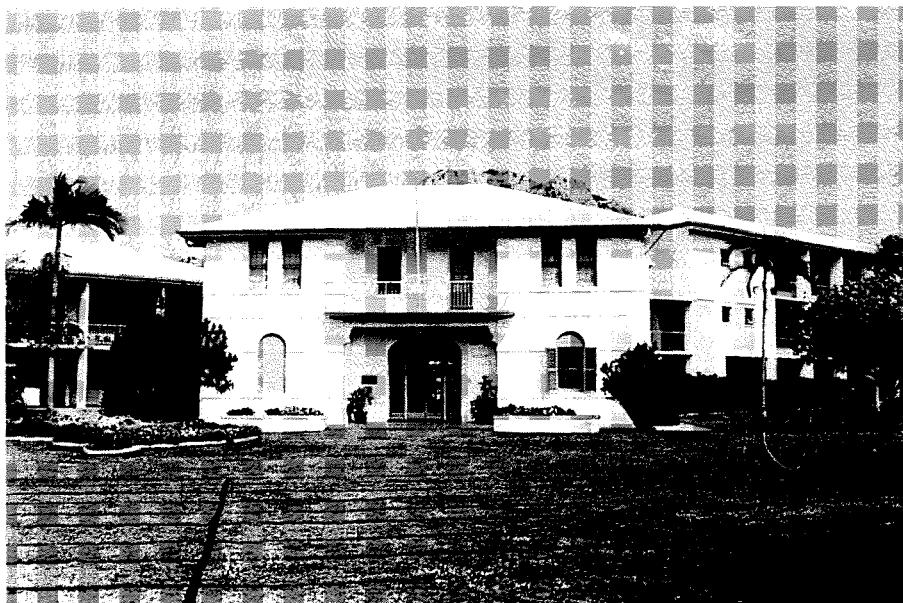
a) North-east elevation.

b) North-west elevation

Plate 2: The former gaoler's and turnkey's quarters.
Photographs by the author, 25 June, 1992.

The Townsville Old Gaol had several problems in its design. A major problem with the gaoler's and turnkey's quarters was the weathering effects of rain. This two-storeyed brick building quickly became damaged owing to the very porous nature of the bricks, unprotected by a balcony or a verandah (QSA WOR/A 369 1884:#6228). There was a slight overhang on the roof but this barely served to protect the first floor, while the ground floor had no shade or weather protection at all.

As a result, the walls became discoloured during the wet season, and remained 'damp and slimy' long after (loc. cit.). Gaoler Thomas Smyth also complained of large cracks in the walls, breaking up the plaster which appeared likely to collapse in places, thus causing the building to be unpleasant to live in during the wet season (QSA WOR/A 369 1885:#5). According to Smyth, the building was most unwholesome to live in and had caused much sickness (QSA WOR/A 369 1884: #6228).

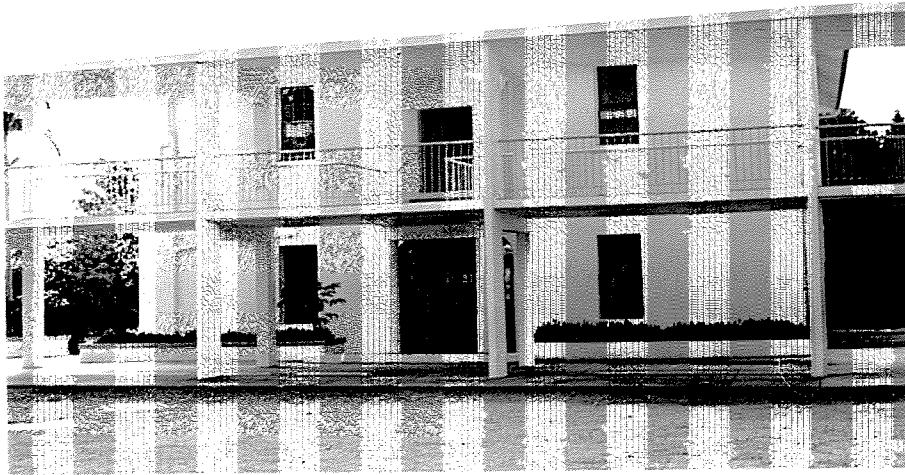
a) South-east elevation.

b) South-west elevation.

Plate 3: The former gaoler's and turnkey's quarters.
Photographs by the author, 25 June, 1992.

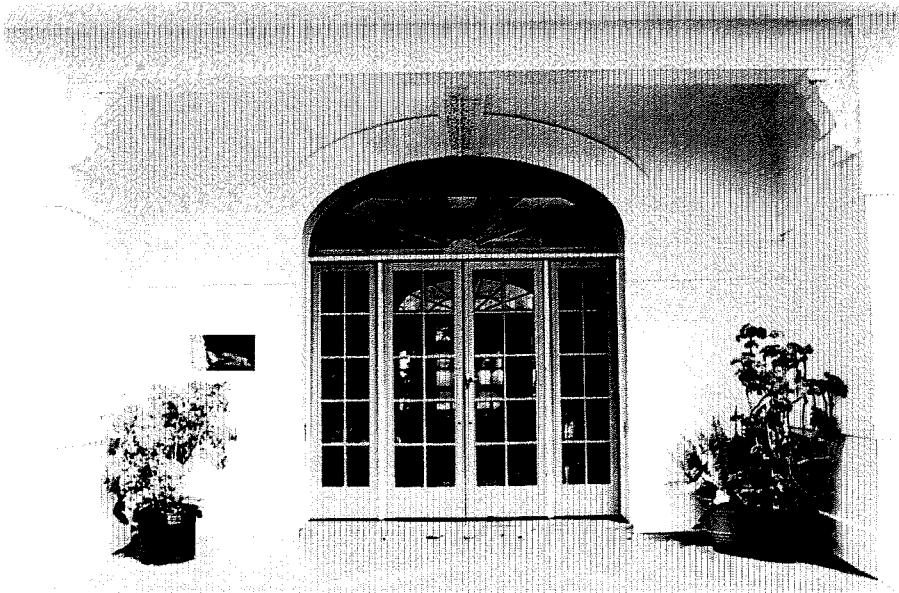
a) Entrance to the covered court, exterior view.

b) Entrance to the covered court, interior view, showing support beams to upper suspended timber floor.

Plate 4: Entrance to the former gaoler's and turnkey's quarters, showing timber and glass doors which replaced the original iron gates, after the buildings use for gaol purposes was discontinued.

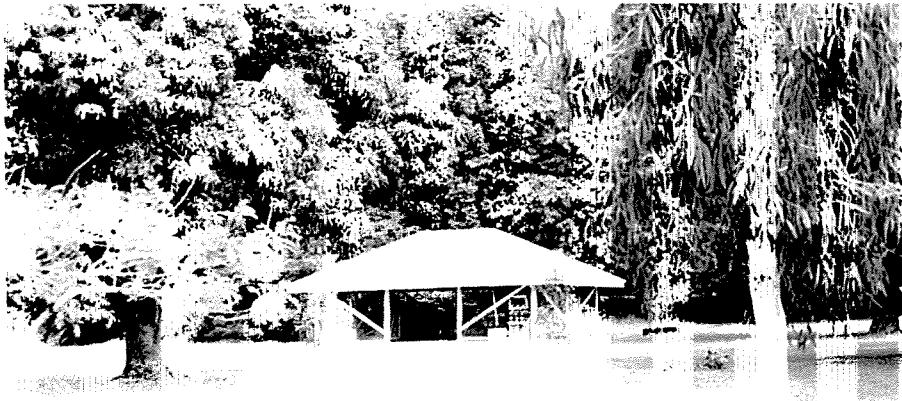
a) Brick security wall, now lowered in height, showing interior junction of semi-circular and front straight walls, south-eastern corner.

b) View of shed of the former Reception House, relocated behind the gaol. A similar construction was used for the sheds of the Old Gaol.

Plate 6: Structures associated with Townsville's Old Gaol.
Photographs by the author, 25 June, 1992.

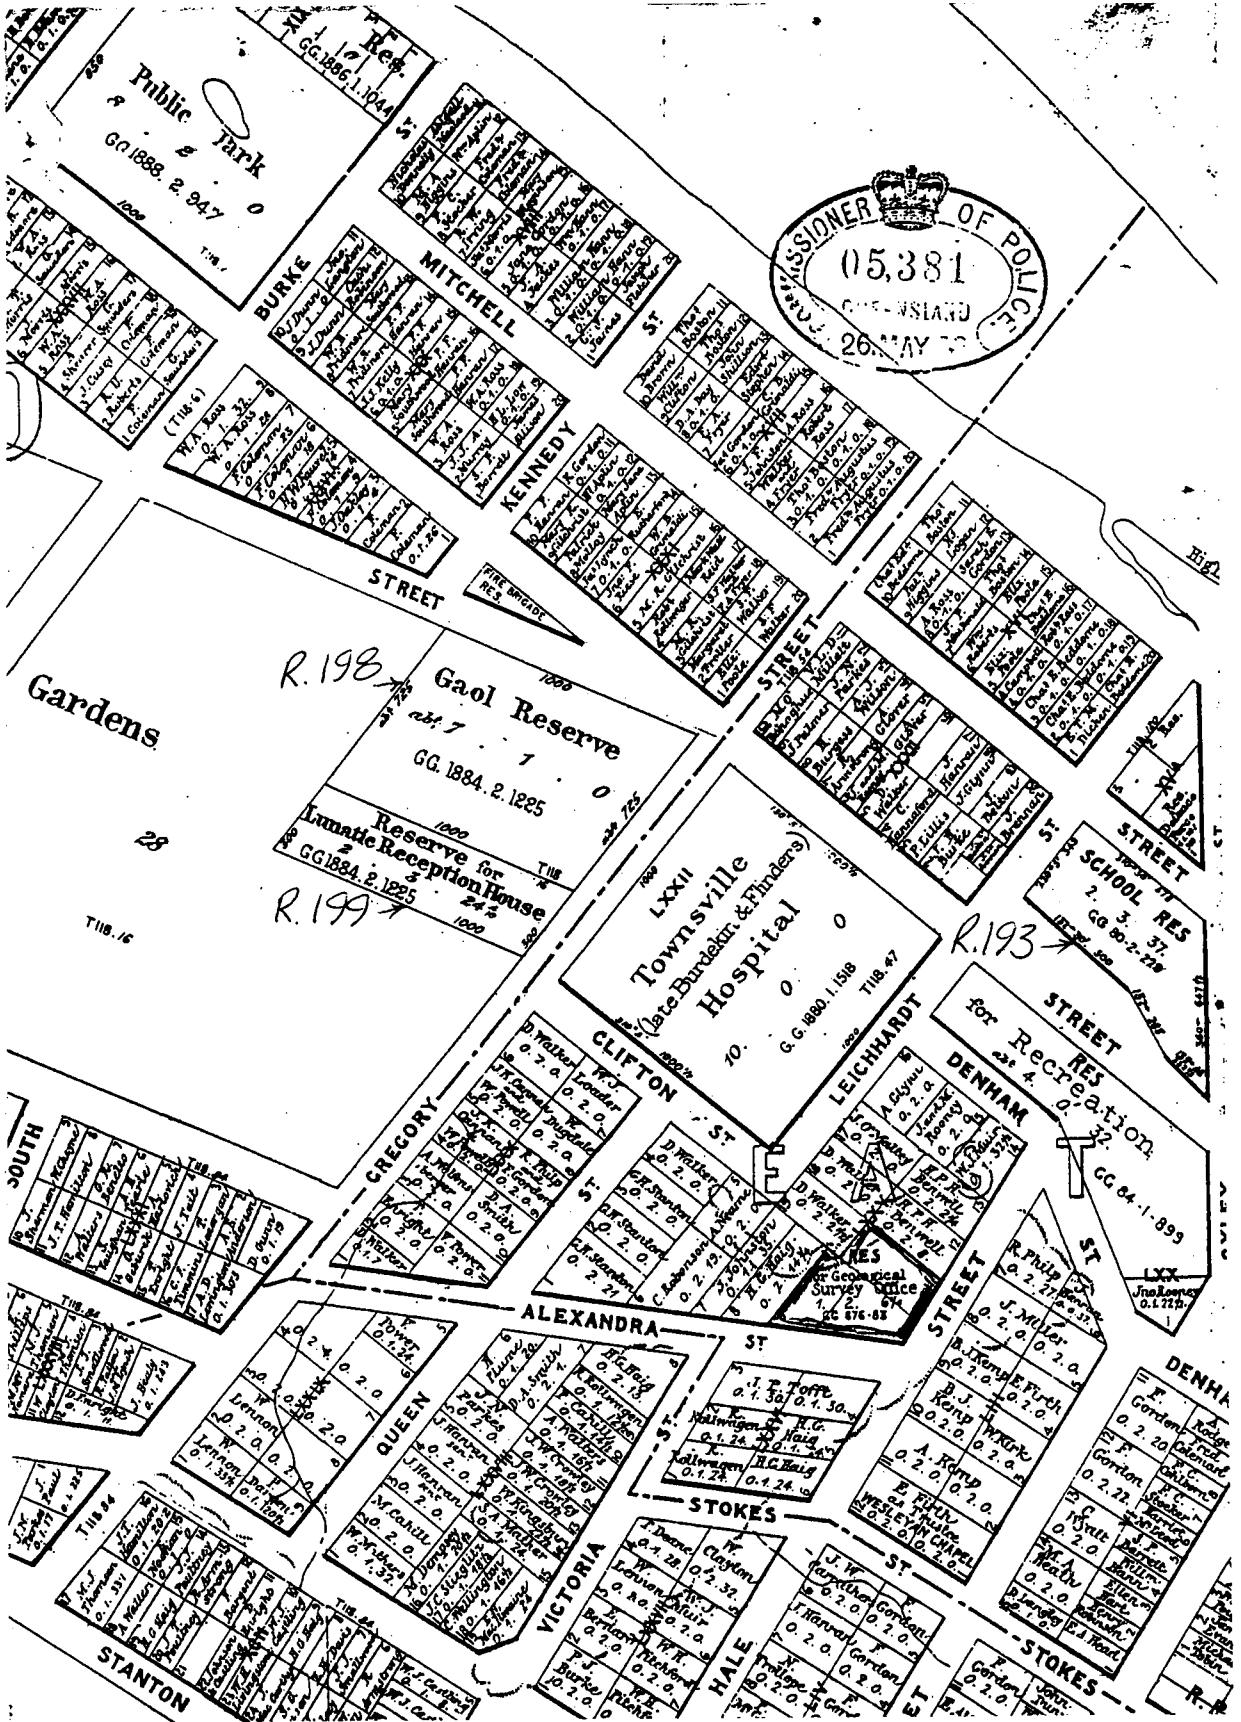
Figure 4.b: Map showing marking of Reserves to be exchanged:
 R.199, R.198 & R. 193.
 After QSA (A/41702 653: #05381).

As described on page 78 and shown in Figure 4.b, Reserve 198 was the Old Gaol premises, Reserve 199 had been used for Mental Hospital purposes, and Reserve 193 was school land.
