SS *Xantho*: Towards a new perspective.
**An integrated approach to the maritime archaeology and conservation of an iron
steamship wreck**

Thesis submitted by
Michael McCarthy Dip. P. Ed., B. Ed., Grad. Dip. Mar. Arc., M. Phil.
in January 1996

For the degree of Doctor of Philosophy
in the Department of Archaeology and Anthropology
James Cook University of North Queensland

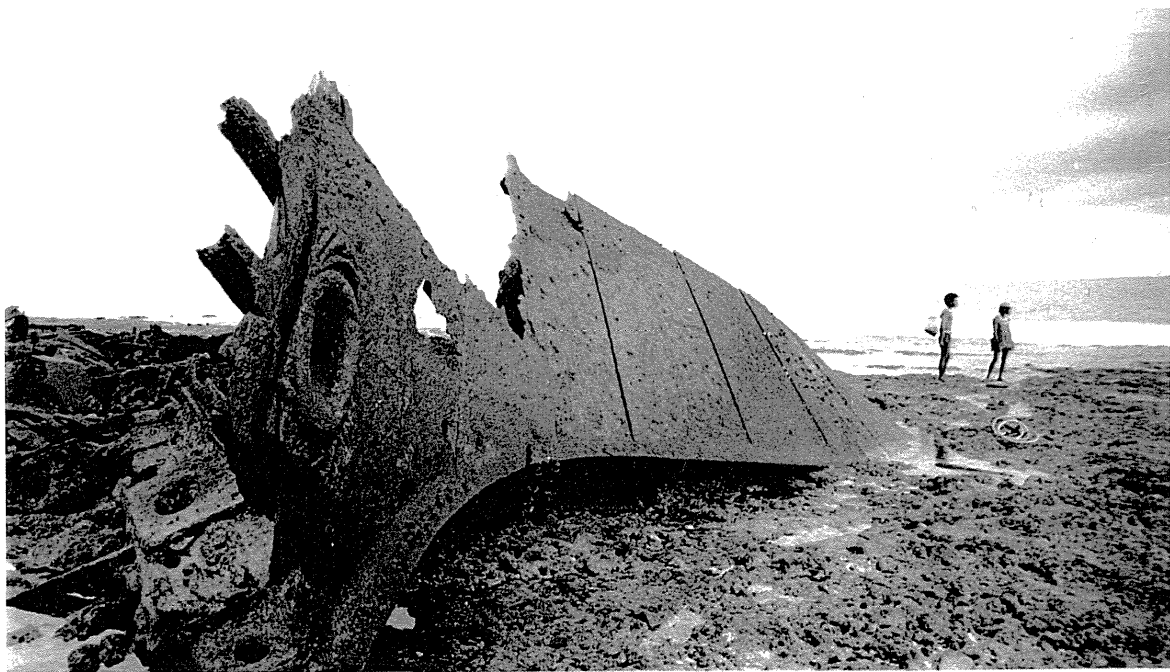
Figure 65: The author inspecting the stern of the iron barque *Ben Ledi*. The illustration shows the integrity of the unit.

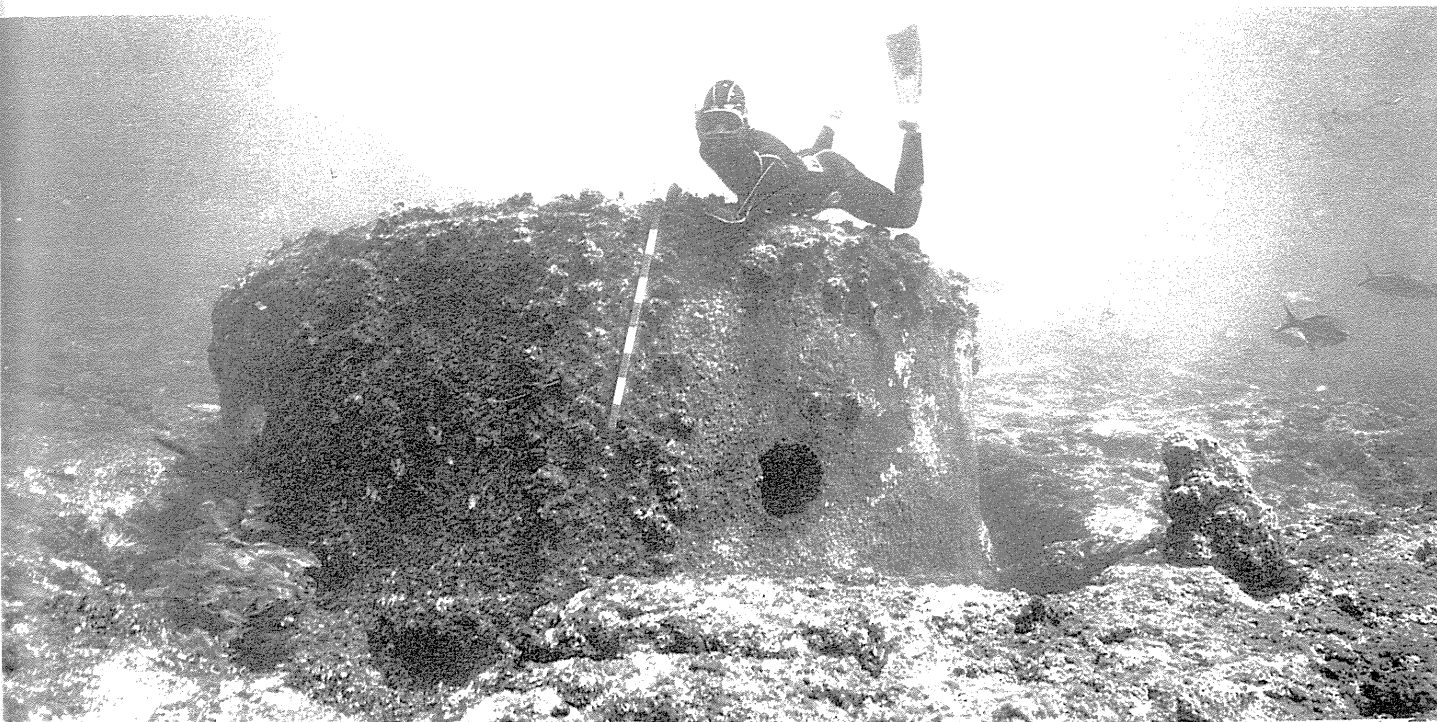
Figure 66-b: Burial in reef structures. A view of the *Windsor* boiler underwater. Photograph by the author (McCarthy, 1982b). The question was put whether the boiler could have fallen into the hole? Given that the hole in which the boiler lies is almost perfectly cylindrical and given the tight fit, it became evident that the boiler had gradually sunk into the reef. The finding of the ship's rudder deep within a rudder-shaped hole, provided conclusive proof.

The boiler, shown underwater in Figure 66b, lies only metres from the one shown in Figure 66a on the drying reef-top. Both lie on their end; one has sunk into the reef, the other has not, posing obvious questions about the site-disintegration processes and the substrate on which the separate parts of the wreck lie. Though there was

considerable discussion and disagreement on this phenomenon when it was first seen, the tight fit of the boiler and the finding of the rudder in a rudder-shaped hole were considered conclusive (McCarthy, 1978a, 1978b). Diving geologist R.J. Brown was also consulted and he agreed, after examining the evidence, that the boiler and the rudder had worked their way down through the reef and that they had not fallen into an existing hole (pers. com.).

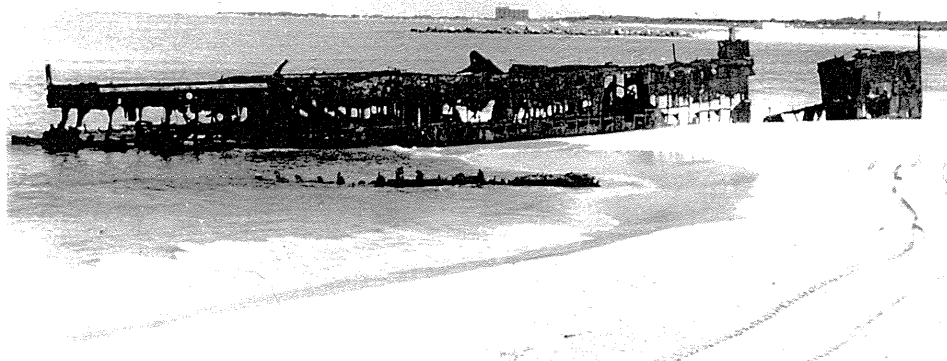
Figure 68: The iron-hulled *Alacrity* in the process of disintegration over a period of about 20 years up to around 1975. *Abemama* can be seen inshore on the aft quarter of *Alacrity*. The uncovering of the two sites is due to dredging nearby. Note the varying angles of the *Abemama* hull to the *Alacrity*. Photographs by D. Gilroy and D. Robinson.¹

Illustrations (Figure 68a-c) of the French-built iron-hulled tugboat *Alacrity* (1893-1931), lost within a few years of *Abemama* and now lying seven metres from it, show that the process applies as much to an upright wooden wreck as it does to the iron hull in the same environment.

¹It is useful to note at this juncture that wrecks can move, even after many years. The evidence appears above in the case of the *Abemama*.

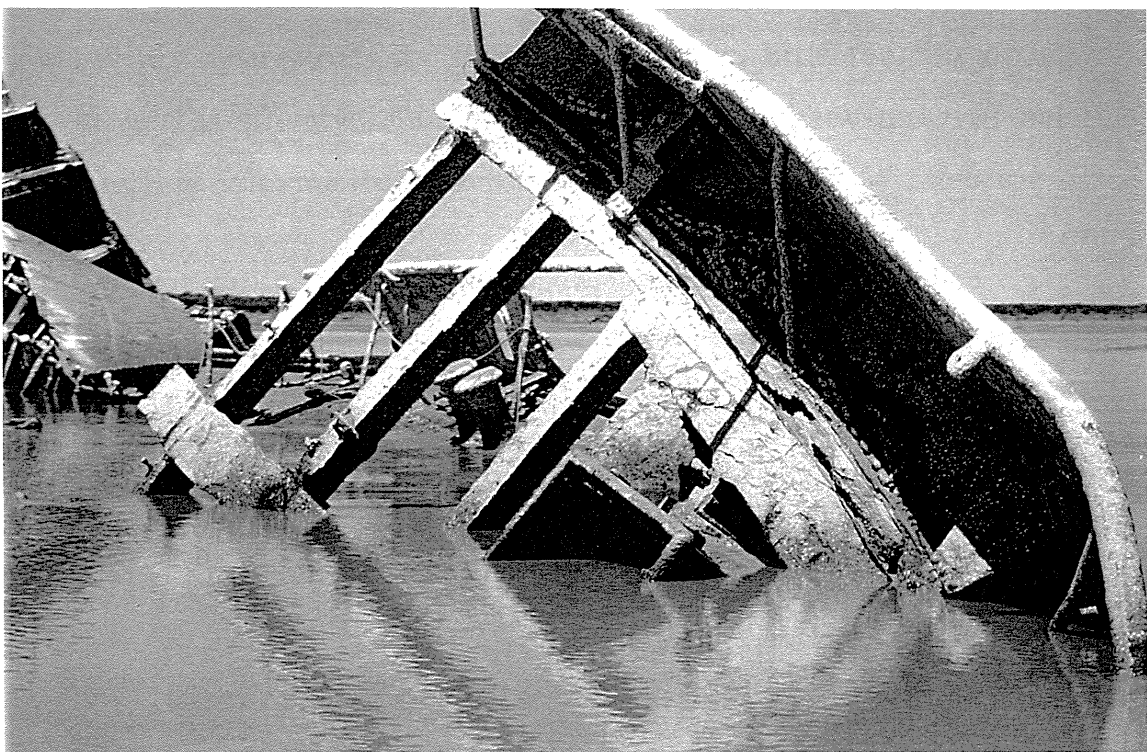
69c: The stern, showing the integrity of the section in comparison with the cargo-hold.

On inspection it became evident that the relative longevity of the midships section is apparently due both to the longitudinal and lateral strength of the engine, bunker and boiler rooms. These form a very strong unit which is heavily braced both horizontally and vertically in traditional fashion and by a heavily-built coal chute at an angle of around 45° from the vertical in the bunker room. The prevailing site conditions of strong, but directionally constant, tidal currents and the absence of the constant pulsing action of seas and swell represent other major factors.

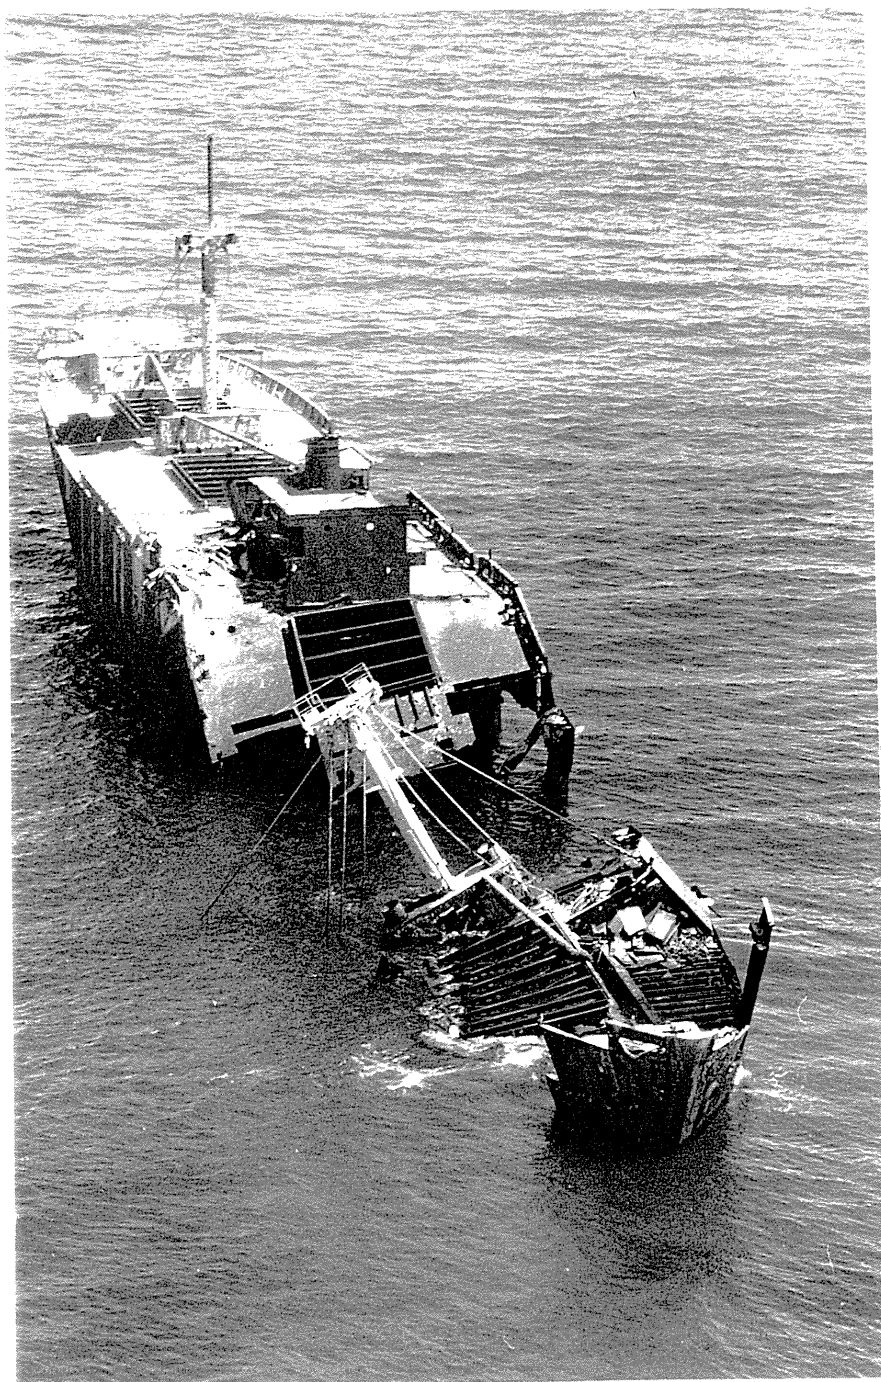
Figure 71: An aerial view of SS *Alkimos* showing the collapse of the forward cargo hold. Photo by R. Gould, 1995.

An interesting example of the need to control for post-depositional effects is again found on the SS *Alkimos*. The following illustration (Figure 71) shows an apparent collapse in the forward cargo hold and an intact bow triangle, as expected.

Though fitting the expected mould for natural transformation processes at iron and steamship sites, these features are actually the result of cultural transformations in the form of secondary salvage over a number of years (Nairn and Sue, 1975); making it essential to account for all post-depositional factors before making comment on the processes involved. The process of site disintegration in the case of such vessels is on-going and occasionally quite dramatic. The derrick and fore-deck shown in Figure 71, above have now totally collapsed, leaving only the fore-peak above the waves ahead of the bridge (Veth, pers. com. 1996).

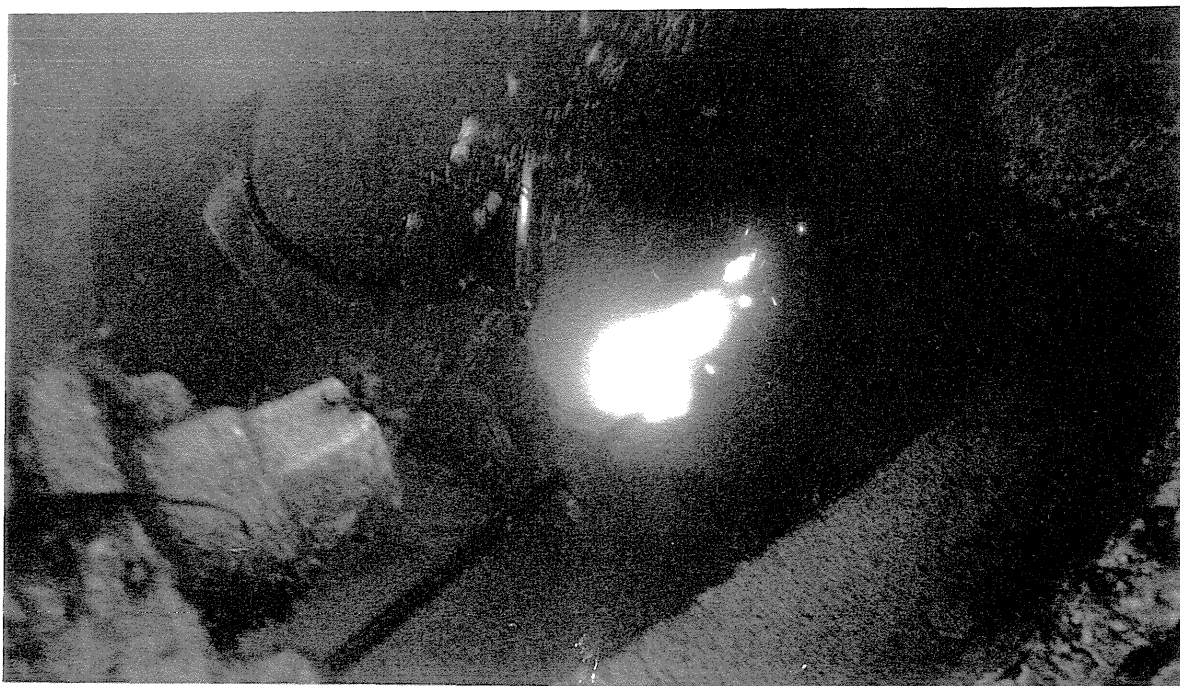
Figure 79: Cutting in progress. Photograph M. McCarthy.

combination of the noise from the escaping gases and the glare from the cutting tool (Figure 79).¹

Though planned as a test-cut, there was so little original metal holding the engine and its box frame to the vessel that within the space of a few hours, the engine was cut free (Kimpton and McCarthy, 1988).

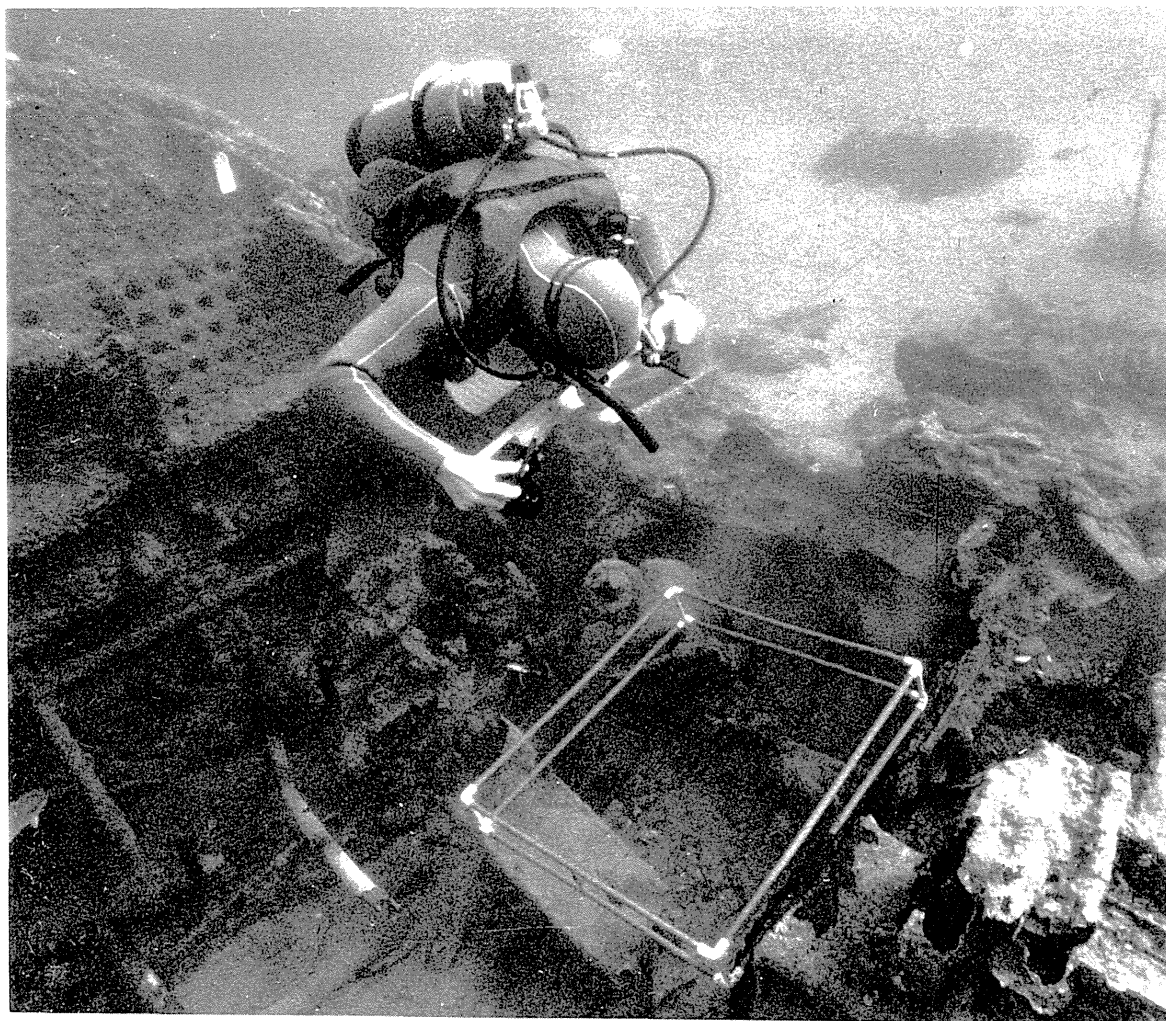
Figure 82: Photographer Pat Baker employing two Nikonos III cameras with 15mm Nikonos lenses and a double grid square used for keeping the cameras in a horizontal plane. Photograph by N. Clarke.¹

Throughout the excavation, the stereoscopic system shown in Figure 81 was deployed. It comprised a twin 15 mm underwater camera system mounted on a one metre-long bar and a double grid frame which allows the diver to locate the cameras vertically above the target. Intended as a three dimensional supplement to manual recording, it provided a very useful cross reference where the manual recording required checking or augmentation in the laboratory (cf. Green 1990: Ch. 5).

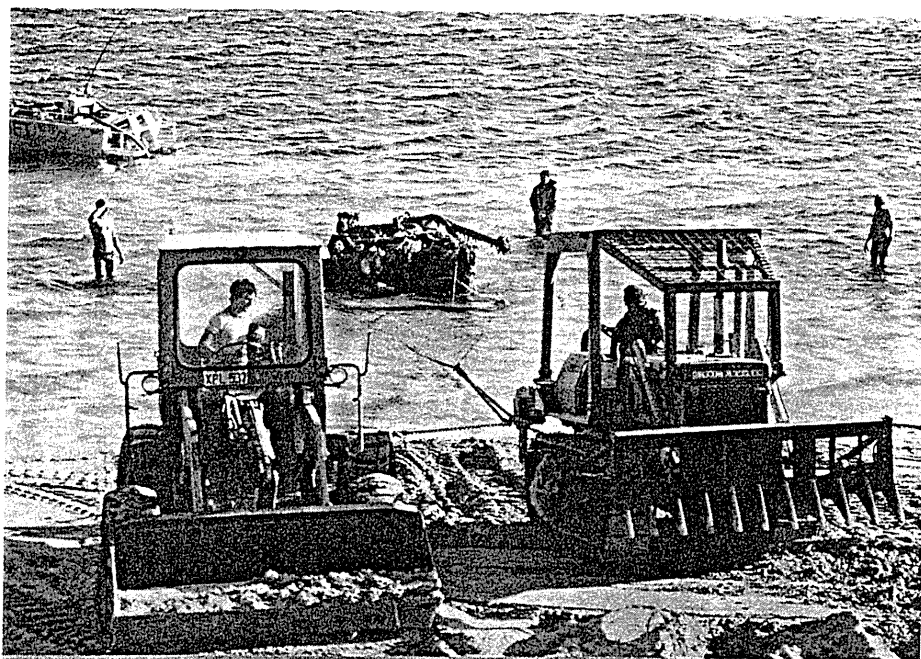
Figure 85: The engine being dragged ashore on the sled. Photograph by P. Baker.

The underwater slope ahead of the sled was modified by excavating with the water dredge. A bulldozer and front-end loader were then shackled to the chains on the sled which was then slowly towed into progressively shallower water, until the top of the engine greeted air after 113 years on the sea-bed.¹ The sled was then towed along the shore and up the slope to a parking zone overlooking Port Gregory.

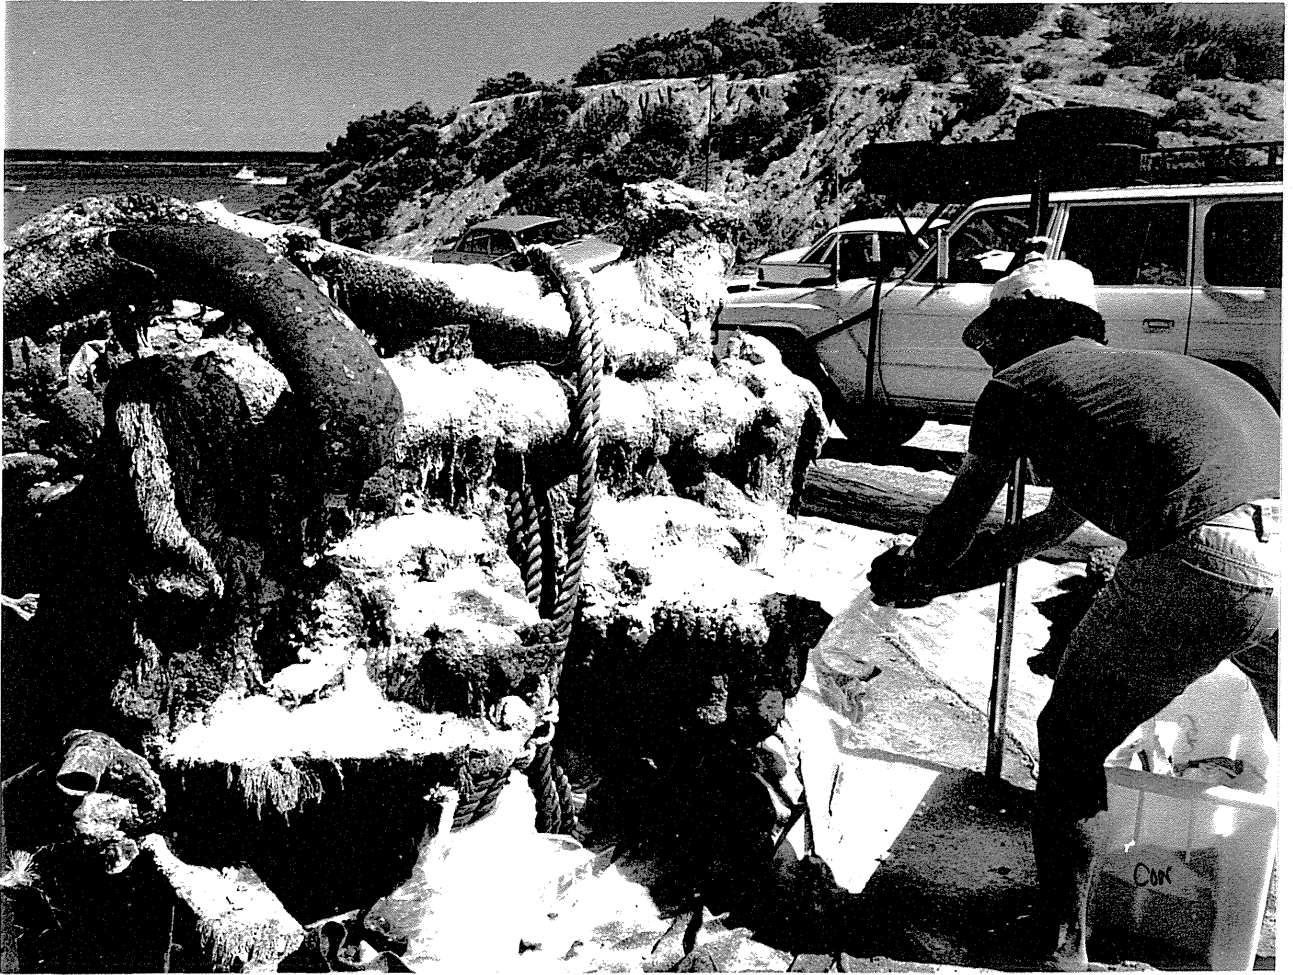
Figure 86: The engine ashore, in its coating of Erosel. Photograph by P. Baker.

Once the engine and sled were secured on the land, the earth-movers were unhitched and the photographers and conservators went about their business recording and preparing the engine for transport south. This included 3D recording of the engine by photogrammetrists from Curtin University using a special-purpose camera with glass negatives so that an accurate record could be obtained, should the engine not survive the journey intact.¹

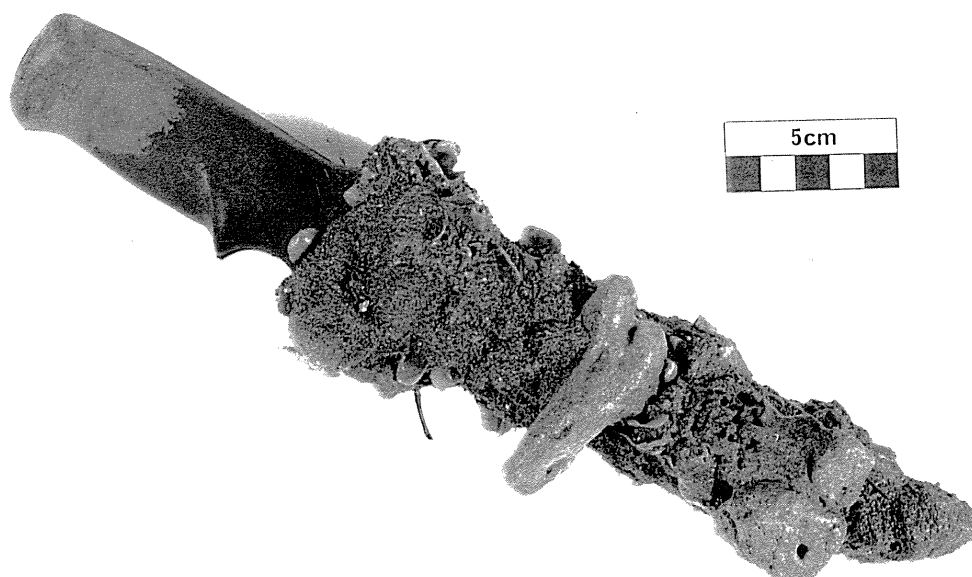
Figure 94: A diver's knife after nearly a decade on the sea-bed alongside the *Xantho*. Photograph J. Carpenter.

The knife was recovered and preserved intact as a comparative specimen. It shows the results of a decade of concretion growth and corrosion on modern steel at the *Xantho* and provides an insight into what may have happened over quite a short period on the wreck itself. It also provides a useful example of the rapidity of the concretion process (cf. North, 1976). It has proved a most useful comparison and is currently being used for such purposes in other studies (cf. MacLeod, 1995: 58). It will also be referred to in an ensuing discussion of the formation of concretion on the *Xantho* engine and in its interstices.

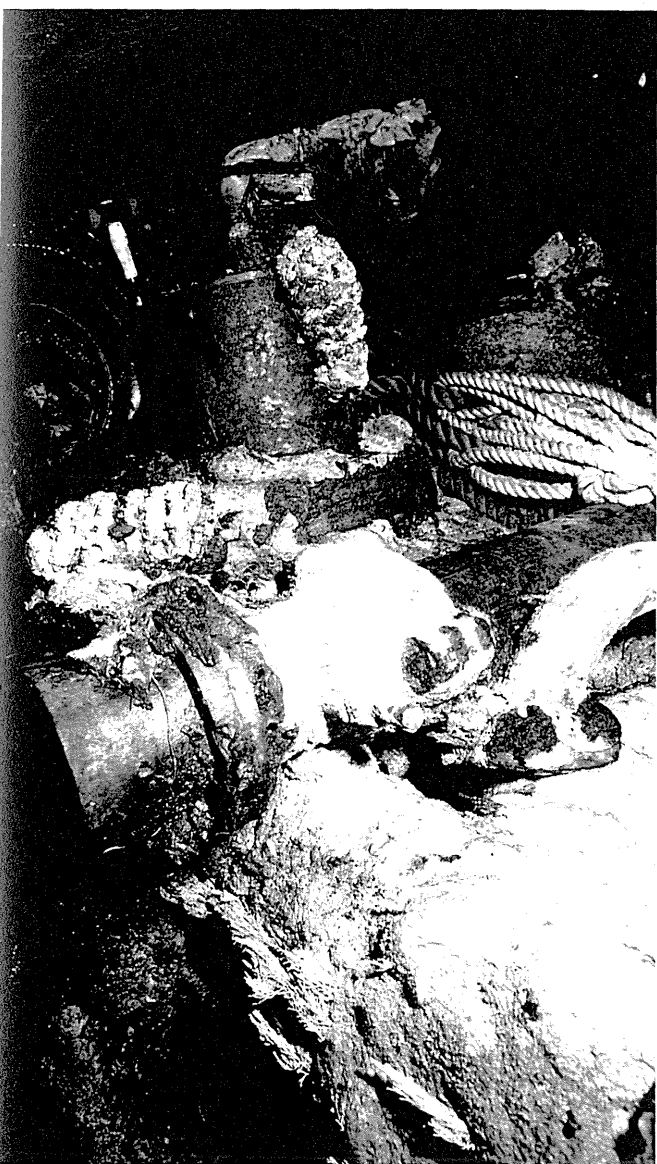
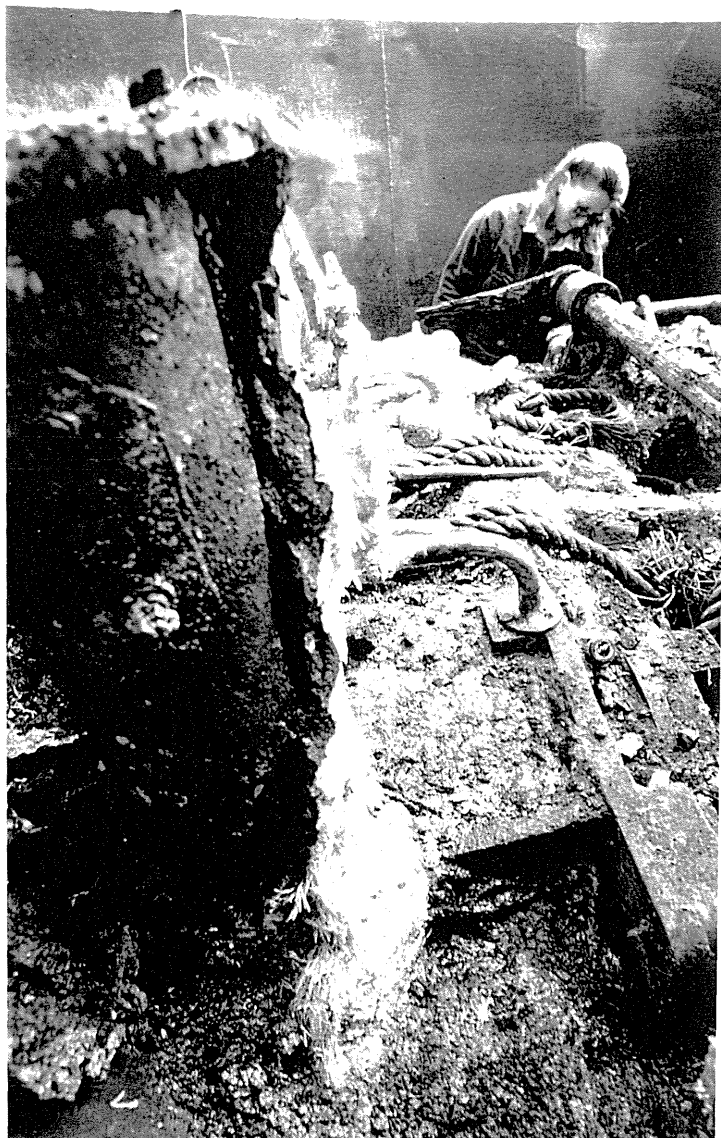
Figure 99: Deconcretion in progress Photographs by P. Baker

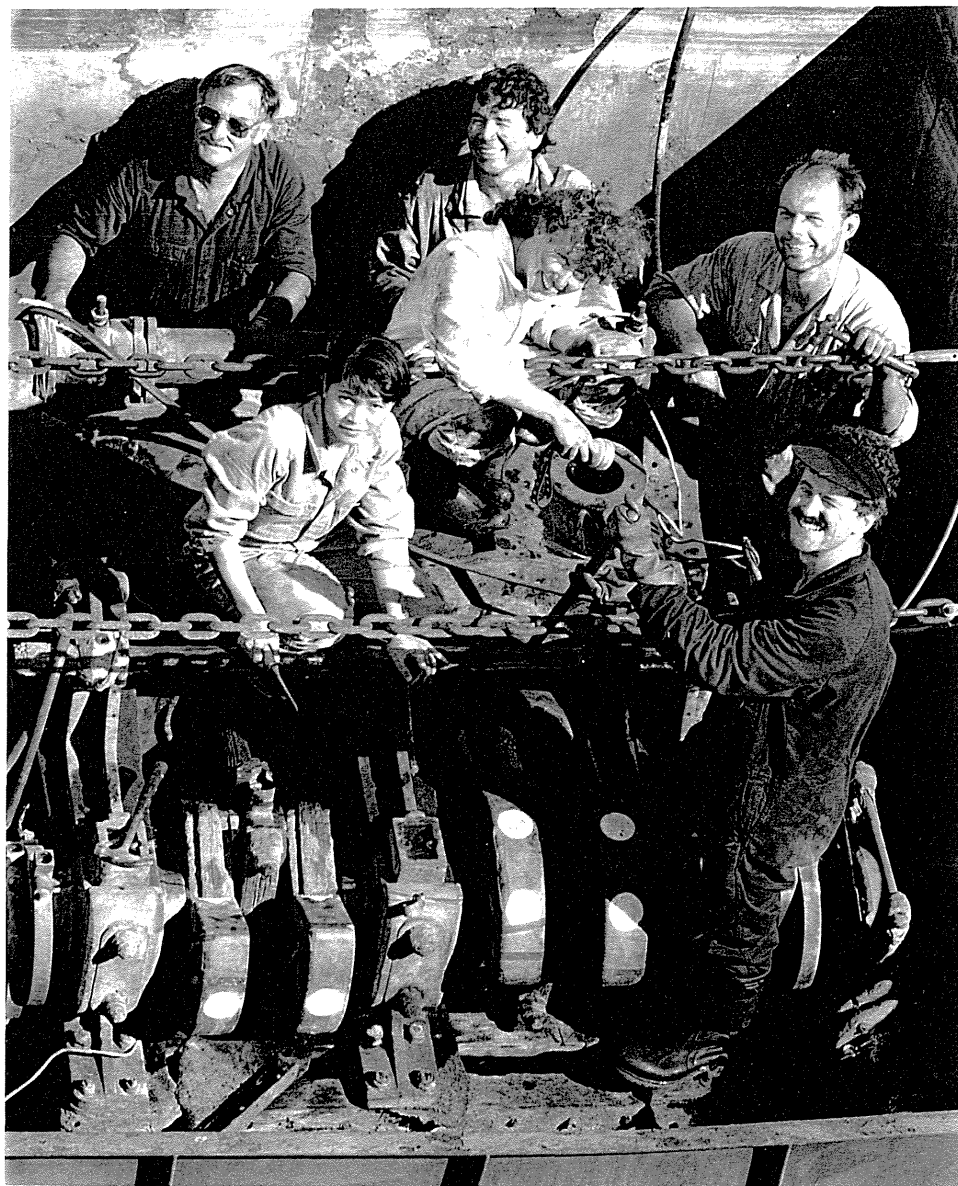
Figure 101: A deconcretion team in the tank, showing the engine after its upper surfaces were deconcreted. From the left: Dick Garcia, (WA Museum), Kolam Gaspar (Brunei), Alexandra Elliott (Canada), the author, Paul Mardikian (France), Ian MacLeod (WA Museum). The wooden foot-rest was bolted to the bearer under MacLeod's left foot

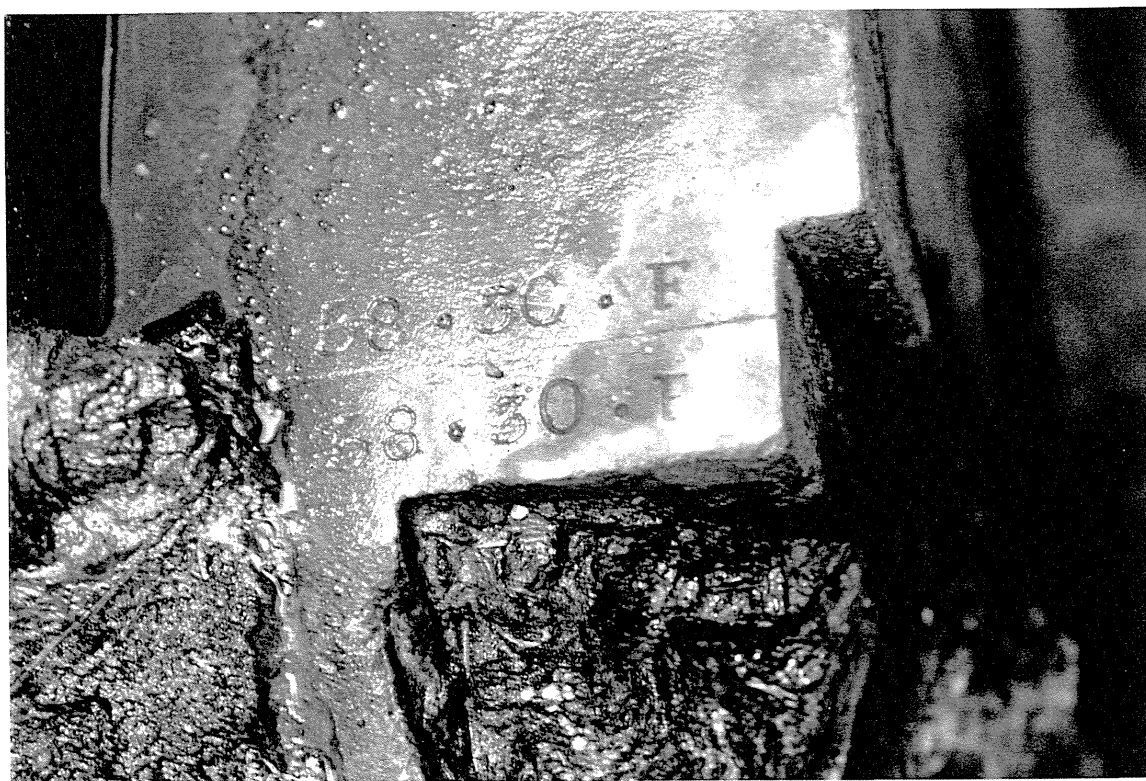
valve chests, the end of the trunks and the brass-work (Figure 103). They were eventually located on every discrete part of the engine, indicating that each unit carrying part number 58 30 F was to be attached to the fore cylinder and that those with the number 58 30 A were to be attached to the aft cylinder. Occasionally the numbers 1-4, and identifying or position fixing dots, were located. On the eccentric straps, of which there were two on each side of the engine, the figures FB and FT (fore bottom and fore top) and correspondingly AB and AT (aft bottom and aft top) appeared. More inscriptions were found as the 'excavation' continued.

Figure 103: A close-up of a valve chest, showing some of the markings found in the deconcretion process. Photograph P. Baker

The markings attested to the possibility that the engine was number 58:30 and that it was capable of being readily assembled and disassembled, with interchangeable parts suitably identified and marked to ensure their correct order and place of application. This led to the belief that this was the 30th engine produced by Penn and Son in 1858. As the engine is recorded in the *Xantho* register as having been built in 1861, the question was put whether it had been stored for the intervening three years before being fully assembled for its fitting into a gunboat.

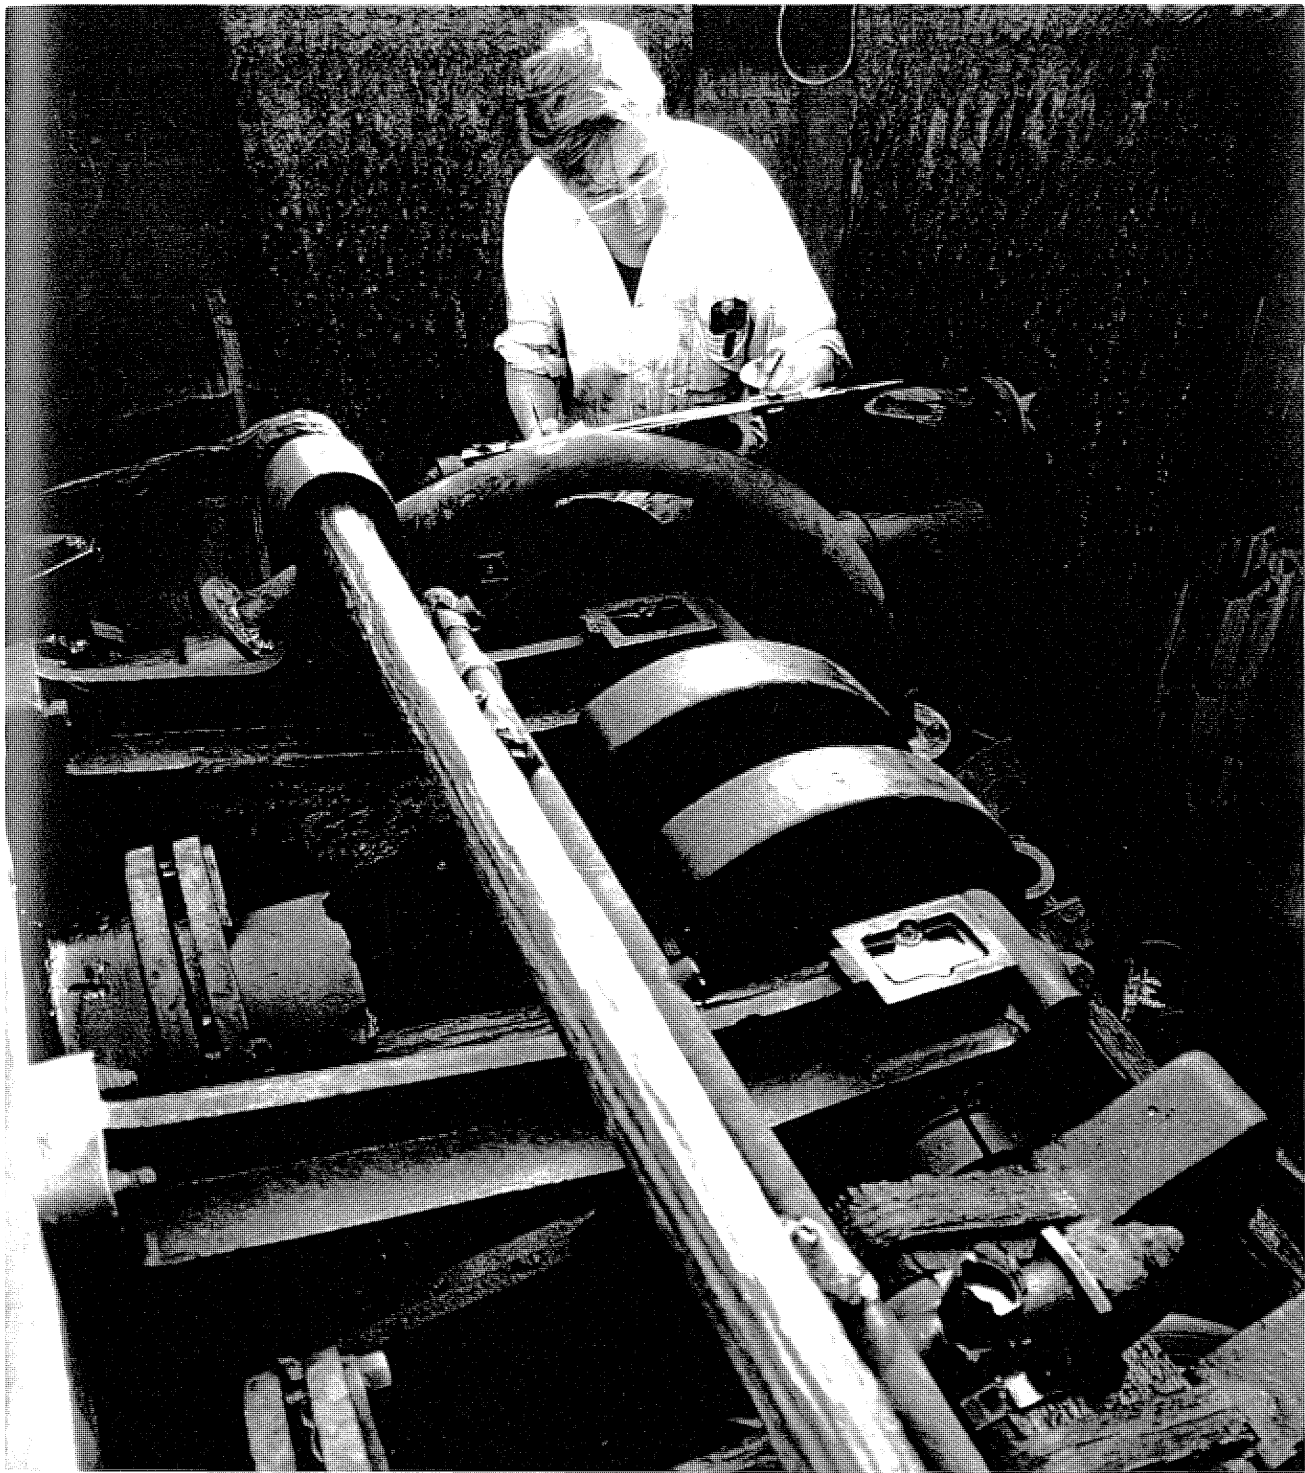
The next deconcretion session, which began in early June 1986, resulted in our steam engineer, Noel Miller making an amazing discovery. While recording an oil cup on the crankshaft he noted that it was designed to take lubricant on each rotation from an oil impregnated wick suspended above the crankshaft (Figure 104, below).

Figure 104: Noel Miller recording the upper surfaces of the engine. The oil cup is in the foreground, right. Photograph by P. Baker.

This in itself was not unusual. The surprising feature was that the cup was open to the starboard side of the ship. This indicated that, when viewed from astern (as in Figures 104 and 105 below), the crankshaft and hence the propeller rotated in a clockwise direction and the top of the propeller and crank moved from left to right, i.e. the propeller and the engine had a right-handed rotation (Engine Deconcretion Book, 23/5/1991: 31).

Further deconcretion work was conducted in March and October 1992 and, by the end of seven years, the engine lay almost completely deconcreted with all but the internal parts of the trunks, cylinders and valve chests, as clean as the day the *Xantho* was lost. The engine looked as if it could run again. In the process, 2,544 kilograms of concretions had been removed from its surfaces and 48 kilograms of chloride ions had been released from within the actual metal of the engine itself (MacLeod, 1992:49). The visible parts were stable and looked as if all they needed was a coating of wax and the engine could go onto the exhibition floor (See Figures 104 and 106).

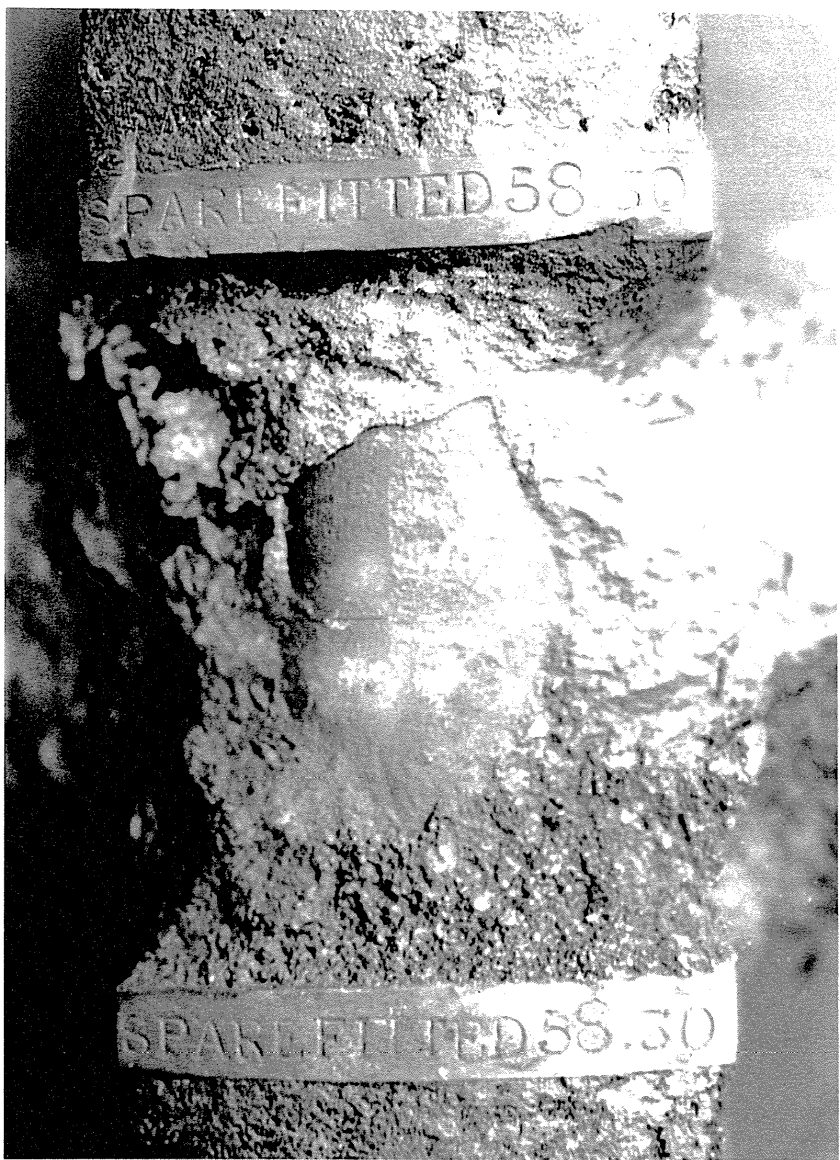
While this work was in progress, the recording of the upper surfaces continued. Deconcretion of the spare connecting rod, which was found in the engine room of the *Xantho* also began. On its surface was the legend SPARE FITTED 58 30, the first indisputable proof of the existence of interchangeable parts. This artefact was sent to the hydrogen furnace for treatment and this proved so effective that it was placed on display almost immediately after the application of a layer of microcrystalline wax. This

Figure 107: One end of the spare connecting rod, showing the markings, SPARE FITTED 58.30. The connecting rod is shown *in-situ* beneath the thrust-block and flanges in Figure 80. Photograph, J. Carpenter.

More importantly the spare connecting rod, when combined with the ubiquitous markings 58:30 F and 58:30 A, indicated that the engine was designed to be easily assembled and that it was of a mass-produced type which would potentially allow the use of interchangeable parts from other similar engines. Broadhurst’s decision to purchase this particular ship,

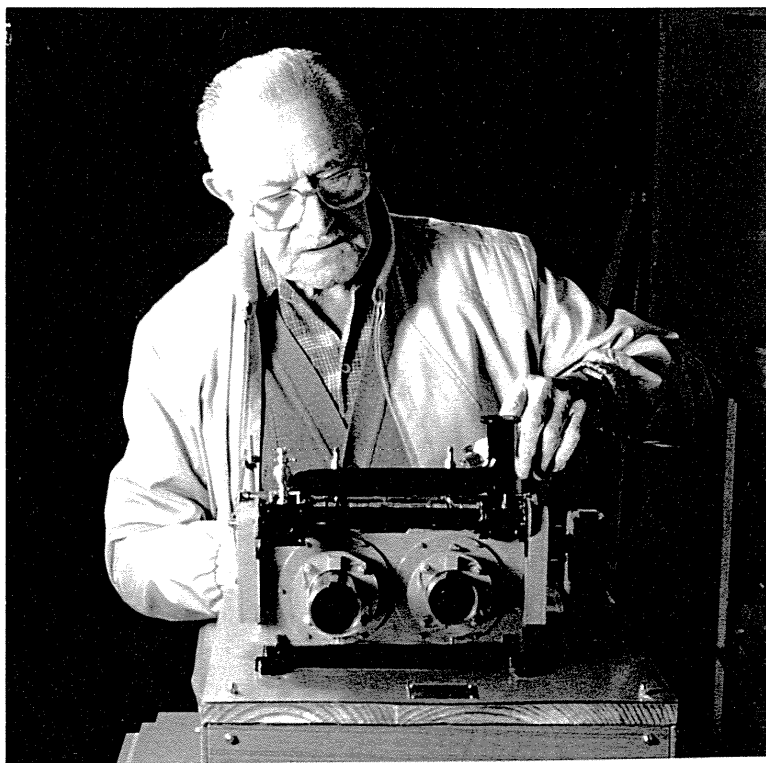
Figure 109a-b: Model engineer Bob Burgess with the model in his workshop and in the exhibition gallery. Photographs by D. Elford and P. Baker.

The working model (Figure 109) has enabled us to examine the engine over what is now an extended period of time. By reproducing each external part faithfully, Burgess has enabled us to understand the engine as a unit and to visualise how it appeared statically and in motion. Insights were also gained into its compact and easily accessed nature, its change from forward to reverse or mid-gear, how it was supported on the engine bed and compactly housed within the vessel.

very good condition. As Burgess assembled the model progress was recorded until finally it was ready to receive compressed air, an accepted alternative to steam in the model world. Not having dealt with a trunk Engine before, Burgess was not sure that the engine would work. It did, however, and from a technical point of view the model has been an undeniable success, proving to those who doubted that a trunk engine could work (or that it even existed) that they were functional and even possessed a number of engineering advantages.¹

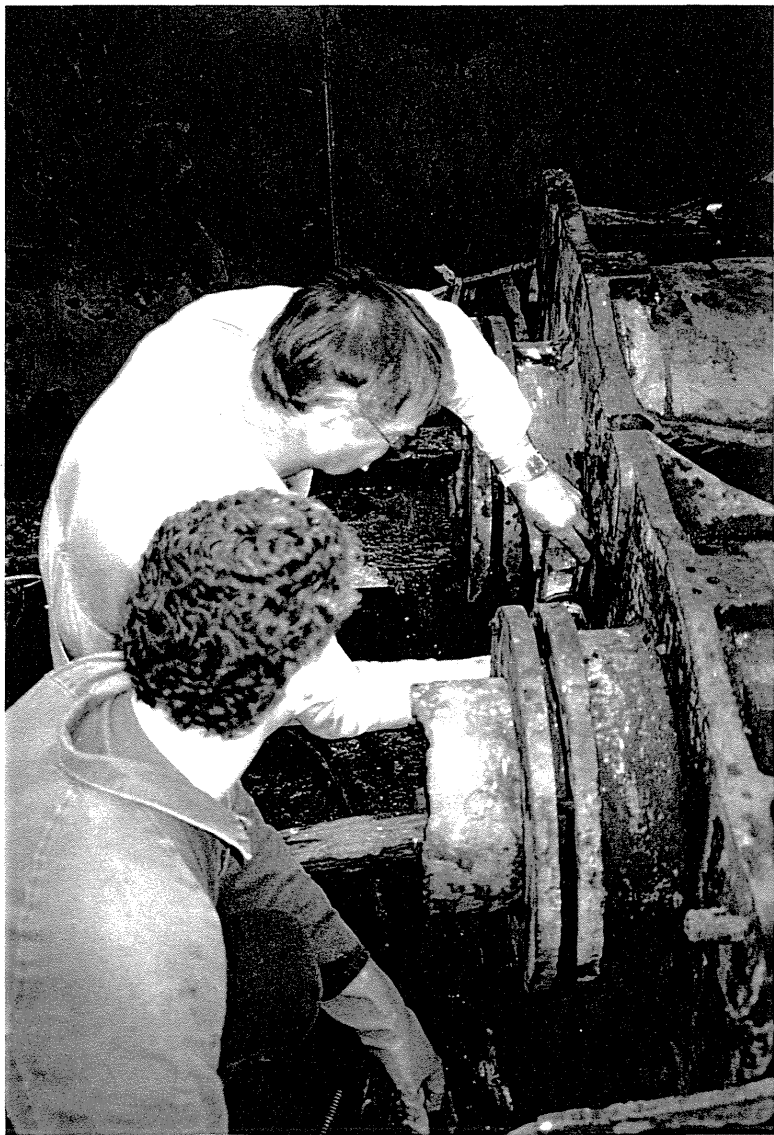
Figure 112a: The separation of the cylinders began with the insertion of a hydraulic jack.
