The Influence of Trail Design on the Impacts of Walkers, Mountain Bikers and Multi-use Trail Users: An Environmentally Responsible Approach

Leah C. Stevenson^{a*}; Anja Pabel^b; Colin Macgregor^a; Lisa Law^a; Jenni A. Judd^{c,d}

Study site

Observations occurred on the Baldy Yabi Circuit Walk and the Atherton Forest Mountain Bike Park trails, which cross the Baldy Mountain State Forest Reserve and Herberton Range State Forest. Baldy Yabi Circuit Walk is a network of 8.5 km of mainly steep walking trails offering views at three lookouts. Two points access the Baldy Yabi Circuit Walk, both with off-road gravel car-parking (Queensland Government, n.d.-a). Walking trails are graded using a class system from 1 (no experience needed) to 5 (specialised skills required) (Council of Standards Australia, 2001a). The Baldy Yabi Circuit Walk is a Class 4 grade and is recommended for experienced walkers, as there are rough trails with limited signage that may require navigation skills, and the trail gradient is only limited to the environmental and maintenance considerations (Queensland Government, n.d.-b). Class 4 trail users are likely to expect opportunities for solitude with limited conta

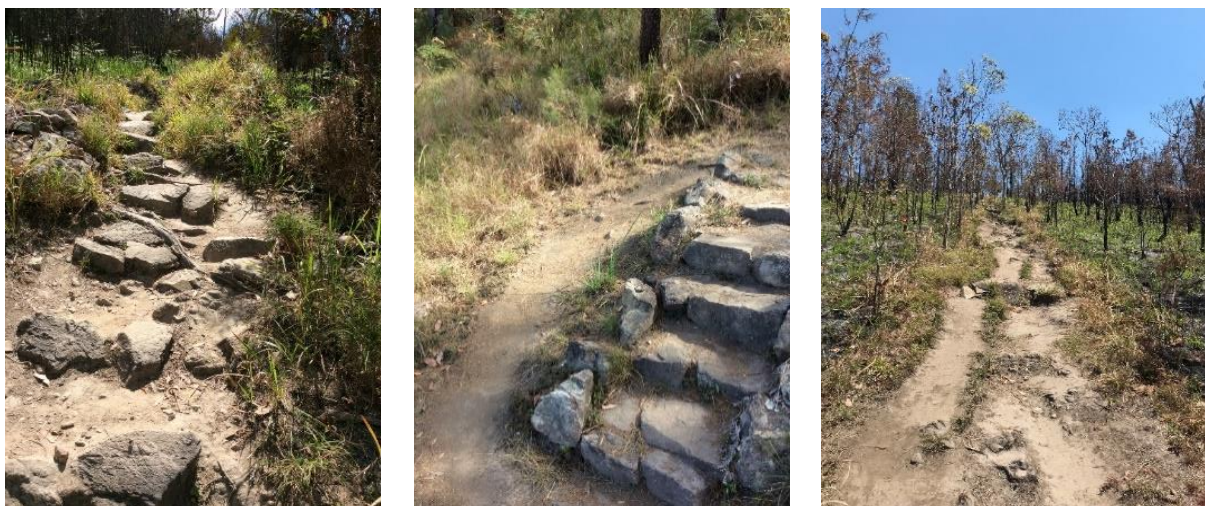
Trail spread occurs when trail users use the edges of the trail to avoid rough or uneven surfaces. On the walker-only trail, small protruding rocks, steep climbs, and stairs were avoided, and instead, the smooth, newly compacted soil on the edges of the trail was used. All three observation intervals indicated that walkers were avoiding the use of the steep, naturally armoured stairs wherever possible. For example, walkers chose naturally compacted soil directly next to the stairs (see Figure 1). On the very steep Mount Baldy side of the walking circuit, a significant number of materials and infrastructure, including prefabricated stairs, natural rock stairs, stretches of cement foundations and rock armouring, was used to mitigate environmental impacts. However, trail diversions used to avoid trail features (e.g., stairs), and obstacles (e.g., small tree roots) continued to be visible at each observation. Stairs with wide sections of ‘scree’ (rocks each side of the trail used to reduce erosion) and ‘cairns’ (rock piles used to help guide trail users to stay on the trail to allow for regrowth to occur) successfully kept walkers on the trail. This was evident by the amount of vegetation growing through the rock armouring. Trail sections with rock armouring restricted trail users to the stairs (Figure 2). Evidence of a planned fire management burn at the bottom section of the walking trails is presented in Observation 1.

Figure 1: Walkers on the Baldy Yabi trail create trail spread by accessing less technical options off-trail. Sites 8, 14, 15 during Observation 1

Trail spread, a common environmental impact, is caused when walkers avoid eroding or sodden sections of track, retreating to the edges of the trail to avoid wet or difficult surfaces (Appalachian Mountain Club, 2008). As slope steepness increases, the force of water also increases, and in combination with foot traffic, this causes erosion hazards for trails (Appalachian Mountain Club, 2008). In this study, trails that used direct lines up the hill, without trail anchors, had significant trail damage. Trail users are causing trail spread and erosion, with multiple trail lines across directly uphill. It is essential for guide trail users to stay on designated trails, and to ensure trail user behaviour does not exacerbate the issue.

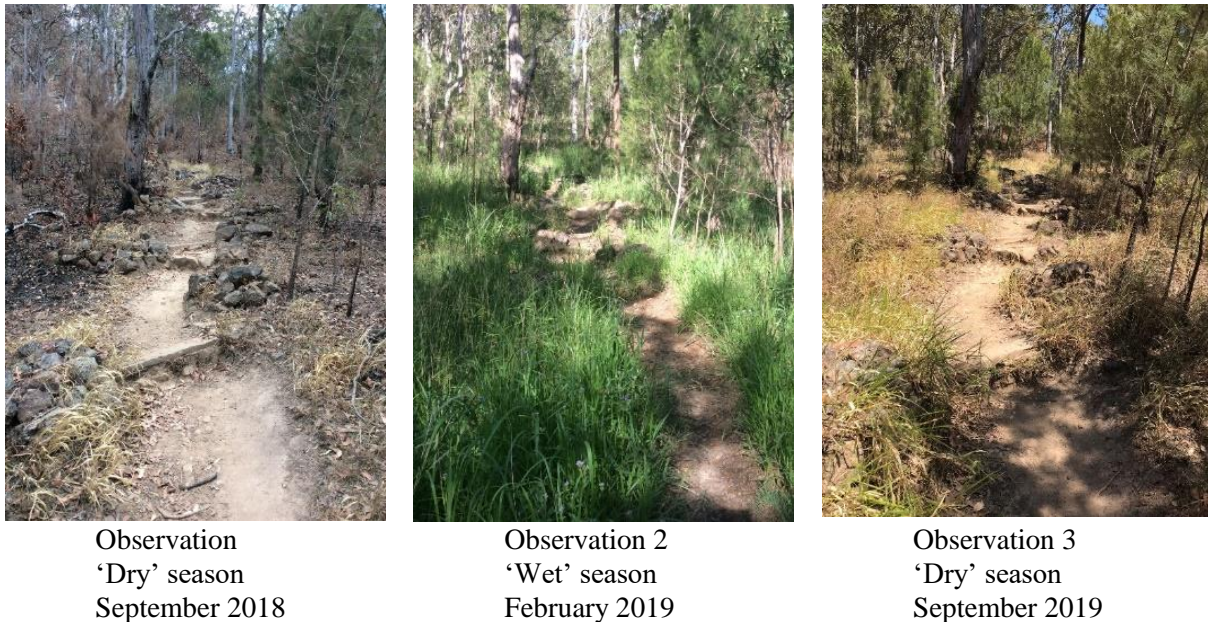
Figure 2: Baldy Yabi Circuit Walk- Site 2, Observations Over 12-Months. Cairns used as definers on walking trails to encourage walkers to use a single step

Shortcutting on walking trails was identified as a major issue. On the walking trail in this study, evidence of soil compaction revealed that walkers avoid stairs and cut out lengths of the trail, mainly employing the old 'direct lines', to reach the walking trail lookouts. Soil compaction is common on walking trails (Pickering et al., 2010), which means making sure walkers keep to trails is essential to avoid trail spread. The current study showed that steps with wide sections of scree can remedy this issue because walkers prefer to use the least technical option on the trail, making steps the preferred option. Walking trail design guidelines emphasise the importance of not creating narrow switchbacks and encourage wider turns fortified with steps, where necessary, to prevent shortcutting (Appalachian Mountain

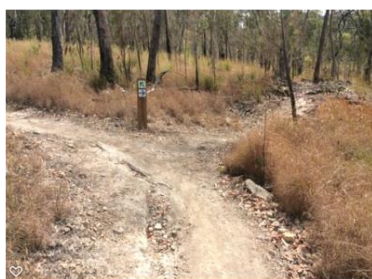
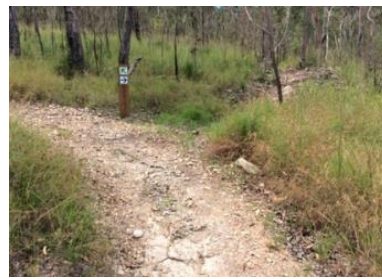
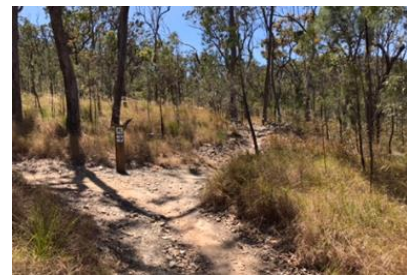
Figure 3 shows an ascending corner of the multi-use trail when the drainage gradient is inadequate. The lack of crown-loading has caused the rainfall to be directed onto the trail, and a significant erosion line was apparent through the centre of the trail. Trail users avoided the eroded section, causing the trail to be widened to create a new mainline on the right of the eroded section. Though drainage issues are apparent, no significant changes to the trail condition were identified over 12 months.

Observation
'Dry' season
September 2018

Observation 2
'Wet' season
February 2019

Observation 3
'Dry' season
September 2019

Figure 3: 'Green' Multi-Use Trail. Lack of Crown Loading to divert water off the trail causes the trail to widen. Site 41 observed over 12 months

Mountain bike trails mainly incorporated an outward drainage system and were more likely to be graded as *good* compared to inward drainage graded as *fair* or *poor*. Not only does the trail design need to consider potential natural environmental impacts, e.g., water erosion, but it also needs to consider how people will use the feature to ensure it does not cause additional erosion.
