VIBRATION ANALYSIS OF AN AIRLIE BEACH HOUSE: A CASE STUDY IN AUSTRALIA

Keywords: vibration, Airlie beach house, structure analysis

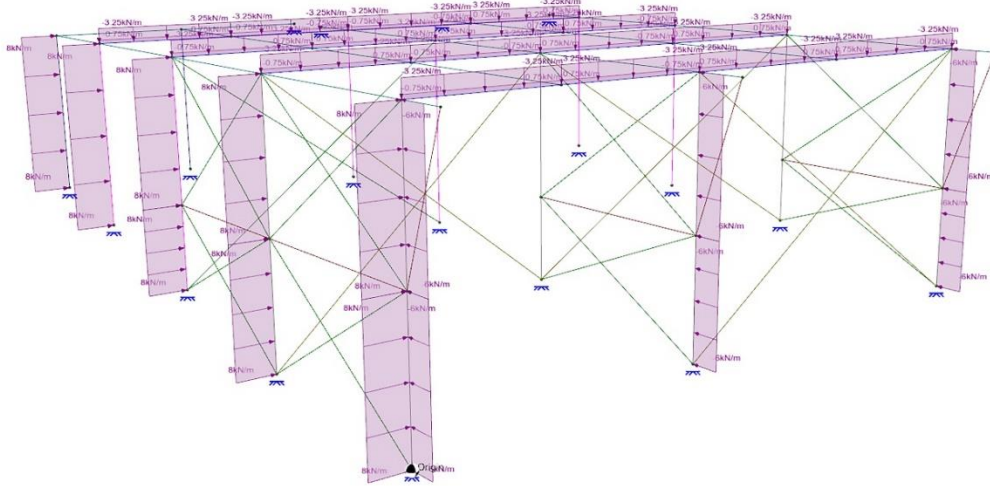
Fig. 2. AS 4055-2012 case with live and dead loads

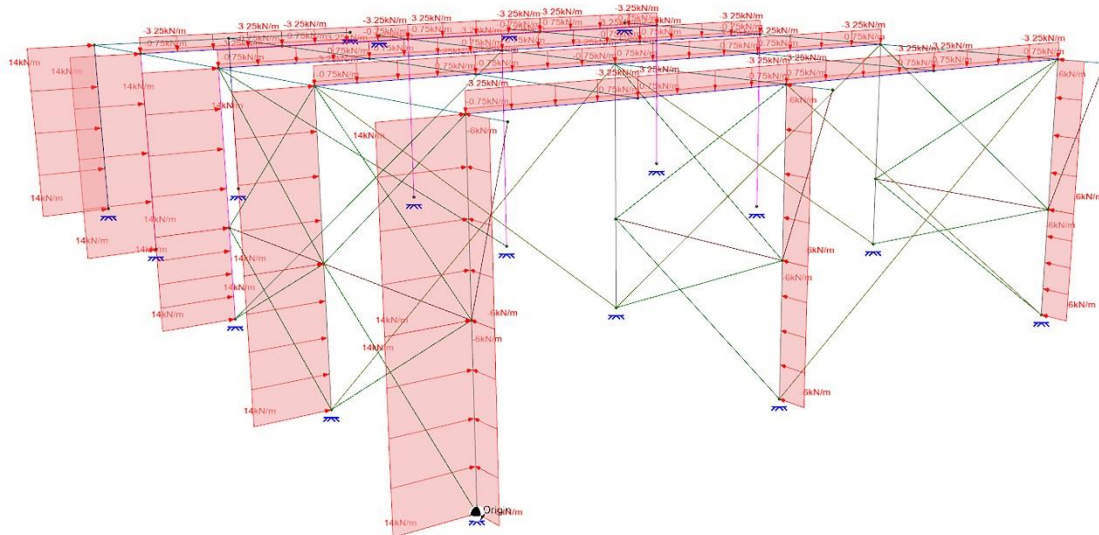
Fig. 3. AS 1170.2-2002 case with live and dead loads

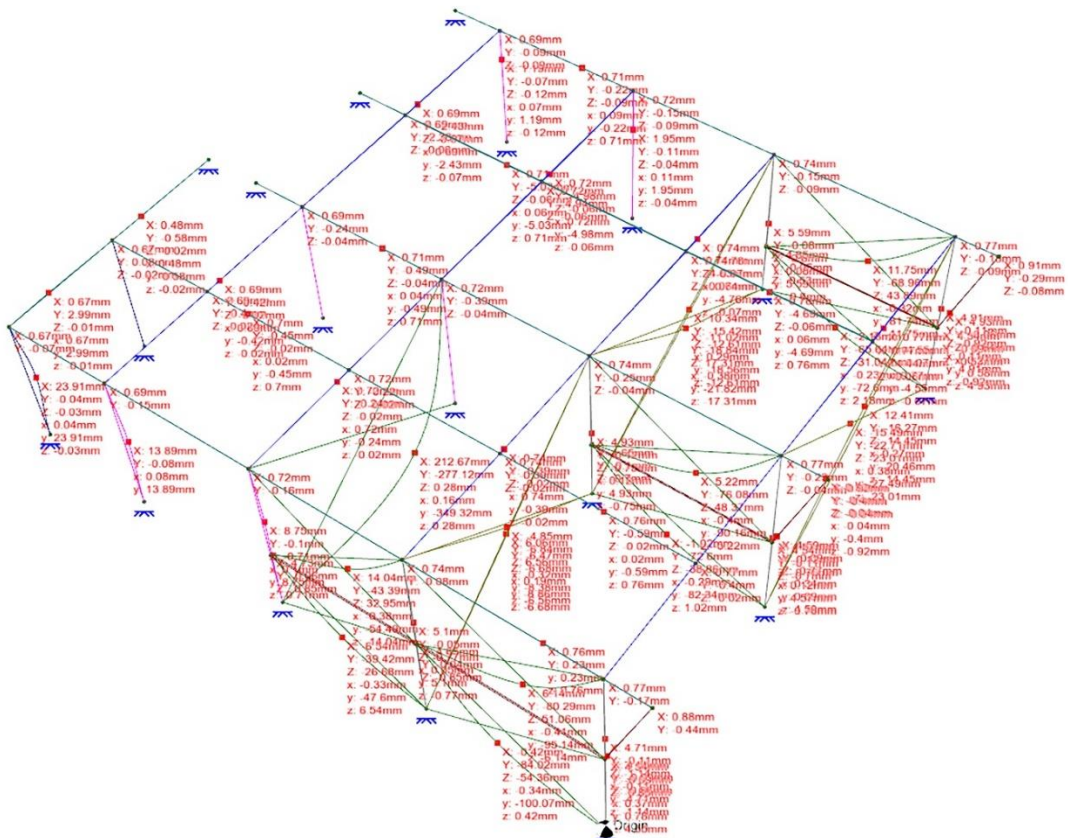
Non-linear static analysis was used to determine nodal displacement values at locations where structural members are connected. The displacement values at every node were then analyzed to determine the location of the greatest vertical displacement (Figure 4).

Fig. 4. AS 1170.2 load case nodal displacements

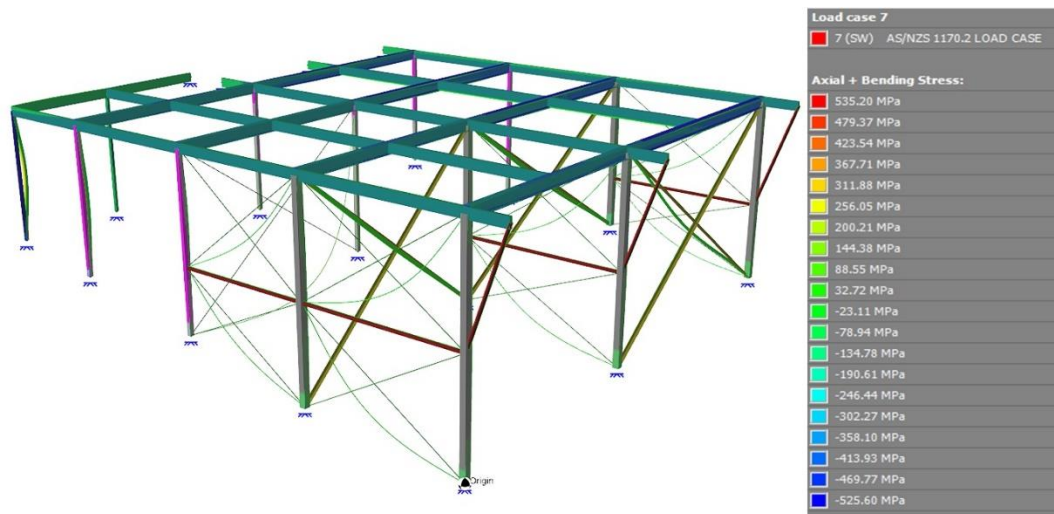
Additionally, to measure stress distribution in the beam members, they were modeled in SolidWorks and the results are presented in Figure 5 and 5. As seen in Figure 5, the house is largely suspended off the ground but does have a large roughly six by six by a three-meter concrete slab in the back corner. The slab should be causing a large amount of rigidity to the immediate structure if mounted securely since any vibration near the slab will need to move the slab itself or the house would start being damaged in that area. Figure 6 shows a simulation of the bending and axial stress in all the steel members of the house. The estimated max stress found in the bearers is 150 MPa, which is well under the 360 MPa standard AS/NZS 3679.1-350 [3].

Fig. 5. SolidWorks model of the house

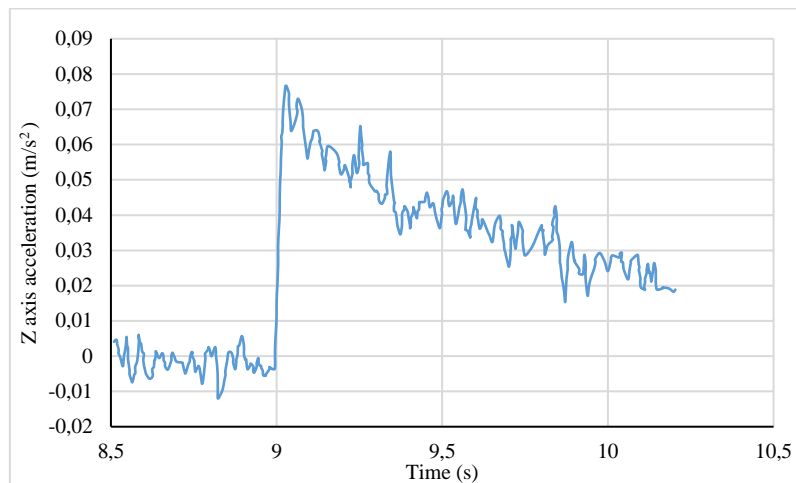
Fig. 7. The finished design of the Airlie house

The following design audit is to analyze the house located at Lot 72 Kingfisher Terrace, Jubilee Pocket (Figure 7). On any building, the wind will cause a natural vibration, such vibration will be almost unnoticeable to people. Such vibration is considered background and contributes to the random noise measuring equipment will detect. When comparing standard wind loading graphs to the measured acceleration data, some similarities explain the noise present in the data.

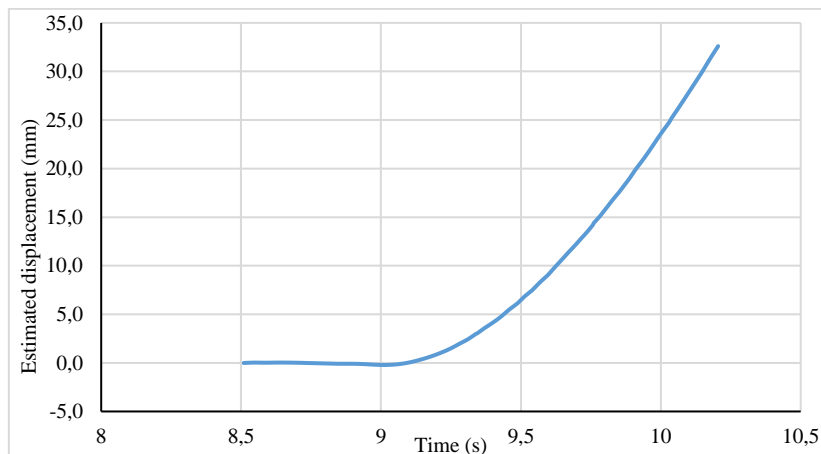
As seen in Figures 8 and 9, the house experiences an illogical amount of vibration relative to the conditions subject to the house. There are no nearby trains passing by, no excessive wind could cause this level of vibration, and damage is not detected either.

Fig. 8. Axial acceleration of the structure

Fig. 9. Estimated displacement

Further analysis is needed to determine the root cause; however, based on the studies done in this report, the house design is valid and does not need any structural changes as it is up to standards.

The first solution is to counter the most sag found in the house's floor supports. The bracing will go between the supports on either side of this point. By adding additional bracing, the rigidity of the structure may lessen any vibrations or reduce their effect. If the vibration cannot be prevented by an increase in rigidity, then the additional bracing will have practically no effect. The bracing will be a copy of the existing bracing designs on the house to maintain conformity, corresponding to the equal angle bracing in fab drawings.

The other solution is to replace the current joist hangers with a fiber-reinforced polymer variant. The polymer nature of the hangers will allow any vibrations to be absorbed and lessened at the base of the floor. The polymer joist hangers could also have additional rubber padding

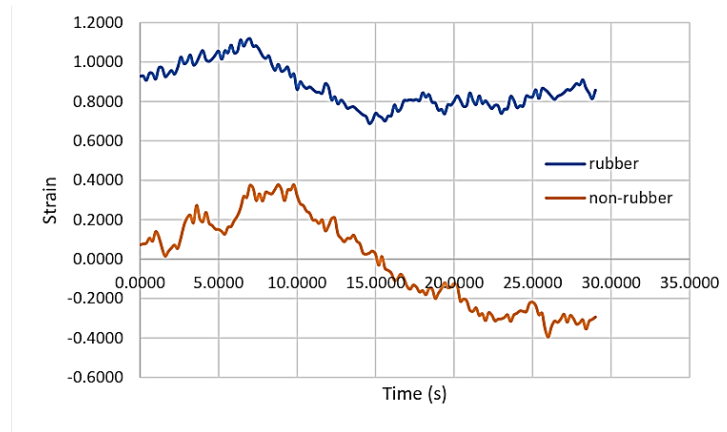
The results of this experiment are shown in Figure 11. The strain without the rubber glanced from the positive into the negative. The case with the rubber, however, showed a constant positive strain, proving that the rubber reduced the extent to which the steel moved.

Fig. 11. Physical testing results

From these ratios, the rubber was determined to reduce the change in strain by 4.55x. This should be proportional to the overall displacement as strain is merely a measurement of elongation. Although this is not as accurate, it shows a rough idea of the level of vibration reduction. If we take the initial value of 30 mm of displacement and aim to reduce it to below 1 mm of displacement.

Therefore, the vibration needs to be reduced by a factor of 33.333 times to reach below 1 mm. Taking the amount by which the rubber reduces vibration and dividing by this value will give the rough rubber thickness required. That is, 7.326 times the thickness of 5 mm gives 36.63 mm. Thus, 36.63 mm of rubber is required to reduce the vibration assuming ideal conditions and rubber strain reduction is linear. The recommended amount of rubber is 40 as the original value of 36.63 mm will be rounded up to add a level of vibration reduction.
