TROPICAL CYCLONE YASI – LOAD TESTING OF TIMBER HOUSES ON A LARGE SCALE

Geoffrey N Boughton¹ and David J Henderson²

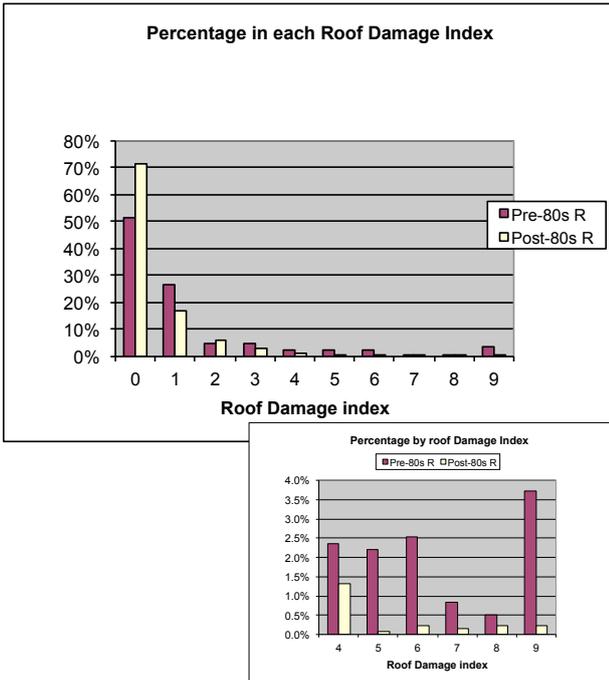
Figure 3: Roof damage index from external survey

In each category of the damage, index 1 to 3 represented fairly minor damage and index 4 and above represented major damage. In each category it was possible to underestimate damage in index 1 to 3, but not in index 4 and above. The damage most relevant to this paper is roof damage, and it is illustrated for all houses surveyed in Figure 3. The inset shows a magnification of the data for index 4 and above.

Figure 3 shows damage segregated into houses built prior to the 1980s and houses built after the 1980s. This classification corresponds with the introduction of requirements for engineered tie-down details into housing in Appendix 4 of the Queensland Home Building Code in 1981 [6].

There is a significant difference between the two types of houses in the zero damage index, with around 70% of the recent houses having undamaged roofs and only around 50% of the older houses.

When viewing the more significant damage in the inset to Figure 3, it can be seen that the Pre-80s housing had higher percentages of more serious damage than the Post-80s housing.

- A total of less than 3% of the Post-80s houses had roof damage rated at level 4 or above.
- More than 12% of the Pre-80s houses had roof damage rated at level 4 above.
