Tropical Cyclone Larry: Estimation of wind field and assessment of building damage *

JD Ginger[†], DJ Henderson and CJ Leitch

Cyclone Testing Station, School of Engineering, James Cook University, Townsville

SUMMARY: *Tropical Cyclone Larry made landfall on 20 March 2006 near Innisfail, causing significant damage to buildings in the surrounding areas. This paper is based on the field survey and assessment of the performance of buildings, which experienced severe winds in the Innisfail region during Tropical Cyclone Larry. The peak gust wind speeds in the study area are estimated at 50 to 65 m/s, which is less than the region's current design wind speed. Damage to the housing stock was estimated at about 20% (not including water ingress). Contemporary housing fared considerably better than older housing, reflecting marked improvement of construction detailing and better structural condition, and satisfactory performance of relevant standards. Failure of roller doors, loss of roof battens when fastened to rafters with one or two nails, and loss of rafters or trusses when anchored to top plates with skew nails only, were common. Structural component failures of under-designed cold-

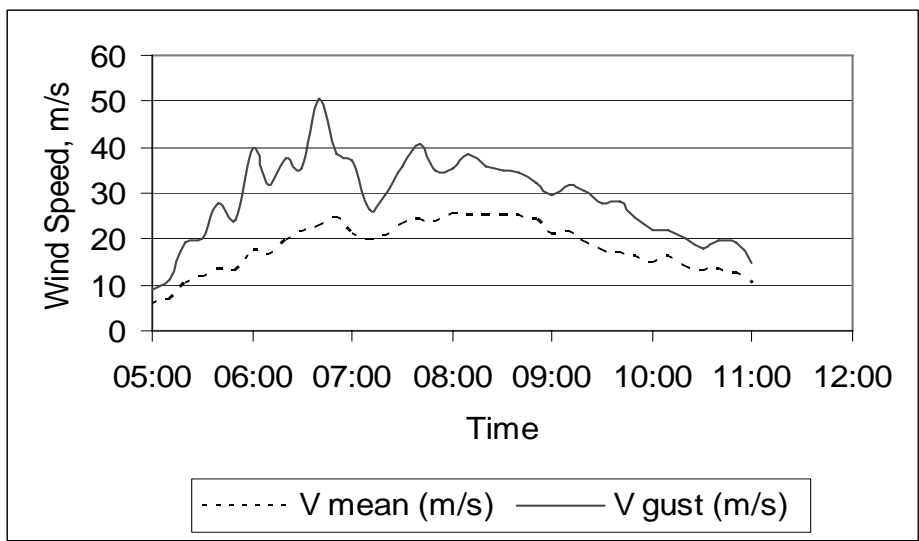
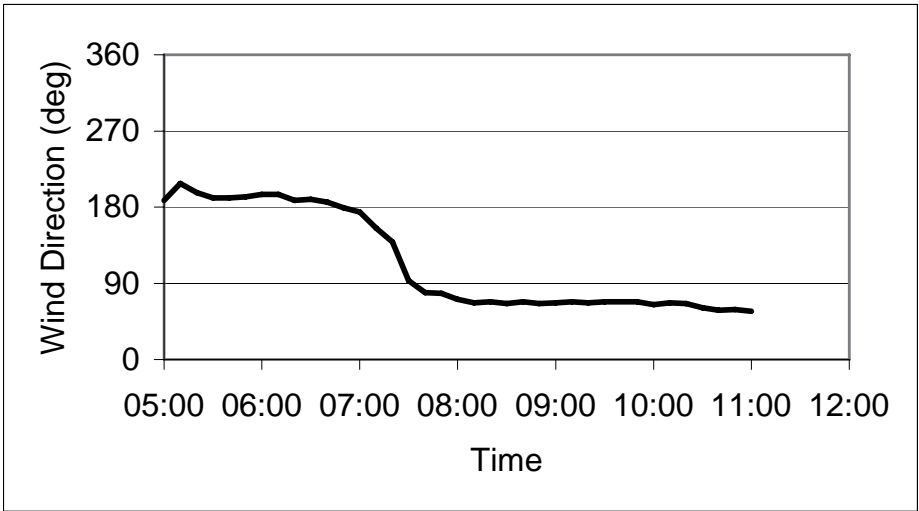
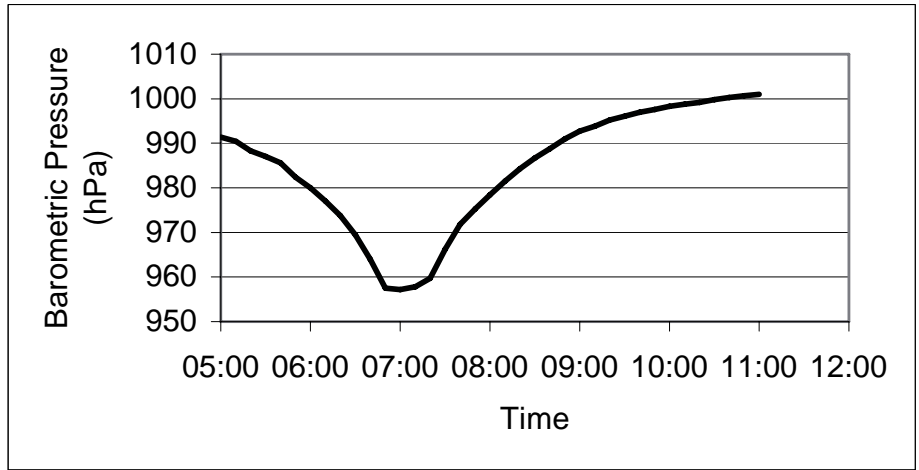
Figure 3: South Johnstone AWS data for (a) wind speed, (b) wind direction and (c) atmospheric pressure (courtesy Bureau of Meteorology).

Wind speed, direction and barometric pressure measurements obtained from the South Johnstone Automatic Weather Station (AWS) are shown in figure 3. At this site, the approach wind direction changed from 185° (S) to 80° (E), with corresponding peak gust wind speeds of 51 and 41 m/s, respectively, and a minimum barometric pressure of 957 hPa, as

the eye passed just to the north of the site. Higher wind speeds and lower central pressures would be expected near landfall. Based on evidence from damage to structures and vegetation, and discussions with residents, the strongest winds in Innisfail were from the south to south-southeast and then from the west to northwest following the passage of the eye. In Kurrimine Beach and Mourilyan (in the areas to the south of Innisfail), the strong winds were southeast to south-southeast, and south-southwest to north-northwest in Babinda and Mirriwinni (areas to the north of Innisfail).

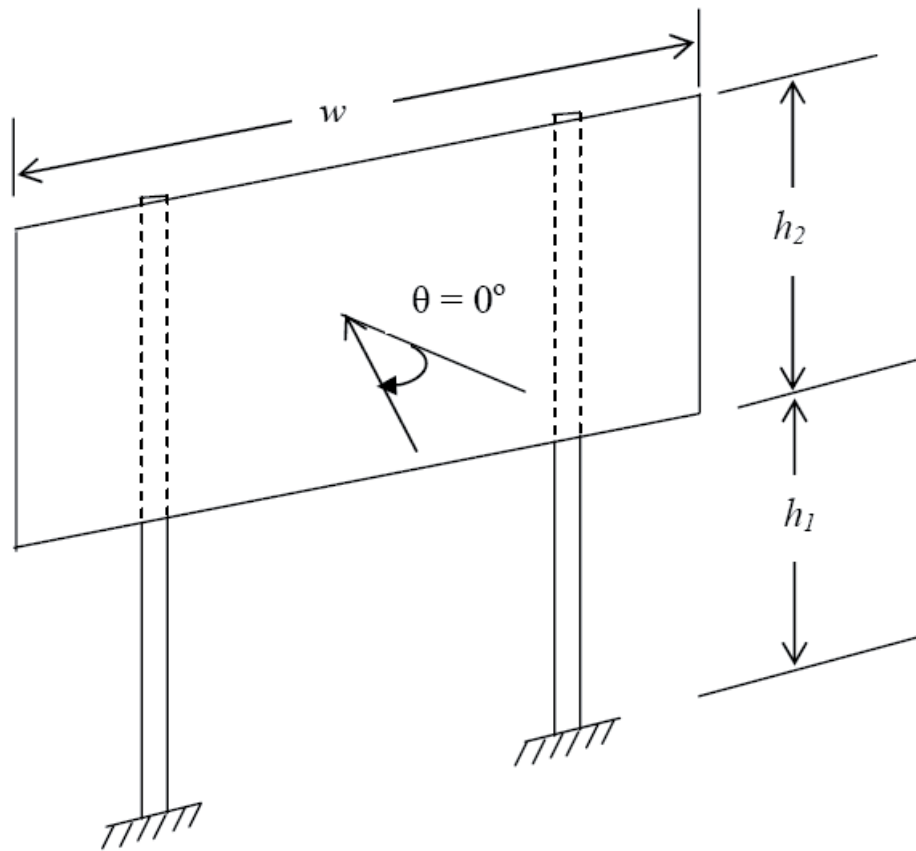
Figure 4: Typical road sign (Area $A = w \times h_2$).

The peak net wind load, F_n , across the sign is shown in figure 4 and given by equation 1.

The resulting maximum (ie. base) bending moment, M_{max} , on the post(s) is given by equation 2, where the lever-arm l is the distance from the plastic hinge in the posts (ie. point of bending failure, typically close to the base) to the centroid of the sign.

A plastic hinge in the post(s) is created when the bending moment generated by the wind load exceeds the plastic moment capacity M_p of the post(s), as shown in equation 4. The wind speed at centroid height required to cause failure of the post(s) is then determined from equation 5.

Importantly, Hoerner (1965) and many others have shown that for plates of these typical dimensions, $C_{F,n}$ is almost constant for winds approaching within $\theta = \pm 45^\circ$ from normal to the face, as shown in figure 4. This means that these road signs can be used as a robust

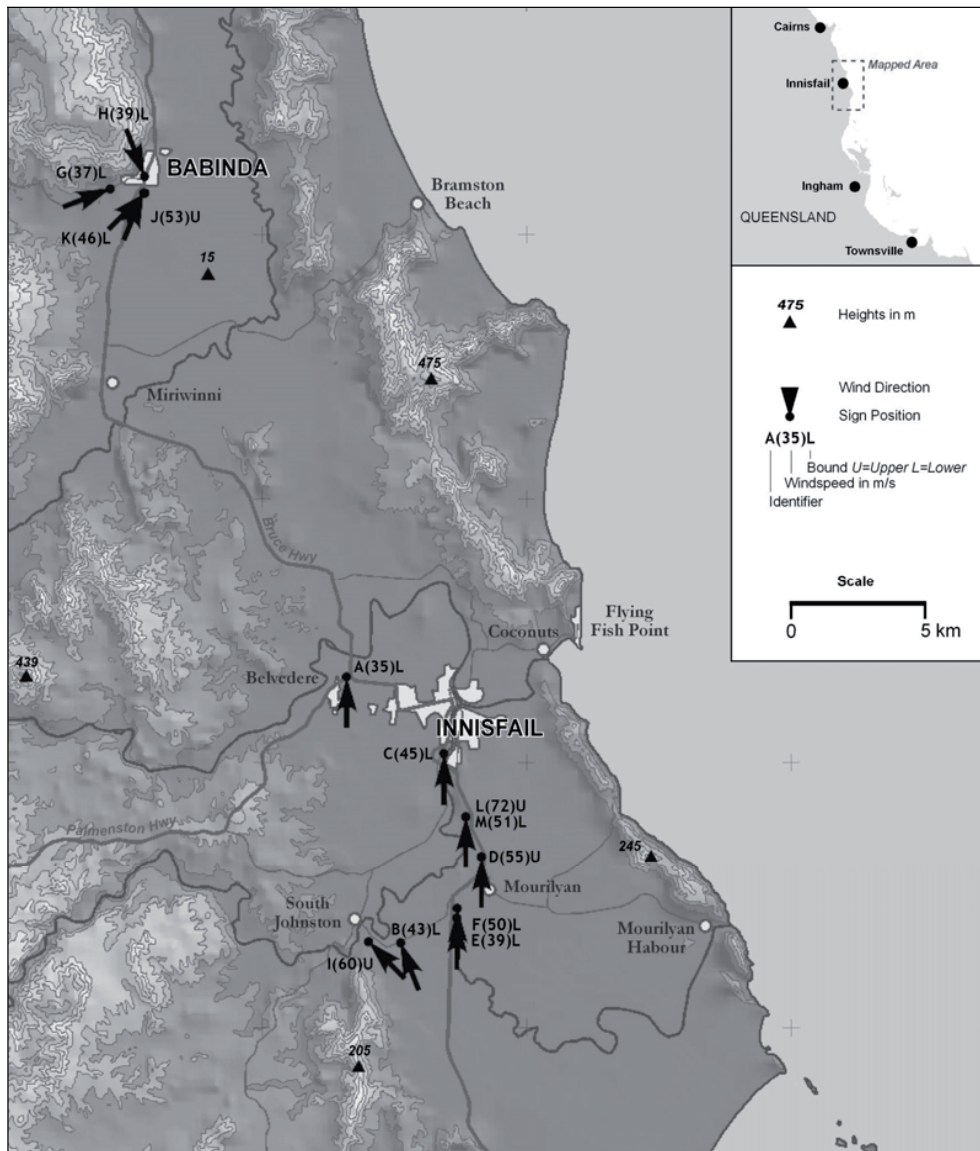
Figure 6: Upper and Lower bound wind speeds based on analysis of road-signs.

51 and 72 m/s, respectively, giving a lower bound (L) from the larger sign and an upper bound (U) from the smaller sign, indicating that the maximum gust wind speed was between these two values in this area. Similar analyses were conducted on a number of signs in the study area, and the U and L wind speeds obtained are indicated on the map in figure 6. Based on this and other damage, the maximum (10 m reference height, in flat open terrain) gust wind speeds in the study area are estimated at between 50 and 65 m/s. Local wind speeds can, however, be greatly affected by topographic features such as hills, escarpments and valleys.

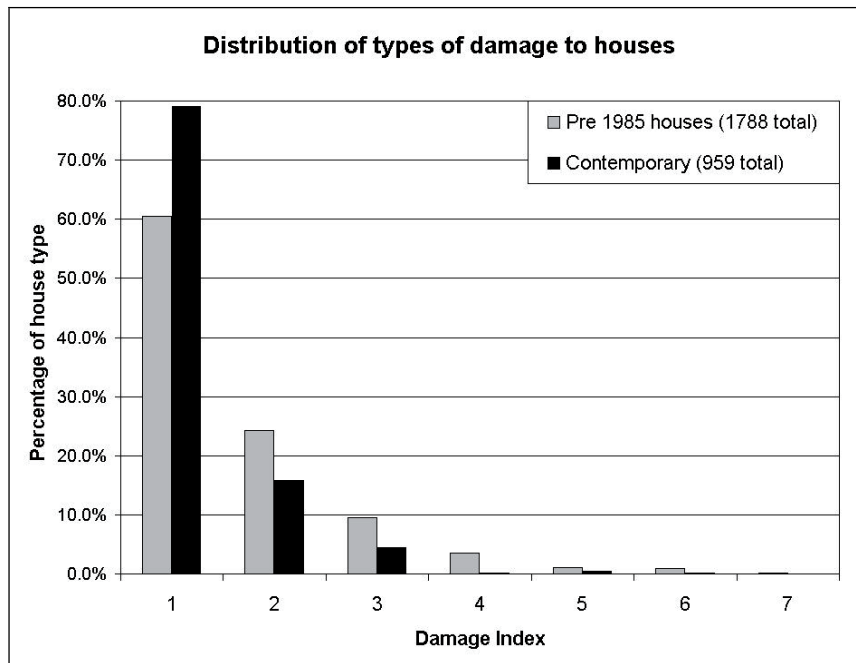
Figure 7: Percentage of Houses by Damage Index (all houses sampled).

This paper presents data from a sample of 2747 houses, of which approximately 50% were sampled by teams from GeoScience Australia using the same CTS damage classifications. The results are presented as Percent of housing damaged vs Damage Index (DI) in figure 7. Figure 7 shows that, overall, contemporary housing (1985+) had a much higher percentage of negligible damage (DI-1) than the pre-1985 houses. There was also a smaller percentage of contemporary housing that suffered significant structural damage (ie. DI-3 to DI-8), compared to older houses. Overall, about 20% of housing experienced significant structural damage (ie. DI-3 to DI-8).

Most of the contemporary houses in the study area were slab-on-ground houses. The majority of these had hollow masonry block walls. Figure 7 shows that contemporary housing suffered less structural damage than pre-1985 housing. Damage to contemporary housing could mainly be traced to either debris impact, or to inadequate fastening of windows, roller-doors, tiles, fascias and guttering. There were examples of wind driven debris penetrating both metal deck roofs and tile roofs causing damage, as shown in figure 11.
