Impact of Cyclone Yasi on the Wreck of the *SS Yongala* Documented by Comparative Multibeam Bathymetry Analysis

In February 2011, north Queensland experienced one of the largest and most severe tropical cyclones on record. Category 5 Cyclone Yasi caused substantial structural damage not only on land, but also at sea, including to the historic shipwreck of the *SS Yongala*. The *Yongala* is of high cultural and natural heritage value and is a major dive tourism attraction. As part of a Queensland Government initiative to document the degree of damage by Cyclone Yasi, changes to its structure were documented by comparative analysis of multibeam bathymetry data of the wreck collected in August 2004 and May 2011 (i.e. pre- and post-Yasi respectively). The storm had a significant physical impact on the c.110m-long wreck. The most pronounced changes occurred in the forward section of the wreck. A 35m section forward of the central deck citadel has rotated around its own axis and the bow dropped more than 5m in depth. Minor deformations were observed at the stern of the wreck and debris was identified on the seafloor around the wreck. The impacts of the cyclone will exacerbate deteriorat

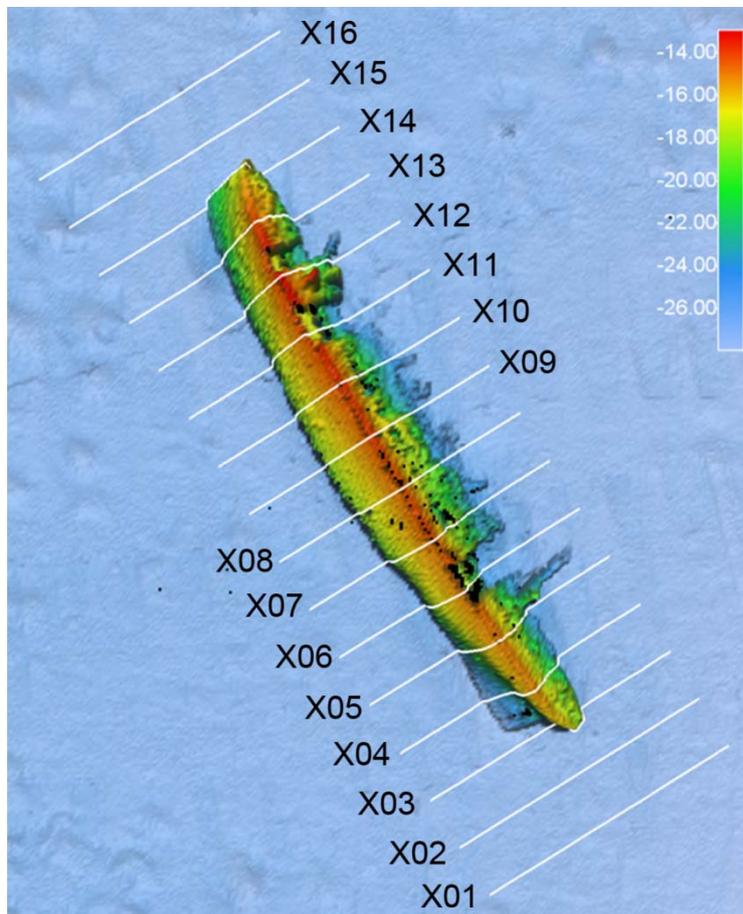
Figure 5. Locations of sections across hull in 10m intervals shown in Figure 6 and Appendix A.

The most pronounced changes occurred in a c.35m-long section forward of the first cargo hold (highlighted in red, Figure 4). The bow at its tip has dropped in height by just over 5m. The forward section of the hull has rotated towards the east, with a pivot point located 35–40m aft of the bow (Figures 5–6). Hull cross-sections X11 to X14 in Figure 6 provide a quantitative determination of this rotation around the wreck’s axis.
