# Assessing the Gulf of Carpentaria mangrove dieback 2017–2019

## Volume 1: Aerial surveys

by Norm Duke, Jock Mackenzie,  
John Kovacs, Grant Staben, Rob Coles, Apanie Wood & Ysabel Castle

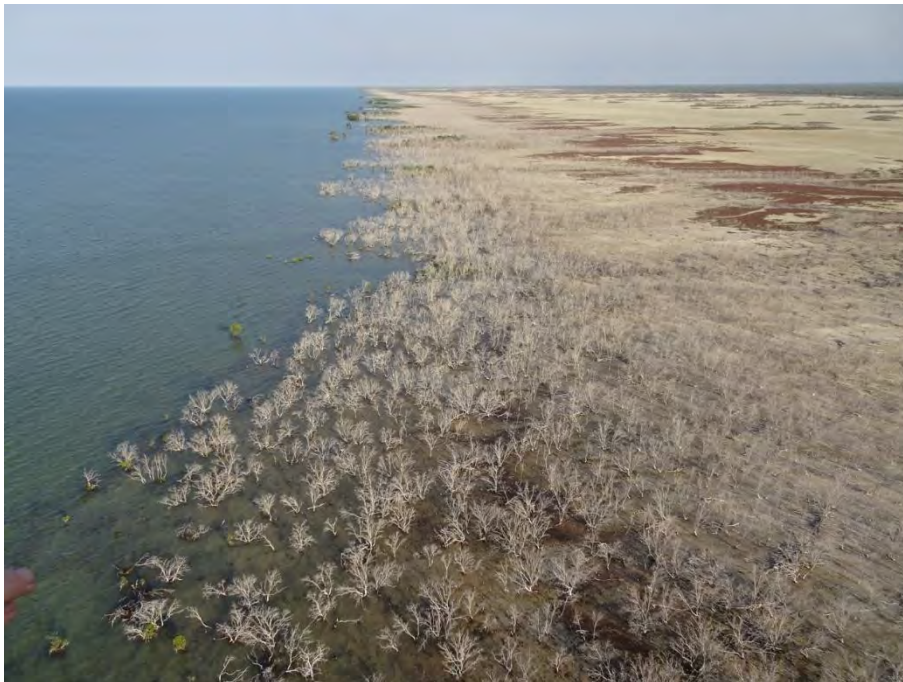
*Figure 0.3. Aerial surveys revealed the full extent of the 2015–2016 mass dieback of mangroves in the Gulf of Carpentaria from Queensland to the Northern Territory. Image shows Transect 1A in the Northern Territory taken in October 2018.*

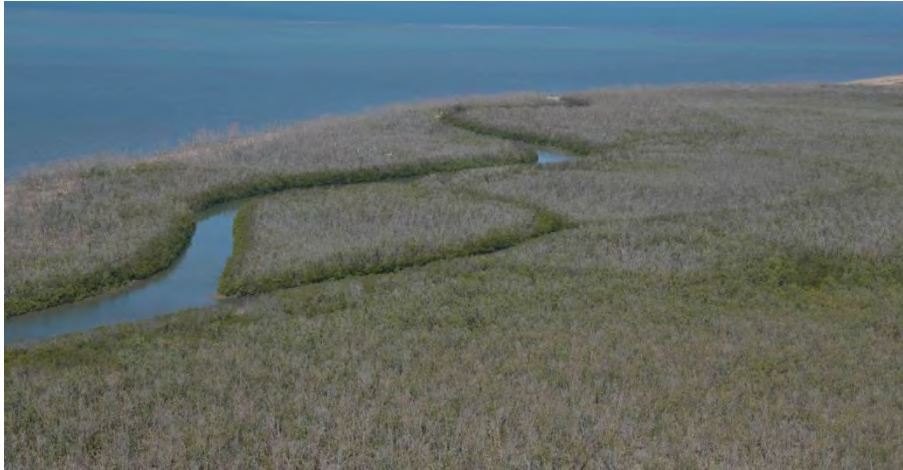
*Figure 0.6. During the 2019 aerial survey, we observed extensive and severe canopy damage caused by Category 4 Tropical Cyclone Trevor in February, that year. The impacts were evident in shoreline and mangrove vegetation along 400 km of Gulf coastline from Calvert River to Wearyan River. These impacts on tidal wetlands had been unreported before the NESP surveys. The damage to recovering 2015–2016 dieback areas was significant and emphasised the importance of quantifying accumulative impacts.*

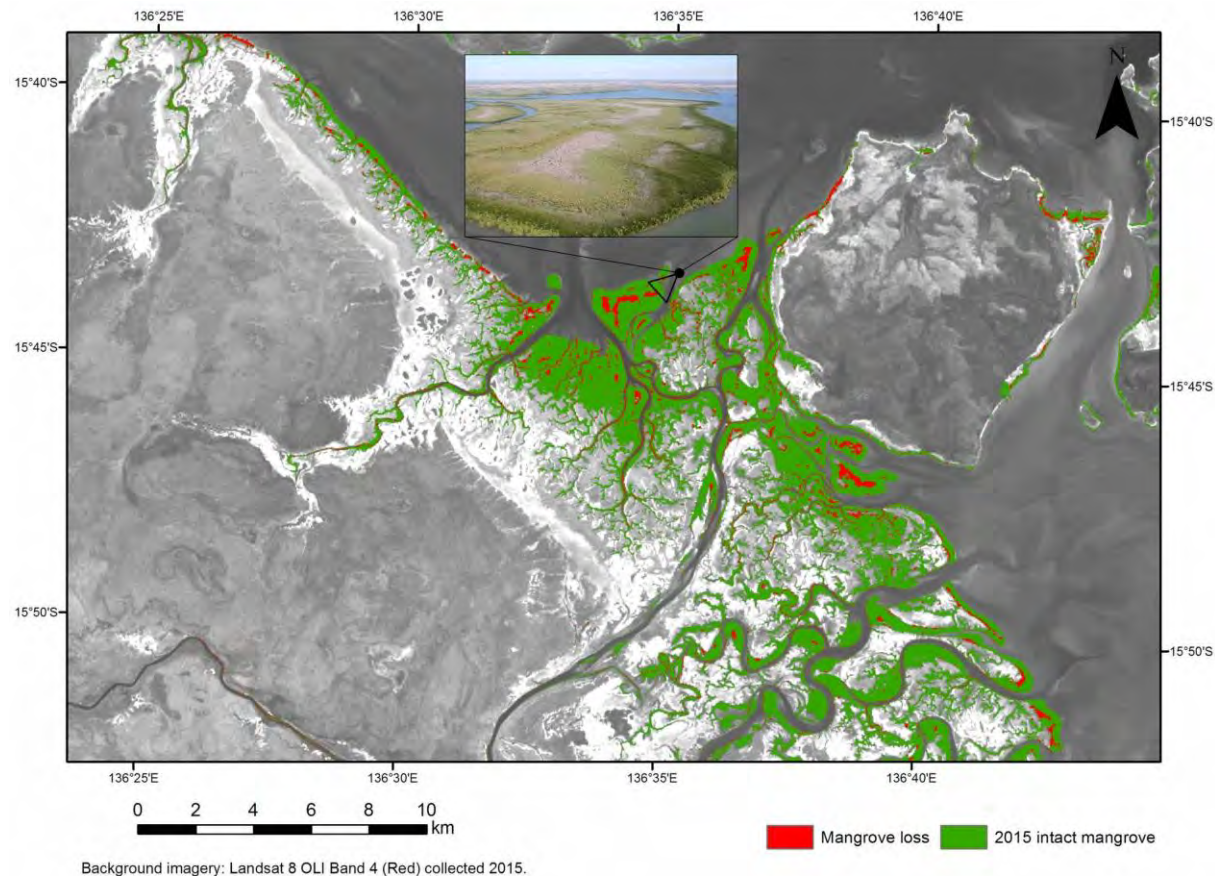
*Figure 1.1. Mangrove dieback was notable (in red) amongst surviving mangroves to show the common occurrence of greatest impact along seaward shorelines rather than in estuaries. This image shows the coast around the mouth of the McArthur River and Centre Island just south of Mule Creek in the Northern Territory. The inset image taken in June 2016 shows a section of mangrove shoreline where dieback was in adjoining mangrove zones of *Avicennia marina* and *Rhizophora stylosa* where the former bordered the inner saltpan–saltmarsh zone. Such distributional patterns uniquely distinguished this instance of mangrove dieback in 2015–2016.*

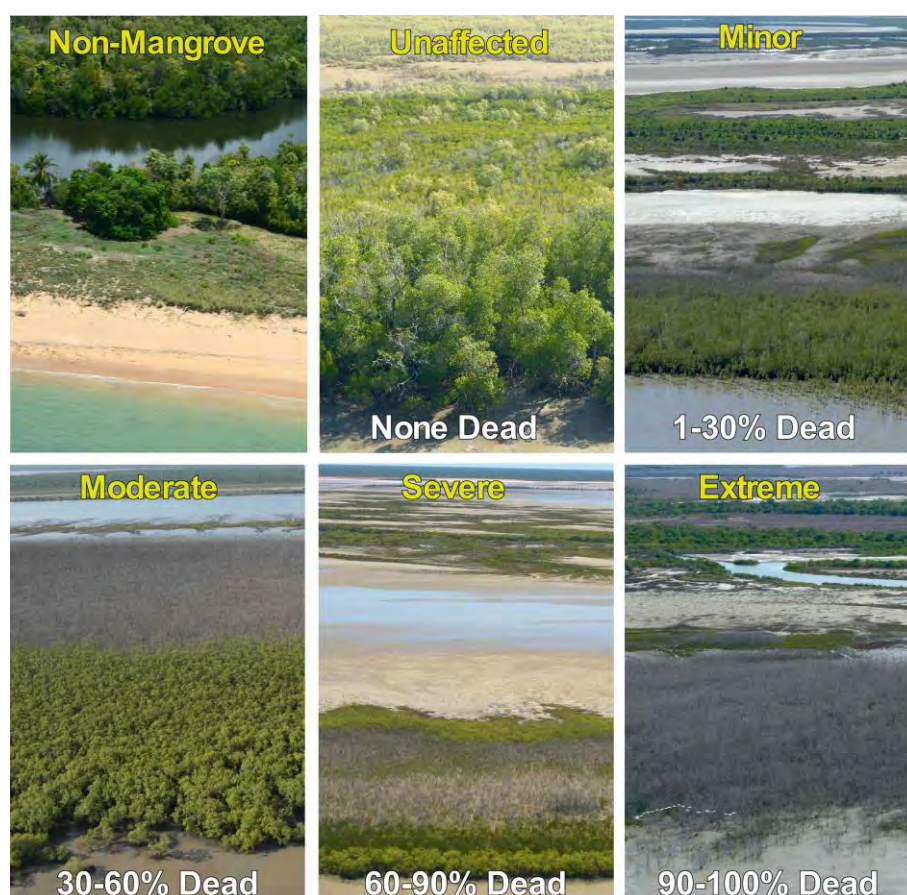
Figure 2.2. Six categories used in the assessment of mangrove presence and dieback severity quantified in these investigations by the proportional loss of the rear or upper back part of the shoreline mangrove fringe (Vol. 2: Figure 2.2). Shorelines without mangroves at the sea edge were classified as non-mangrove shoreline. Images taken during the 2017 aerial survey.

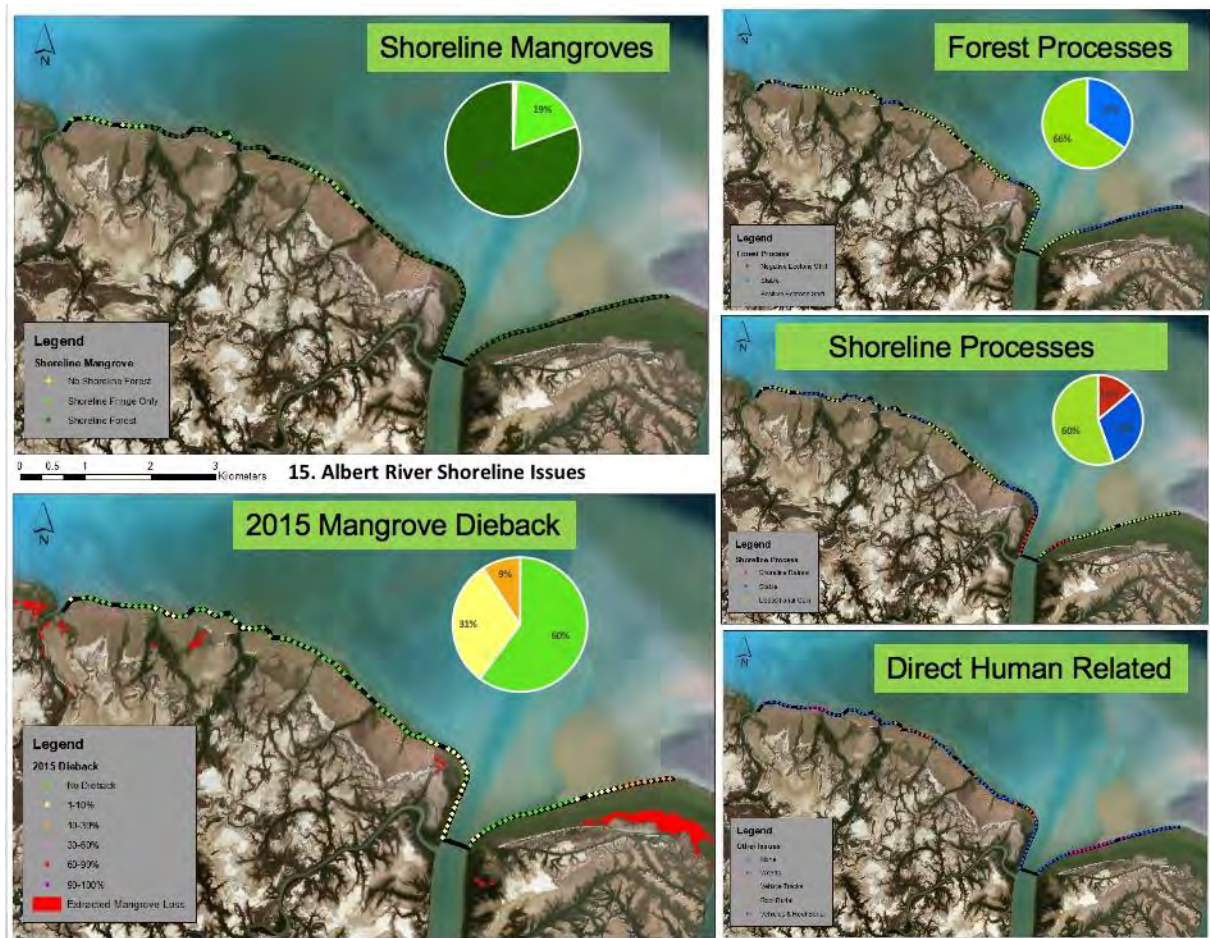
Figure 2.6. An example of the key features of shoreline change observed and recorded in the Albert River mouth and shoreline.

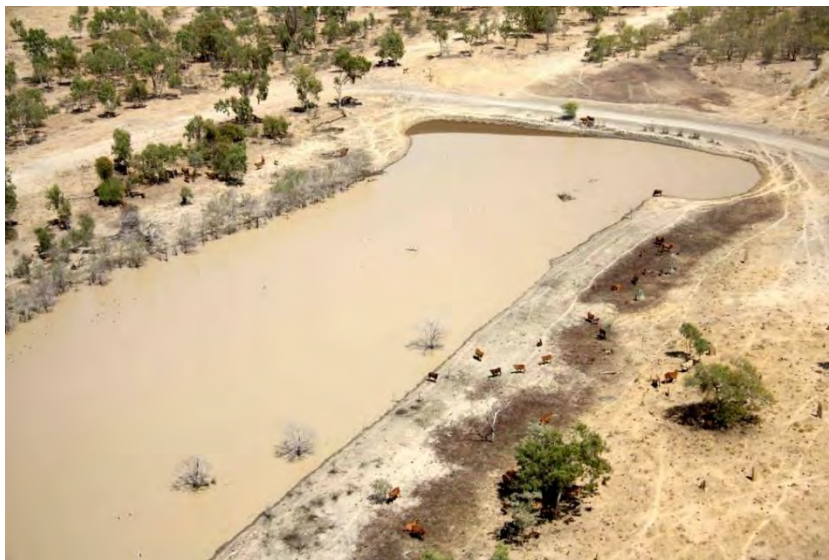
#### *Altered hydrology (Figure 2.7)*

**Indicator.** The distinguishing feature is unnaturally pooled water amongst tidal wetlands. The presence of likely construction works, and track damage can be indicative of Human influences as compared to Natural influences like storm drift.

**Impact.** The damage can be dead mangrove trees or canopy dieback as well as the dieback of flooded vegetation upstream.

Figure 2.7. Altered hydrology causes the blocking of natural flushing of tidal mangrove channels.

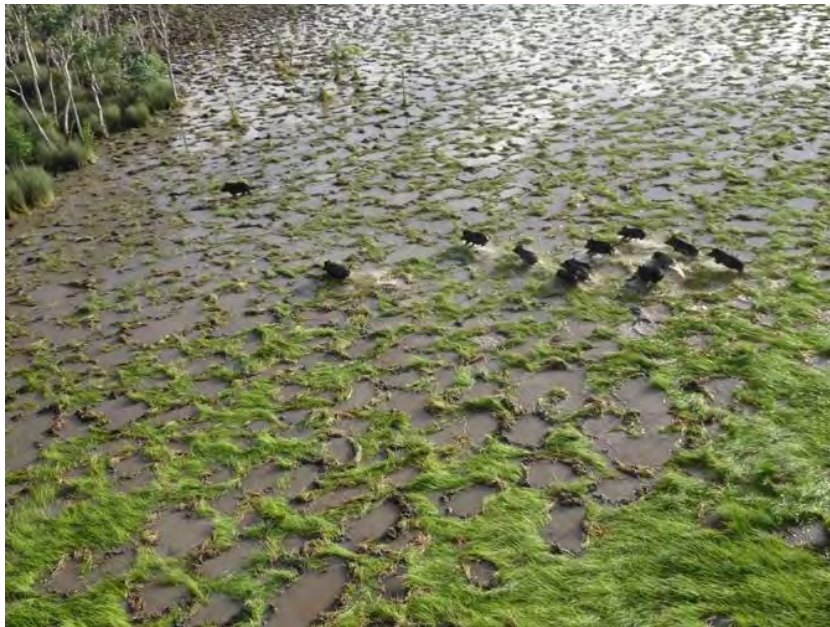
*Feral animal damage – wild pigs (Figure 2.8)*

**Indicator.** The presence of feral pigs, their tracks across mudflats, uprooted vegetation, digging excavations, and wallow pools.

**Impact.** Pig damage is associated with a lack of mangrove recruitment at ecotone zones shifting because of other reasons like increases in long term rainfall, or rising sea levels.

*Figure 2.8. Severe damage caused by feral pigs roaming freely across tidal and freshwater wetlands. The presence of wallows shows the extent of severely damaged habitat as well as disruptions to natural water flows.*

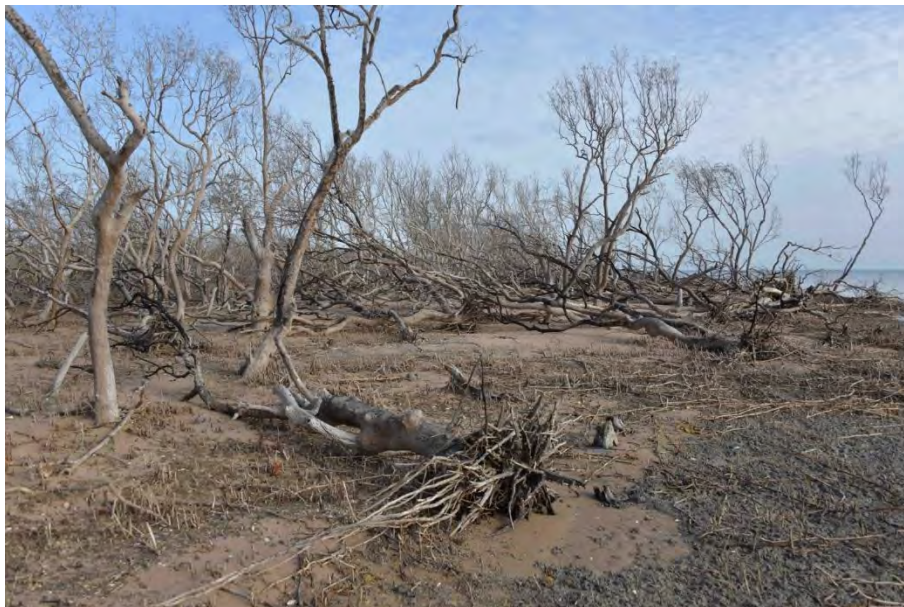
#### ***Storm damage and stem breakage dieback (Figure 2.13)***

**Indicator.** Loss of saltmarsh vegetation and loss of mangroves as defoliated uprooted broken trees as well as the loss of area. The influence of cyclones was quantified in terms of their frequency in proximity to respective shoreline sectors (Figure 2.14). Data was sourced from the Australian Bureau of Meteorology website.

**Impact.** Habitat loss reduces the fitness of tidal wetlands and, as a consequence, the ecosystem benefits are also lost, like their value to local fisheries or their role in the protection of shorelines from erosion.

*Figure 2.13. Strong cyclones cause severe damage to mangrove forests. Damaged shorelines may recover but only after several decades provided seedlings can rapidly re-establish amongst the dead, damaged and uprooted trees.*

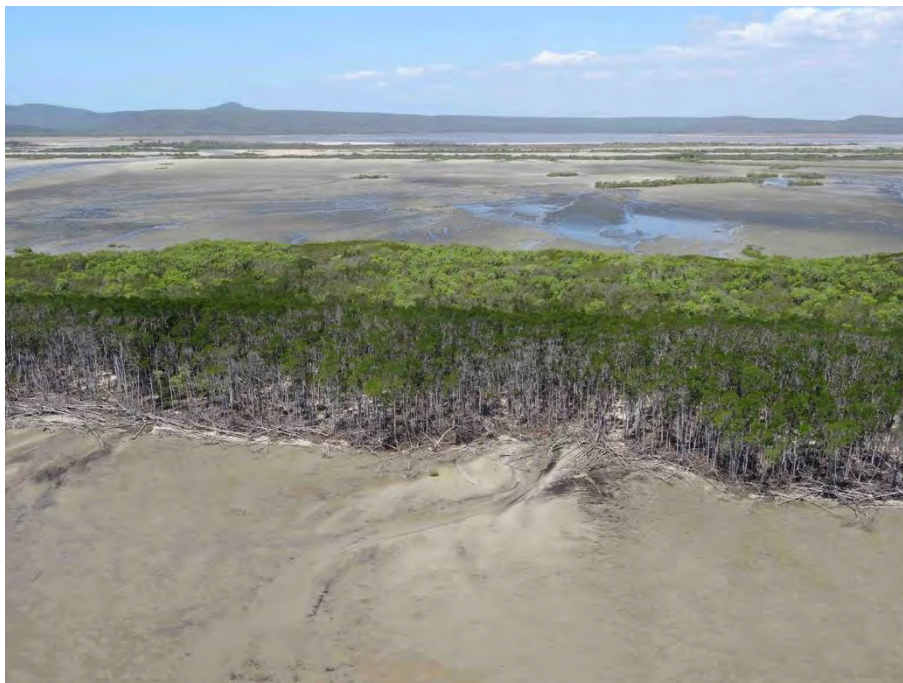
### *Shoreline erosion and seafront retreat erosion (Figure 2.15)*

**Indicator.** Loss of foreshore and shoreline mangrove vegetation is marked by fallen and eroded dead trees and uprooted stumps. Instances often also have a lack of seedlings and recovery regrowth, along with the close proximity of mobile sediment banks and berm ridges.

**Impact.** Loss of shoreline mangrove vegetation not only represents the loss of habitat and ecosystem benefits, but it also identifies locations currently experiencing unsustainable rates of change. Such eroded shorelines are highly vulnerable to further imminent disruptive events because they lack the normal protection of exposure-adapted, frontal trees. These trees, often of the same species, have different growth forms depending on where they grow along the tidal profile. And, once matured, the trees are unable to change and adapt. Exposed frontal trees develop sturdy support structures like the tangle of prop roots of *Rhizophora* species. When the same species grows in the middle of a forest, it has significantly fewer prop roots and support structures. In these circumstances, the inner trees redirect their growth and structure into gaining maximal crown height to better compete and survive. When exposed by shoreline erosion, these inner trees offer no benefit to shoreline protection. The only way shoreline mangroves can be re-established is by new recruits growing in the exposed conditions. This may not be possible during a period of rapidly rising sea levels. Such shorelines are highly vulnerable.

*Figure 2.15. Shoreline erosion and retreat of tidal wetlands occur when sea edge trees are lost. Unlike specially adapted sprawling sea edge trees, lanky inner stand trees are unable to resist strong winds and waves that regularly buffet exposed shorelines. Seedling re-establishment is notably too slow and unable to keep up with the frequency of disturbance in some locations.*

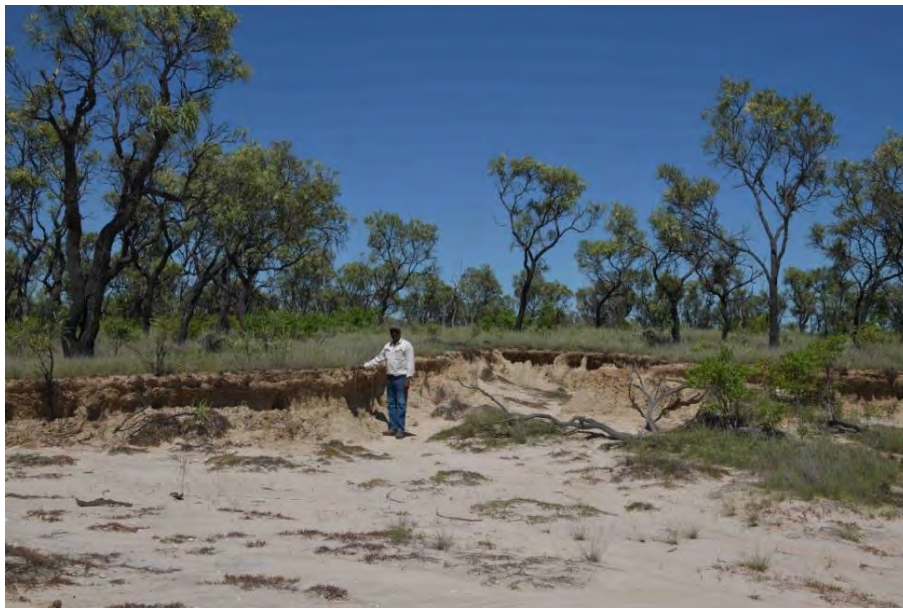
### *Terrestrial retreat erosion (Figure 2.16)*

**Indicator.** There are two notable effects that represent these types of changes: 1) erosion along the upper intertidal edge as a shallow, eroded ledge, and as scouring of small runoff tributaries; and 2) death of established supratidal vegetation, notably dead *Casuarina* and *Eucalyptus* trees. These effects are combined with Mangrove Encroachment which has been scored separately.

**Impact.** This impact mostly concerns the loss of supratidal vegetation and the possible expansion of mangrove areas. The ongoing erosion and death of terrestrial vegetation, however, make it difficult for the re-establishment of bank stability along this major ecotone. These areas are highly vulnerable to added pressures on seedling establishment.

*Figure 2.16. Terrestrial retreat, coupled with saline intrusion, is marked by dieback of supratidal terrestrial vegetation, possible encroachment by seedling mangroves, and erosion along highest seawater margins. This impact comes as a direct consequence of progressively rising sea levels. Such an occurrence is considered a valuable indicator, and because it depends on elevation, the breadth of impacted sites might be greatest in areas of low relief terrain.*

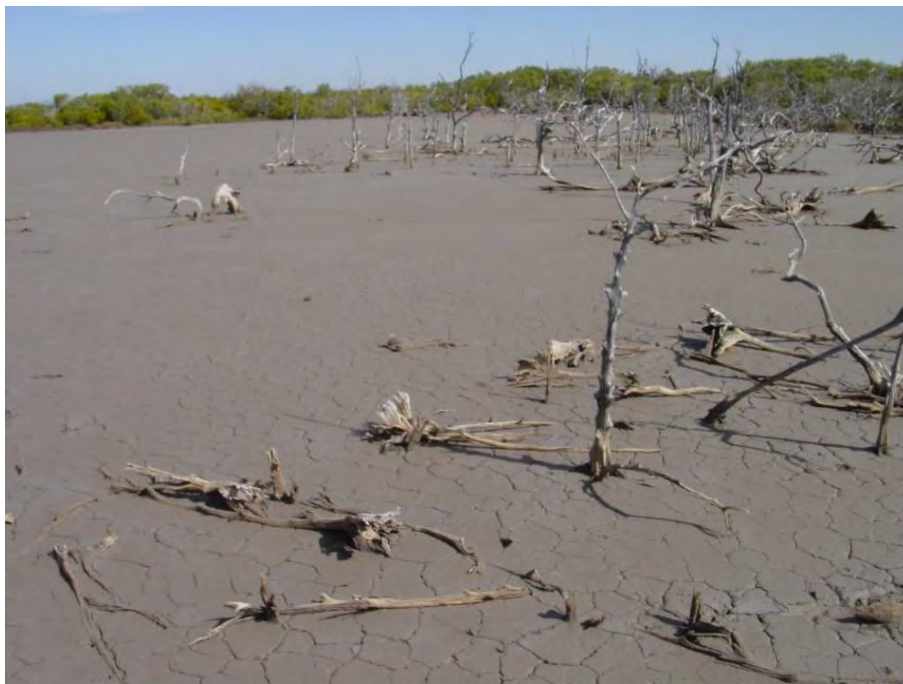
### *Ecotone shift loss (Figure 2.17)*

**Indicator.** Lines and linear patches of dead and stressed mangrove vegetation along upper saltmarsh transition zones within tidal wetlands.

**Impact.** With the loss of mangrove plants, there is a loss of mangrove habitat. But, there is a direct and natural transition to an equivalent area of tidal saltmarsh and saltpan vegetation.

*Figure 2.17. Ecotone shift negative around saltpan margins is attributed to a longer-term decrease in rainfall affecting catchment areas influencing the tidal wetlands.*

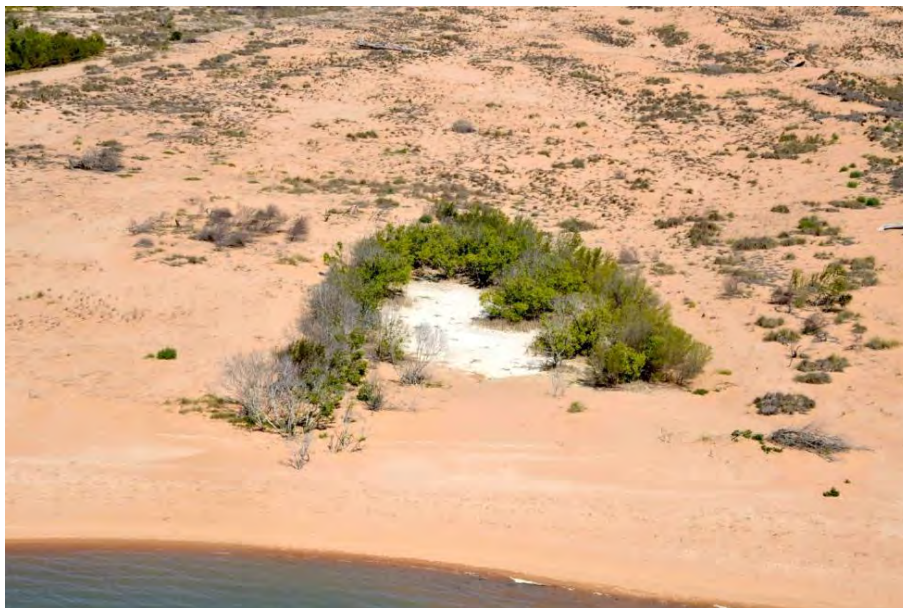
*Natural altered hydrology and impoundment (Figure 2.19)*

**Indicator.** The distinguishing feature is pooled water amongst tidal wetland habitat that is deemed to have resulted from natural causes. The absence of construction works and track damage in the area helps isolate the potential natural influences, like storm drift and channel cut-off.

**Impact.** The damage is often dead mangrove trees or canopy dieback.

*Figure 2.19. Natural altered hydrology caused by the re-deposition of sediments blocking tidal flushing of mangrove-fringed channels.*

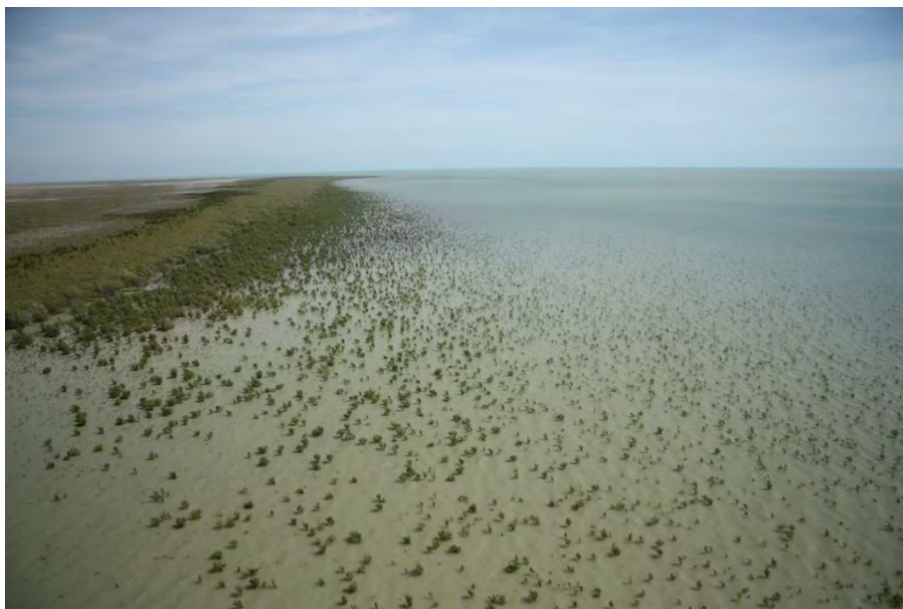
### *Depositional gain (Figure 2.20)*

**Indicator.** Newly recruited mangrove seedling and sapling stands growing on shallow muddy banks generally towards the lower estuarine reaches towards the mouth of riverine estuaries. Various key mangrove genera are involved, including mostly: *Avicennia*, *Aegialitis*, and *Rhizophora*. In general, the depositional gain is indicative of the combination of sediment transport processes including catchment runoff and the reworking of deltaic sediments.

**Impact.** With the increase in mangrove plants, there is a gain for mangrove habitat. But, these new habitats will take many decades to achieve the roles provided by mature stands. As such, this process is likely offset by bank erosion upstream which is generally seen as the active counter condition to depositional gain along typical estuarine meanders.

*Figure 2.20. Depositional gain occurs when mangrove seedlings and saplings occupy accreting mudbanks exceeding elevations above mean sea level. Because sediment deposition can be associated with periodic flood events, the expanding vegetation canopy is often stepped and incremental.*

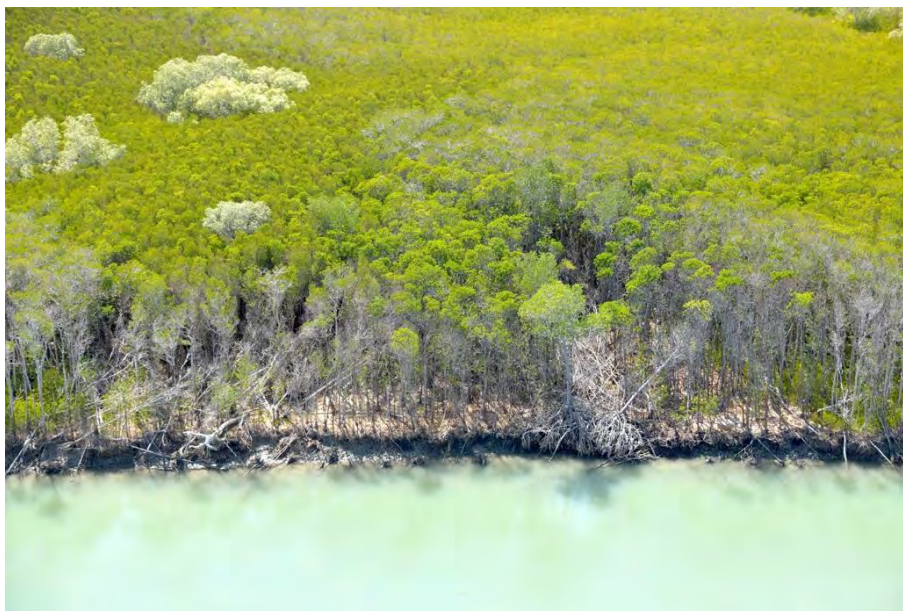
### *Bank erosion upstream (Figure 2.21)*

**Indicator.** Eroded banks are steep slopes, showing bare and crumbling earth faces, slumped bank pieces with intact vegetation, along with general remnants of collapsed and undermined vegetation like fallen trees, uprooted and inundated plants.

**Impact.** Lost mangrove habitat represents a loss of ecosystem benefits. Also significant is the loss of bank stability, much as mentioned in the *Shoreline erosion and seafront retreat erosion* (Figure 2.15) section. Such estuarine banks are highly vulnerable.

*Figure 2.21. Bank erosion occurs in a similar way to shoreline erosion, although bank erosion is arguably more normal where it occurs in counter-response to depositional gain. Accordingly, the two processes are responsible for the slow but natural shift of riverine channels as they meander and migrate across the lower estuarine flood plain. However, when there is an imbalance in these processes, and bank erosion exceeds depositional gain, this would indicate additional influences, as might be expected with rising sea levels and an increase in the volume of water in the estuary.*

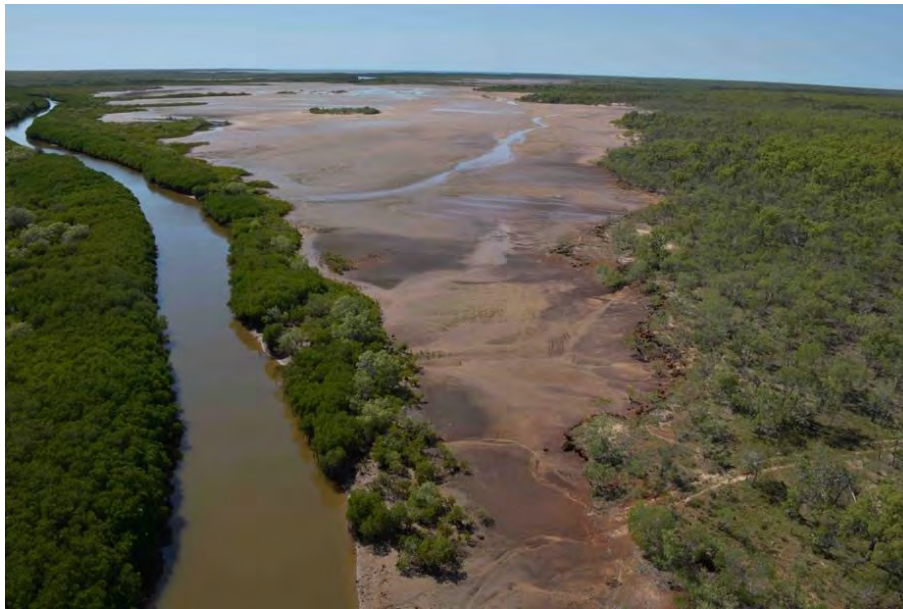
### *Pan scouring and erosion (Figure 2.22)*

**Indicator.** Scoured saltpan surfaces marked with drainage lines coupled with a lack of saltmarsh vegetation across the saltpan.

**Impact.** The loss of saltmarsh habitat is significant. There is also a further supply of fine sediments finding its way into the estuary and likely further contributing to depositional gain.

*Figure 2.22. Surface sheet erosion is another consequence of additional water in an estuary. As with terrestrial retreat, saline intrusion, and mangrove encroachment, this impact is also associated with rising sea levels. In this case, greater water volumes inundating upper saltpan areas results in sheet erosion and scouring of surface sediments with regular tidal flooding and drainage. In extreme instances, saltmarsh vegetation, including natural layers of microphytobenthos, have been unable to establish, so the whole inundated area is scoured leaving bare sediments and pools of residual waters.*

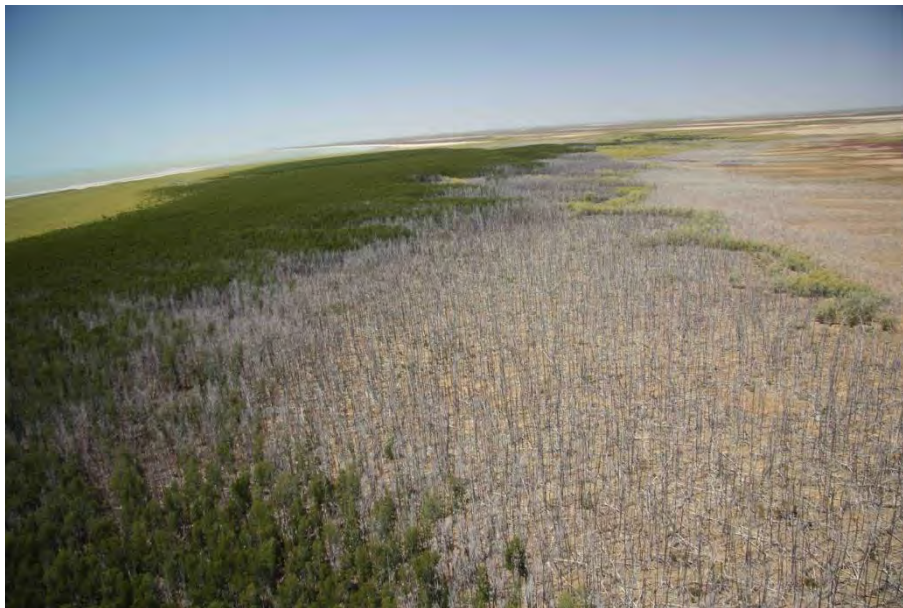
### 2015–2016 Mangrove dieback (Figure 2.25)

**Indicator.** The zone of dieback extending along the ‘back’ edge of the seaward mangrove fringe. Occasionally the entire fringe dies. Also, where there are distinct zones of *Avicennia* and *Rhizophora*, the dieback edge occurs at the upper margins of each zone separately.

**Impact.** This kind of dieback is uncommon; however, the effect is in some ways similar to that of ecotone shift loss (negative). The latter is driven by longer-term decreases in rainfall while the 2015 mangrove dieback is also due to severe moisture deficit with reduced tidal flushing levels. The latter may be temporary, but the impact is long-lasting and severely damages affected shoreline environments. These damaged areas are highly vulnerable to severe storms like tropical cyclones.

Figure 2.25. The 2015–2016 mass dieback of mangroves mostly was distinguished by dead trees at the upper tidal elevation edge of species zones, like this less common instance at the mouth of the Leichhardt River in September 2019 involving concurrent dieback in adjoining zones of *Rhizophora stylosa* (centre left) and rear fringe *Avicennia marina* (to the right). Such a broad zone of *R. stylosa* was absent along most shorelines around the Gulf.

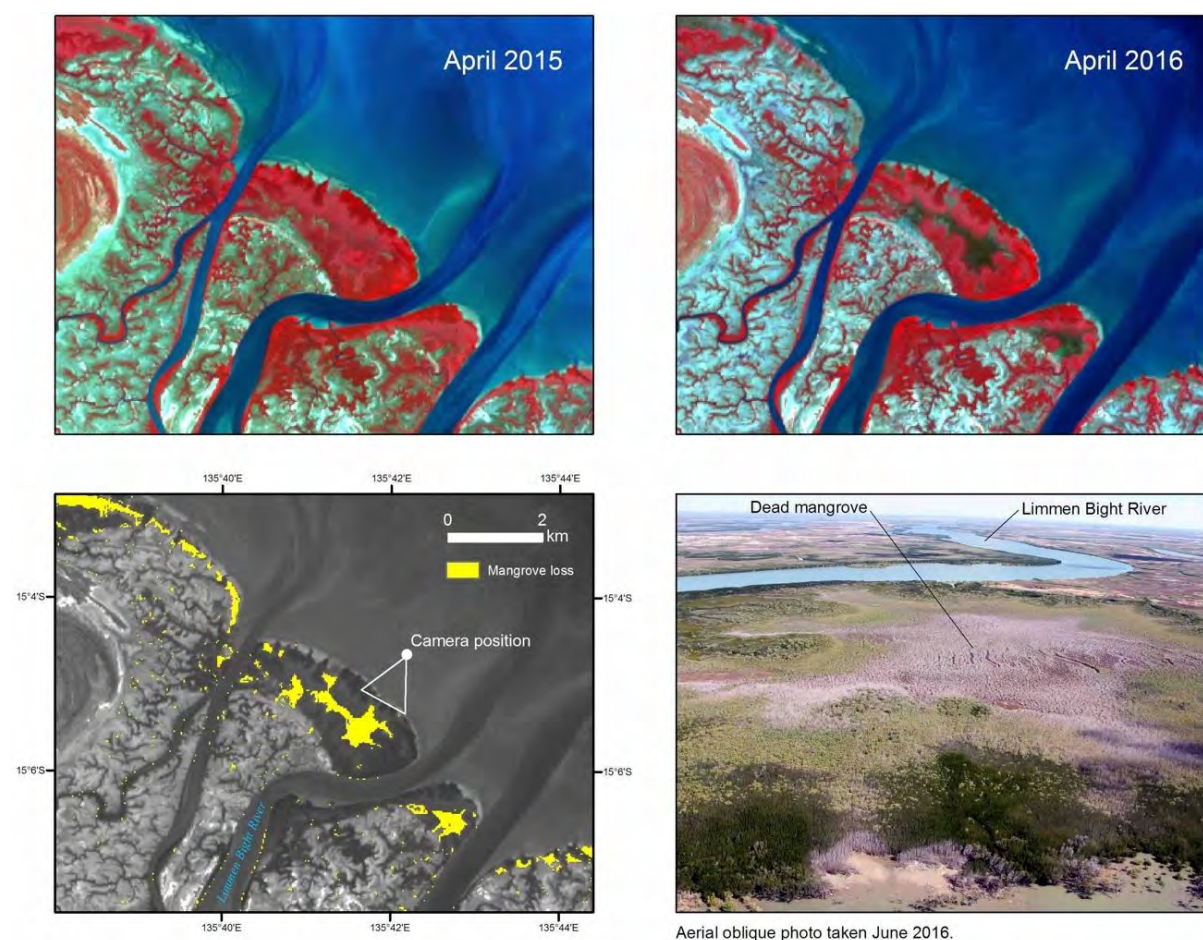
Figure 3.1. Interpretations from satellite imagery compared to an image taken during a preliminary aerial survey in June 2016 (lower right). These images show the occurrence and nature of the 2015–2016 mangrove dieback event. The top two images show mangrove areas in false red colour before and after the event. The lower left image shows areas of dieback and the position of the camera taking the aerial survey image.

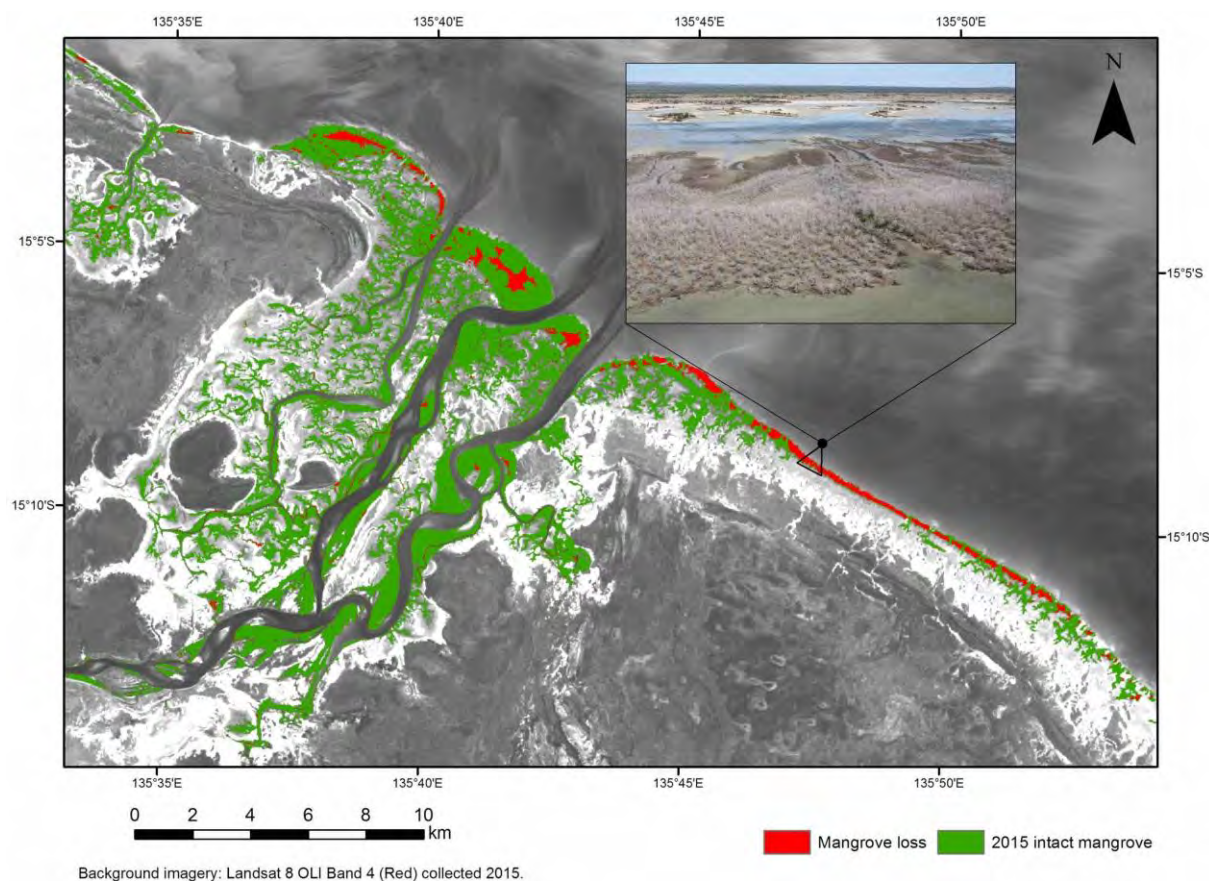
Figure 3.2. The mapping assessment used change detection between 2015 and 2016 imagery to show the timing and locations of mangrove loss. This view shows the distribution and nature of the 2015–2016 mangrove dieback event in the area around the mouth of the Limmen Bight River, in the south-west region of the Gulf of Carpentaria. The inset image taken in June 2016 shows a section of mangrove shoreline where all of the shoreline mangrove fringes had been lost.

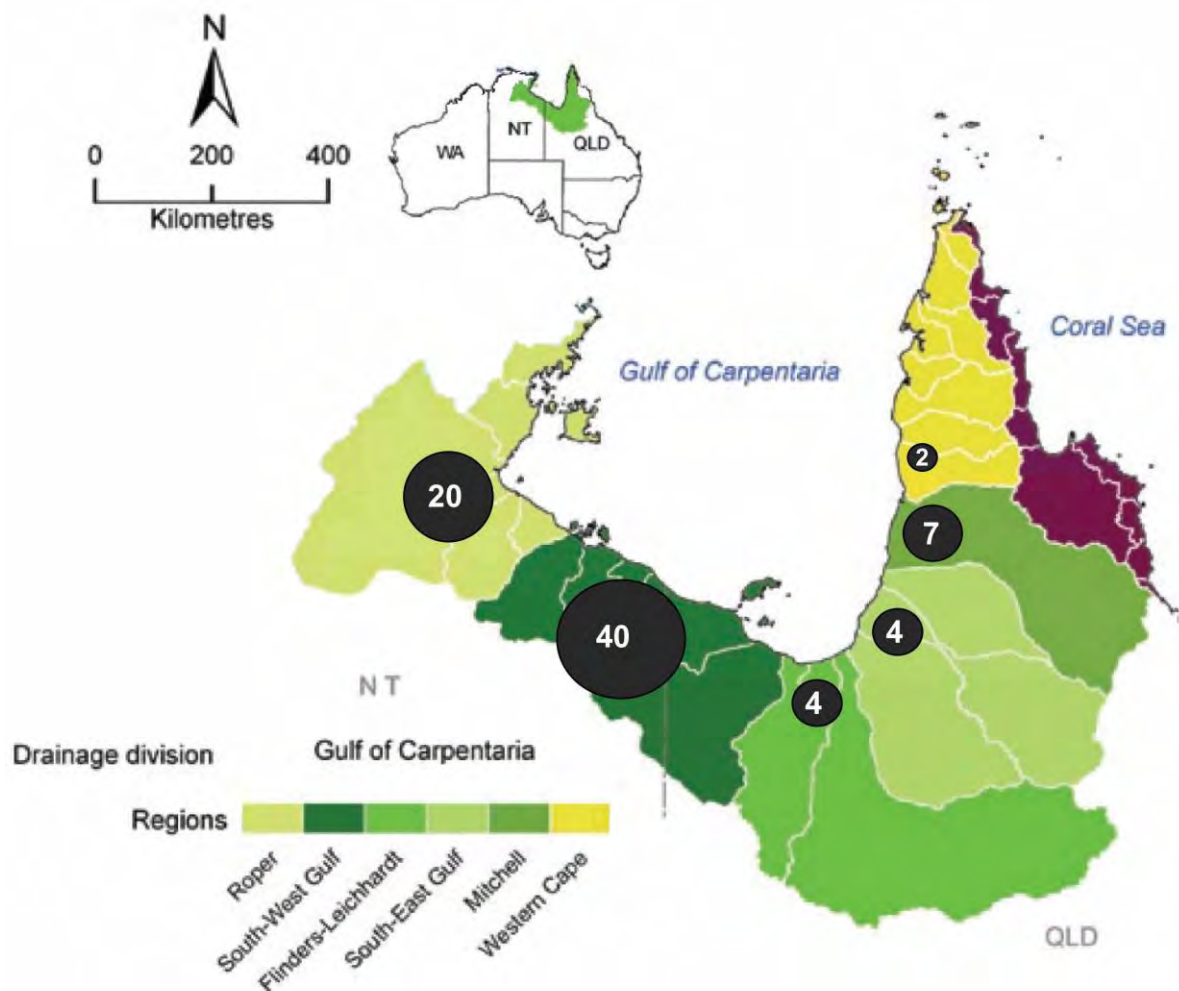
Figure 3.3. Areas of mangrove dieback loss (black circles, values in km<sup>2</sup>) determined from the mapping of tidal wetland habit in 2015 and 2016. Six regional areas as the major Gulf drainage divisions (CSIRO, 2009a, 2009b, 2009c, 2009d, 2009e, 2009f, 2009g, 2009h, 2009i).

The Gulf drainage division (Figure 3.3) with the most mangrove dieback was the SW Gulf region with a significant second in the Roper region, followed by much lower amounts in the other four regions. In summary, the total area of mangroves affected was 7,650 ha (76.5 km<sup>2</sup>) from a total mangrove area within the impact study area of 134,270 ha (1,342.7 km<sup>2</sup>). This showed that around 6% of mangroves were severely impacted across this large southern section of the Gulf.

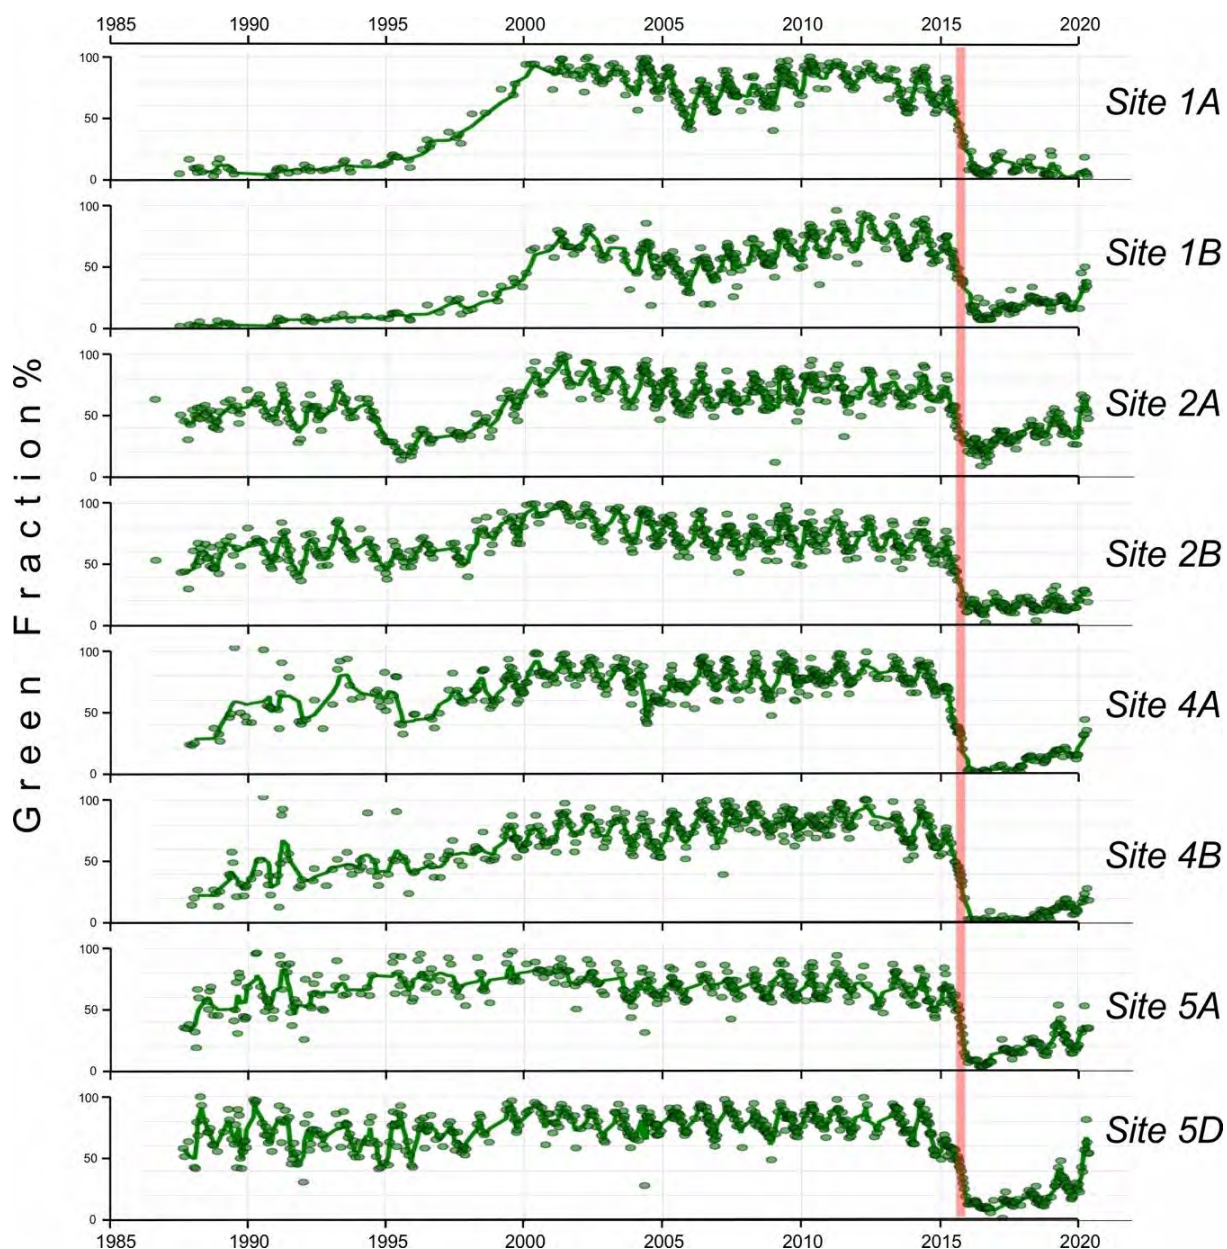
Figure 3.4. Time series plots of green fractional cover estimates from Landsat for the eight transect locations at the four field sites (Figure 2.1) in the Northern Territory (sites 1 and 2) and Queensland (sites 4 and 5) during 1987 to 2020. The red line indicates the synchronous timing of the late 2015 mass dieback event. The widespread impact was coincident with the widespread, dramatic and sudden temporary drop in sea level registered in local port tide gauge records.

The key feature of the 2015–2016 dieback of mangroves in the Gulf of Carpentaria was its distinct and synchronous occurrence along more than 2,000 km of coastline. This was evident in canopy vegetation density expressed as a fractional green cover derived from Landsat data for each of eight sites at four locations spread across the Gulf (Figure 3.4). The distinguishing event occurred in each location in late 2015 (red line). Furthermore, note the change in levels of canopy density (the green fraction) in each of the eight time series from 1987 to 2020. Levels start off low in 1987 and generally rise until 2000 at which date they mostly achieved maximum levels. These features were comparable in all locations where there was an apparent recovery trajectory. There were two deductions to be made from

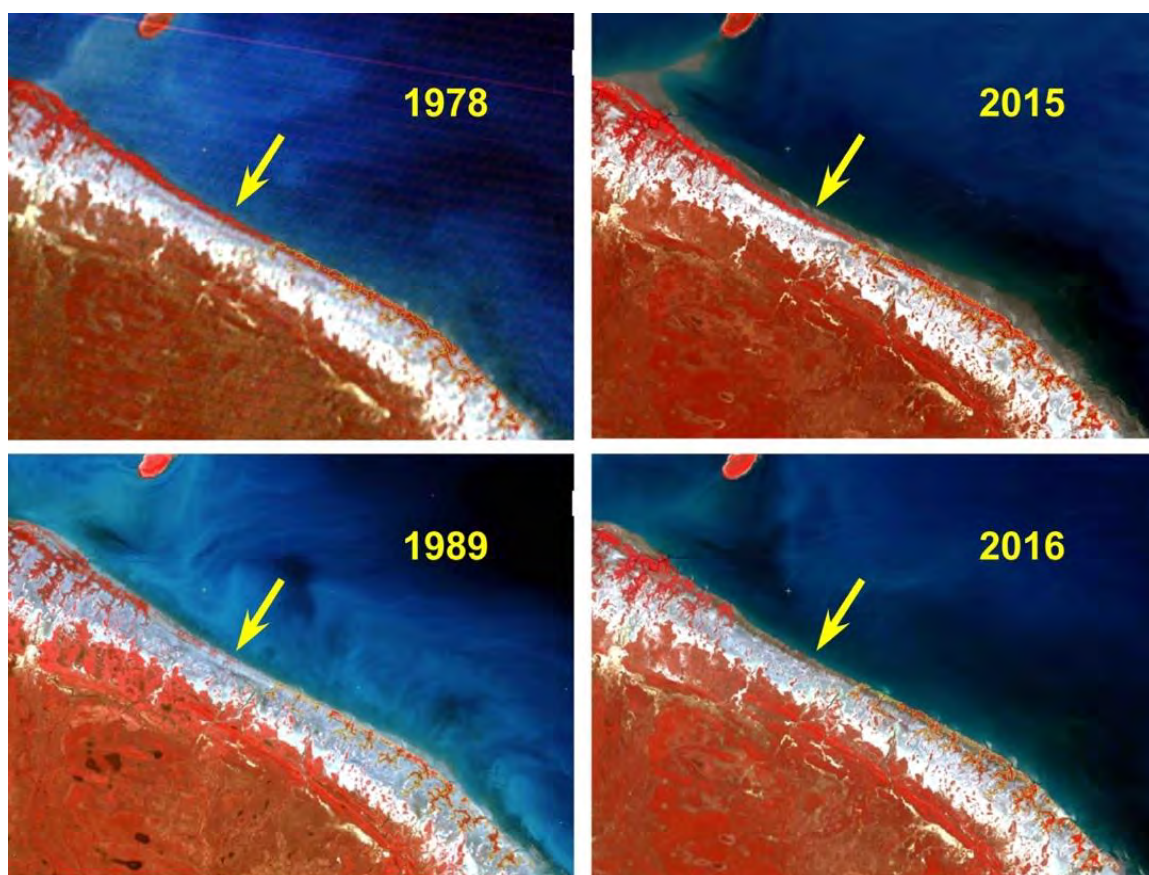
Figure 3.5. Selected time series comparisons show losses of shoreline mangroves (in false red colour) as seen in Landsat imagery. These compare the known 2015–2016 incident (right) with those likely much earlier between 1978 and 1989 (left). These views show the same severely impacted shoreline just east of the Limmen Bight River mouth (Figure 5.102). While no accounts of comparable mangrove losses were reported for the earlier event, these images and other evidence make this a serious possibility. As seen at sites 1A and 1B in Figure 3.4, the foreshore fringing stand followed a recovery trajectory.

Moreover, this earlier occurrence of severe mangrove dieback also appeared to be equally widespread across the Gulf region. Comparable losses along shoreline mangroves near the mouths of the Mitchell and Norman Rivers in Queensland had also occurred in 1989. These findings provide compelling evidence for a possible earlier incident of comparable mass dieback of mangroves in the Gulf region.

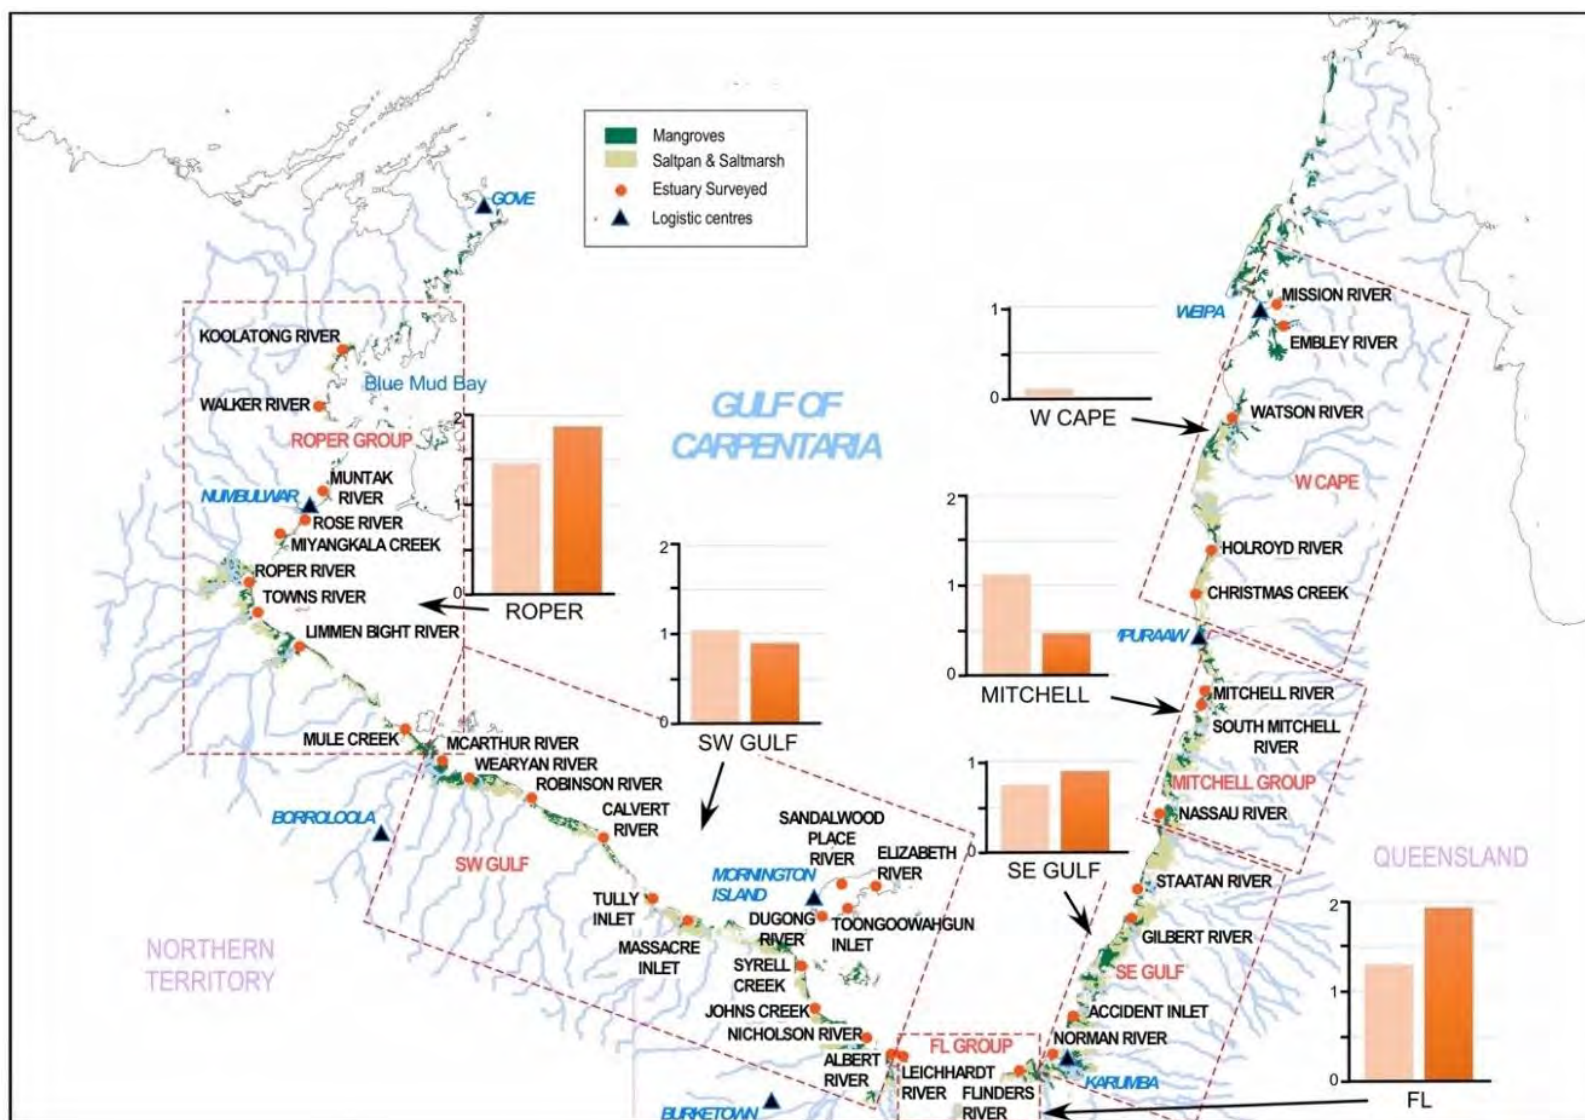
Figure 3.6. Levels of mangrove dieback severity scored in estuary mouths of six drainage divisions (CSIRO, 2009a, 2009b, 2009c, 2009d, 2009e, 2009f, 2009g, 2009h, 2009i) in 2017 and 2019.
