# Assessing the Gulf of Carpentaria mangrove dieback 2017–2019

## Volume 1: Aerial surveys

by Norm Duke, Jock Mackenzie,  
John Kovacs, Grant Staben, Rob Coles, Apanie Wood & Ysabel Castle

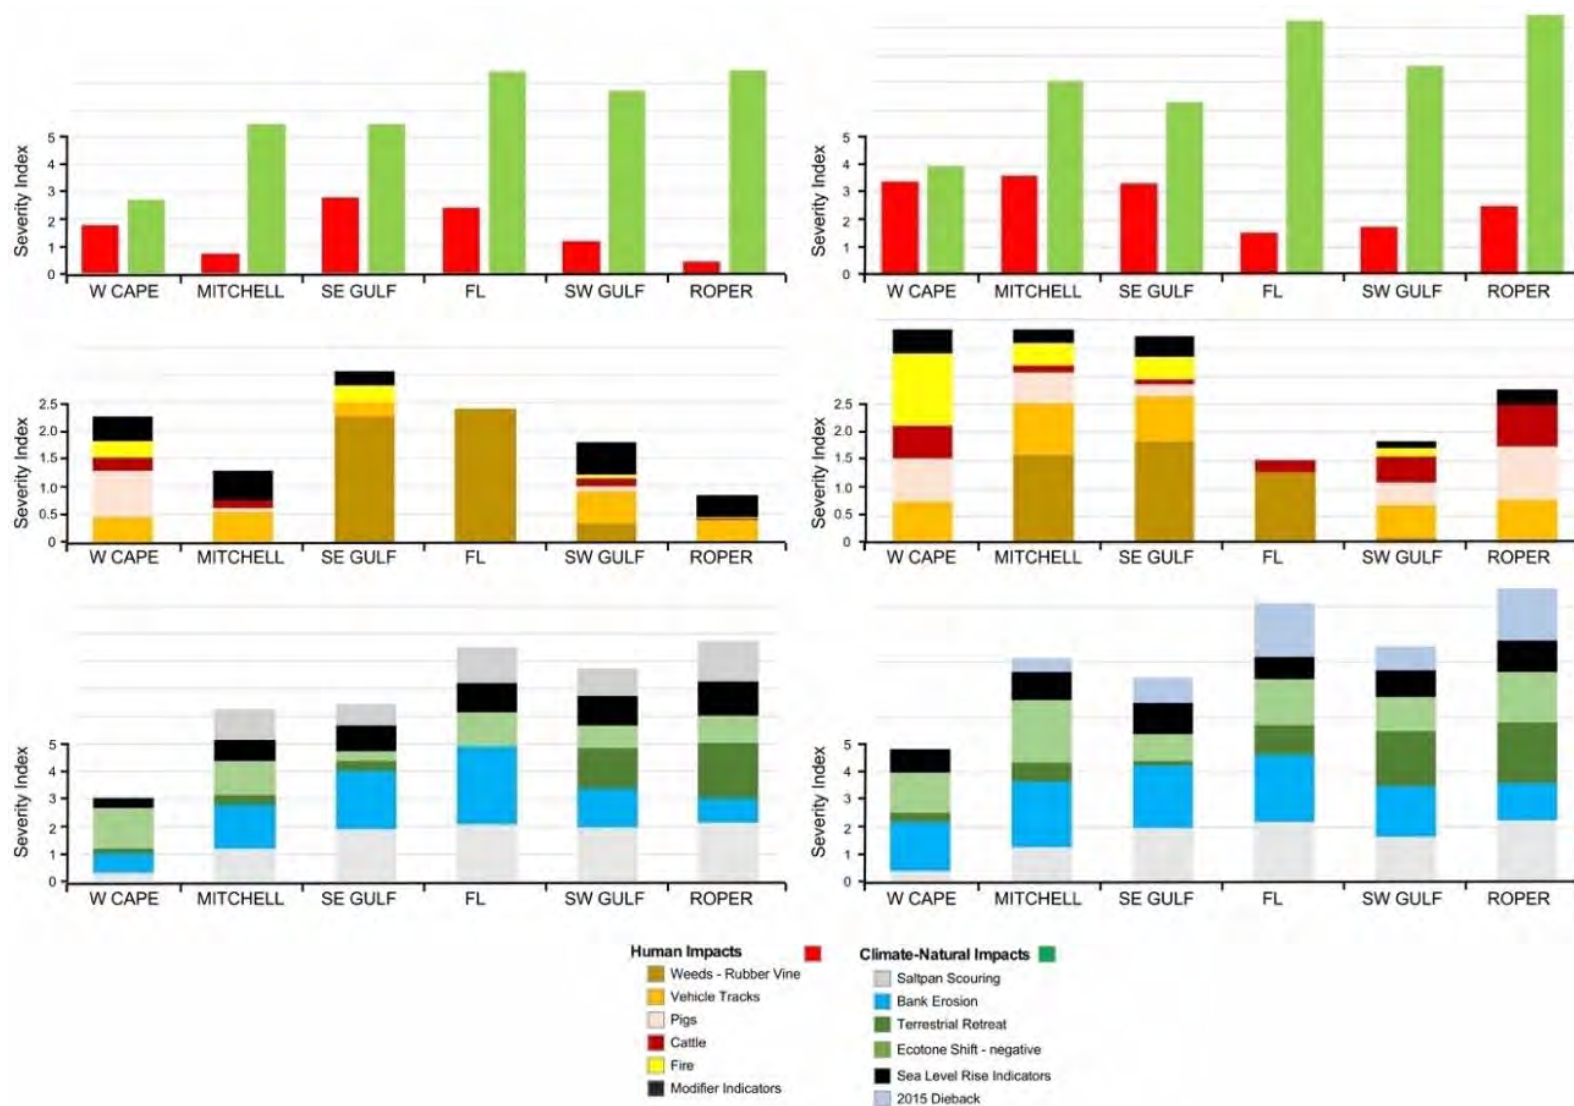
Figure 3.7. Based on the 31–37 estuaries, three levels of histogram graphs comparing severity scores for the six groupings of regional areas in 2017 (left) and 2019 (right), including top pair – human (red) and climate-natural (green) drivers; middle pair – dominant human drivers; and bottom pair – dominant climate-natural drivers.

By comparison, the dominant climate-natural impacts all appeared to increase in severity from eastern to western shorelines of the Gulf. This was the case for the 2015 mangrove dieback damage levels, as noted already, as also seen in two other indicators namely terrestrial retreat and saltpan scouring. Another two indicators, ecotone shift and bank erosion, were relatively high across all regions.

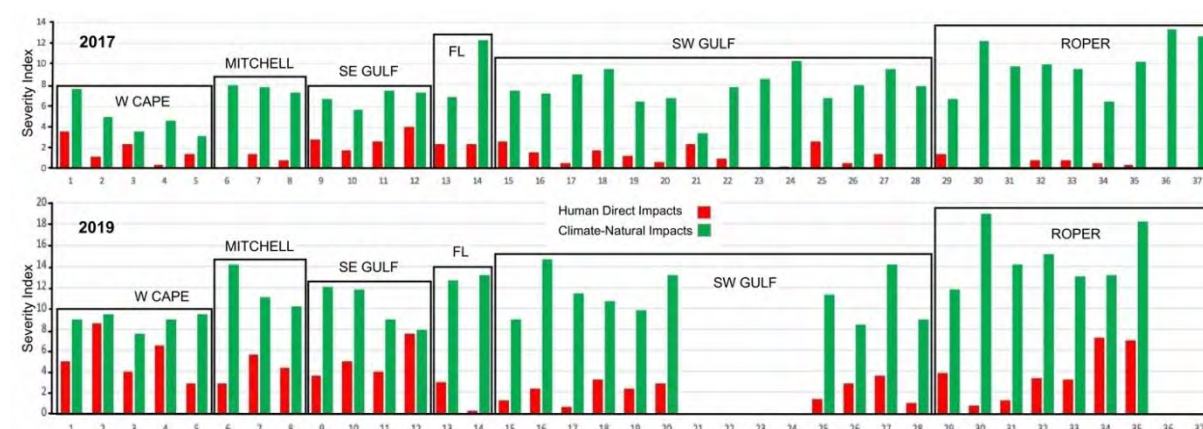
Indicators of mangrove and shoreline condition were grouped for the relative influences of human and climate-natural drivers. A notable trend of increasing climate-natural factors (green bars) was observed for regions in the east and extending to the west in 2017 and 2019 (Figure 3.8). Human influences (red bars) were less severe, but there was a tendency for their decreased influence over the same ordering of regions to the west. Human influences were generally greatest in Western Cape and the SE Gulf regions, a feature largely consistent with port and urban facilities of Weipa around Mission and Embley Rivers, and Karumba at the mouth of the Norman River. High levels in the Mitchell region during September 2019 reflect the relatively high level of recreational and monitoring activities compared to those in December 2017.

Figure 3.8. Comparing human and climate-natural impacts for 31–37 estuary mouth sites (Table 2.1, Figure 3.6).

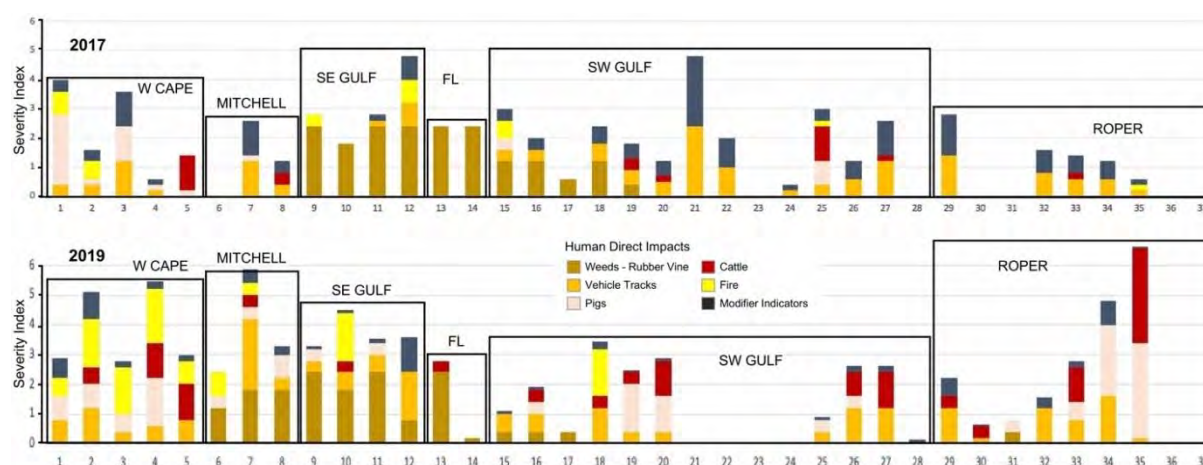
The five most severely rated indicators overall were: human impacts (Figure 3.9) – weeds (particularly rubber vine), vehicle tracks, feral pigs, stock animals and fire scorch; and climate-natural impacts (Figure 3.10) – saltpan scouring, bank erosion, terrestrial retreat, ecotone shift negative and 2015–2016 mangrove dieback.

Figure 3.9. Comparing the five overall highest scoring impacts from human factors for 31–37 estuary study sites (Table 2.1, Figure 3.6).

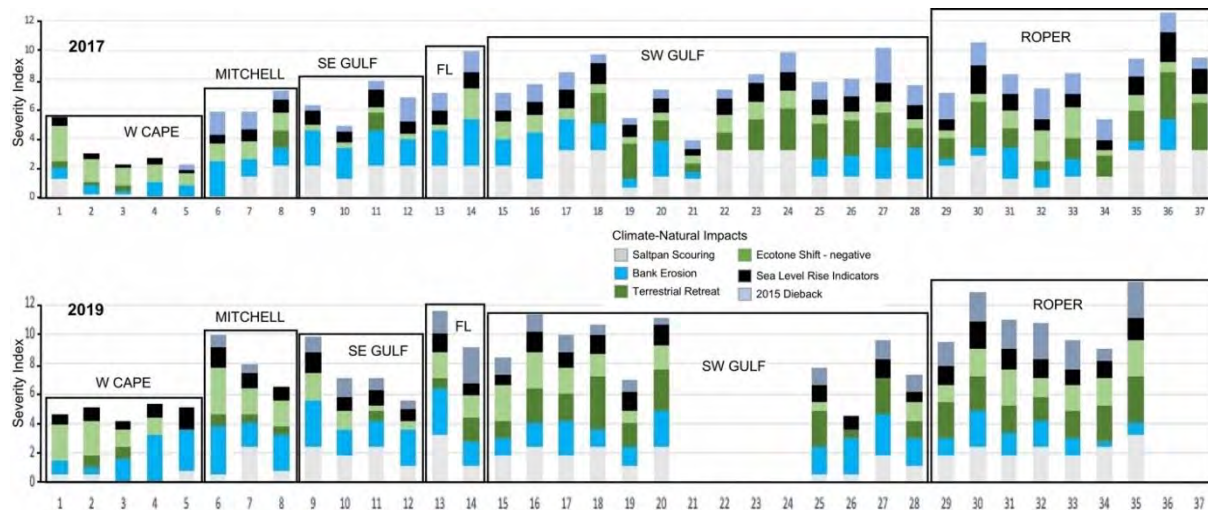
Figure 3.10. Comparing the five overall highest scoring impacts from climate–natural factors for 31–37 estuary study sites (Table 2.1, Figure 3.6).

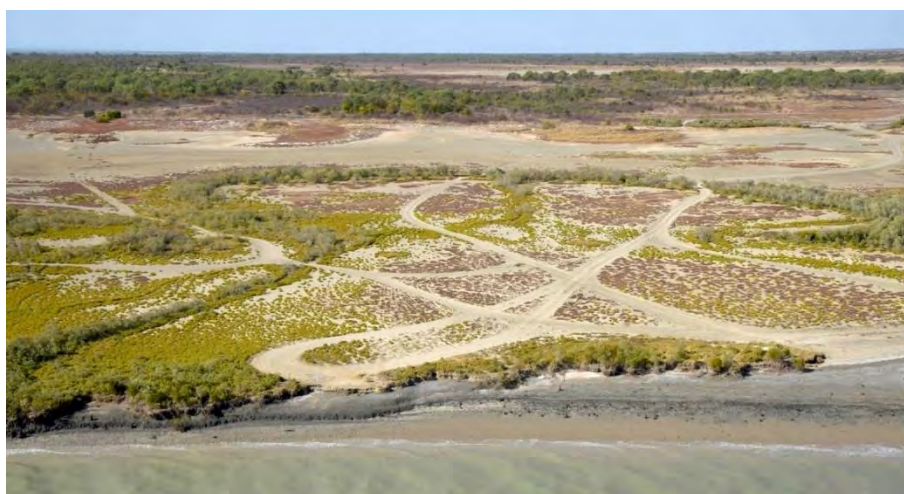
While human-related impacts are largely self-evident, like damage from access tracks (Figure 3.11), it has been useful to quantify their relative importance based on our visual characterisation of the severity of such effects (Table 3.2 and Table 3.3). Because the causes are evident, these observations potentially translate into tangible management recommendations for the limitation and constraint of particular harmful agents responsible.

Figure 3.11. Access tracks across tidal wetlands damage delicate mangrove and saltmarsh plants with repercussions on the longer-term survival of these areas.

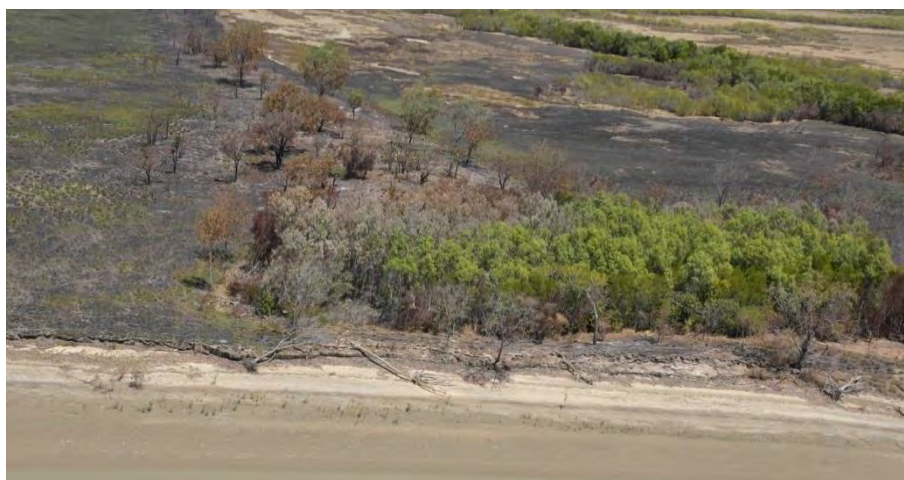
For the climate–natural impacts, the habitat indicators reflect the delivery of regional and less localised drivers. These were identified and quantified based on the various responses observed. Specific examples include shoreline erosion; bank erosion, terrestrial retreat, and storm damage. In general, responsible drivers are expected to influence multiple response indicators. For instance, sea level rise is likely to affect at least both shoreline erosion and terrestrial retreat. In another example, storm damage might affect shoreline erosion; and be confounded by root burial and altered hydrology. Factors like fire were noted, but the effects were patchy (Figure 3.12).

Figure 3.12. Mangroves are very sensitive to fire. Frequent hot grassland burns during neap tide periods have devastating impacts, scorching and killing vulnerable edge stands.

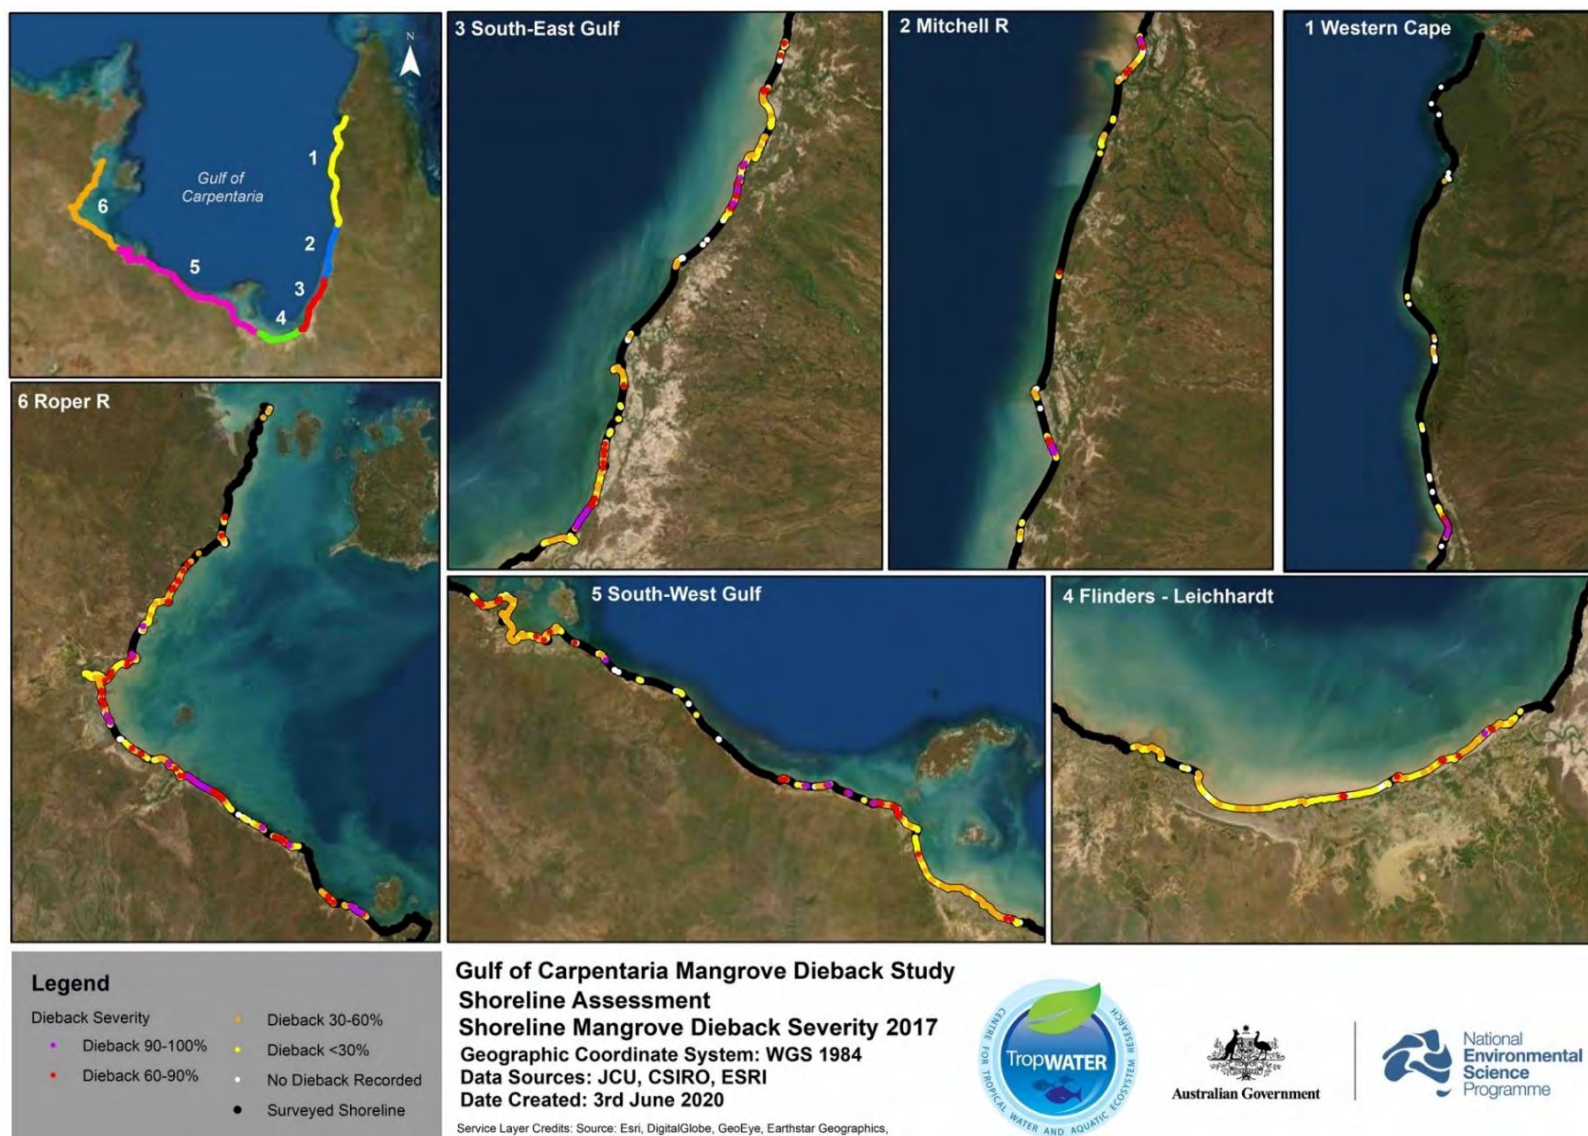
Figure 3.13. Mapped shorelines, showing mangroves and the extent of dieback severity classes for each of the six drainage regions (Figure 3.6).

In total, 551.1 km (72.3%) of mangrove shorelines showed some level of dieback impact. The region with the least amount of dieback was the Western Cape with 16.9 km (58.5%) – this being restricted to shoreline fringing stands in the southern extremity (Figure 3.13). By contrast, there were greater losses in all five other regions – ranging from 64.1%–79.9% of seaward edge mangrove stands. It was notable that these losses to the shoreline fringe were at the ‘back’ or upper edge at the saltpan-mangrove ecotone – mostly not reaching the seaward edge. The distinctive result was that most shorelines (97.5%) had intact surviving seaward stands. And, 72.2% of impacted shorelines maintained their seaward fringe. This augers well for the longer-term recovery of these shorelines since surviving vegetation offers some protection from exposure to large waves, strong winds, and storm conditions.

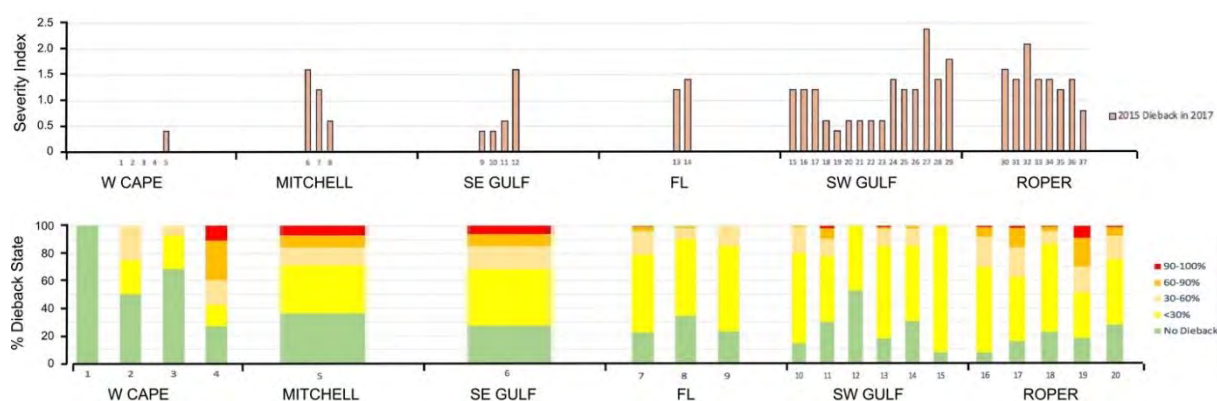
Figure 3.14. Distribution of 2015–2016 mangrove dieback across the six drainage regions of the Gulf of Carpentaria (Figure 1.4) scored in estuary surveys as overall severity (top graph; numbers refer to estuaries in Table 3.5 and in shoreline assessments as proportions of dieback extent – no dieback, 1%–30%, 30%–60%, 60%–90% and 90%–100% loss of the seaward fringing zone (lower graph; numbers refer to the region shoreline or subsections within each region).

The most severe impact of 90%–100% loss occurred along 16.5 km (2.2%) of the seaward fringe zone, and these losses were present in all six Gulf regions. The maximum coast length of this highest level of impact was 6.9 km (3.4%) in the Roper region and 5.9 km (6.0%) in the South East Gulf.

Aerial assessments of the distribution of 2015–2016 mangrove dieback are summarised in Figure 3.13. Findings from the shoreline assessments of extent are compared with estuary severity scores (see *Region and site summary data* section; Figure 3.14). The overall conclusion has been that the dieback was unusually widespread and patchy with variable levels of impact severity affecting mangroves around estuary mouths, although greater levels of damage were scored along seaward fringing shorelines. The Western Cape region was less affected with a transition from non-affected shorelines towards the north to higher levels in the south. Moderate to extreme dieback levels were recorded in all regions. The extent of dieback and the high levels of severity recorded with these studies had never been recorded before from a single event.

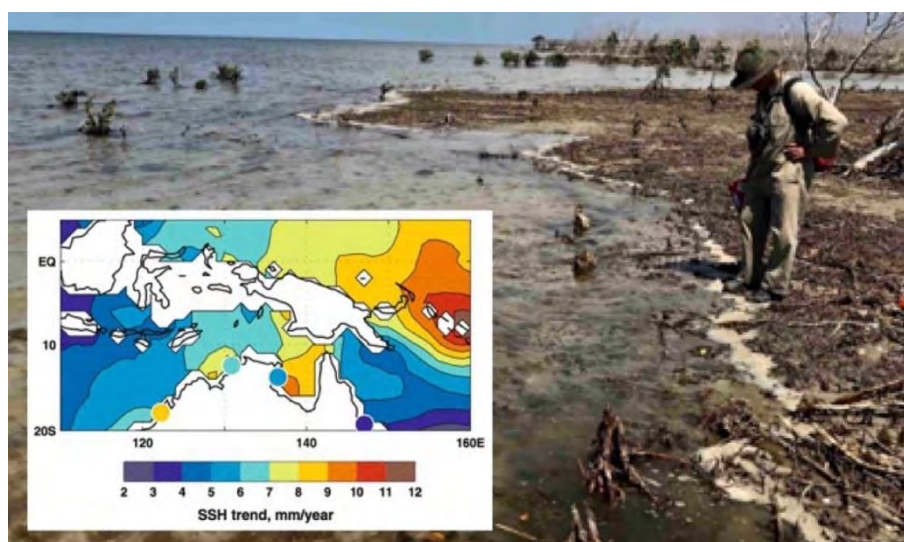
With the loss of so many mangrove trees (76.5 km<sup>2</sup> with this one incident), the retreat of shorelines might be expected to follow as overall sea levels rise (Figure 4.2). But, by how much? Has there been any recovery? The occurrence of such a large-scale disturbance to shoreline mangroves has raised serious concerns about the consequences on shoreline mangroves and the growing risks these habitats face as threatening pressures escalate

Figure 4.2. Shoreline erosion occurs when sea edge trees are lost, as seen in the Gulf of Carpentaria (Limmen Bight shoreline at site 1 (Figure 0.7), Northern Territory, in 2018). Surviving plants are unable to resist strong winds and waves that regularly buffet exposed shorelines. Seedling re-establishment is seemingly too slow and unable to keep up. This can be due to rising sea levels, but at a local scale further impacts are caused by severe cyclones. Inset: Sea level trends estimated from satellite altimeter data from January 1993 to December 2007 in the region. Comparable sea level data from tide gauge data from the National Tidal Centre are indicated by the coloured circles.

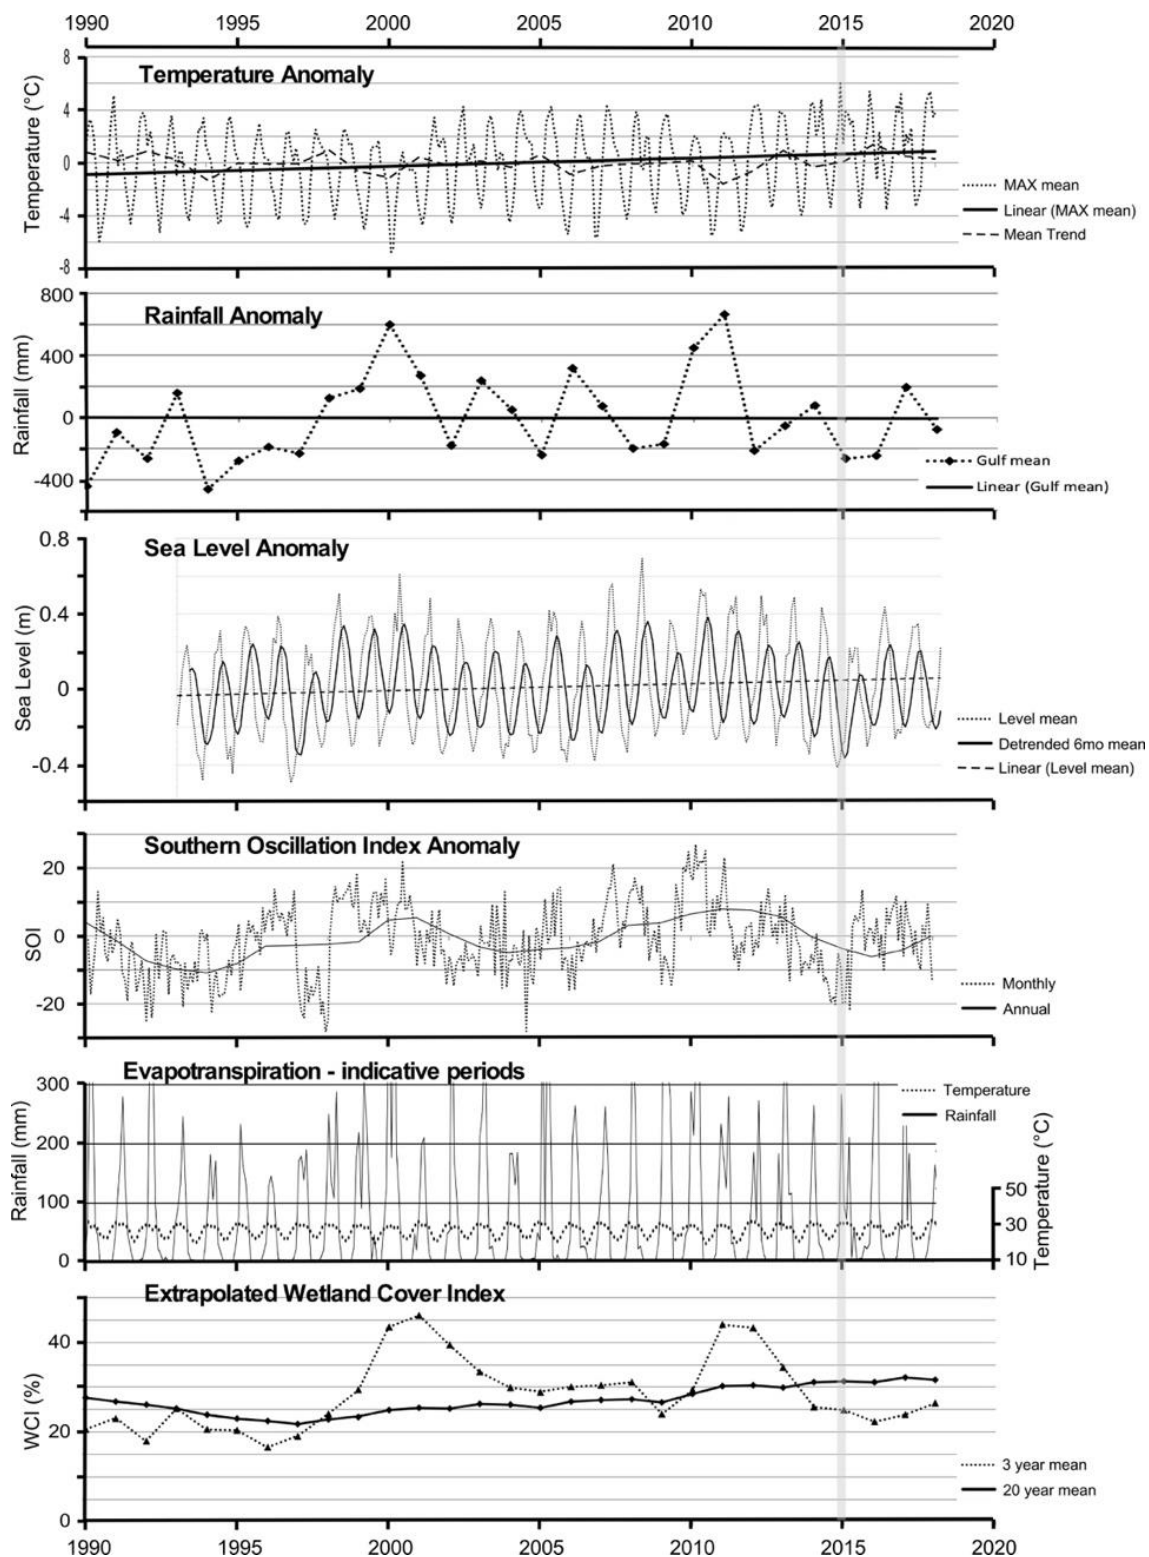
Figure 4.3. The condition of climate and environmental factors up to and after the 2015 mangrove dieback event (grey vertical line) in the Gulf of Carpentaria. Data were sourced online, mostly from the Australian Bureau of Meteorology. Factors showing anomalies were calculated using the 1990–2019 reference period and include (top to bottom): a) temperature monthly and annual mean maxima plus the overall trend; b) rainfall annual means plus the overall trend; c) sea level monthly means, the overall trend, and the detrended six-monthly means; d) the Southern Oscillation Index monthly and annual means; e) indicative levels of evapotranspiration shown as periods when the temperature exceeded rainfall at respective scales; and f) wetland cover index levels deduced from its rainfall correlate (Duke et al., 2019a) using three and 20-year running means.

These findings were inconclusive, however. Firstly, note that low rainfall levels (Figure 4.3b) had not resulted in mangrove dieback on previous occasions when rainfall conditions were similarly low, like during the mid 1990s. Furthermore, note the indicative evapotranspiration periods (Figure 4.3e) also had no specific correlative links to the mass dieback event. Secondly, this observation was supported by an assessment of the wetland cover index (WCI), as the percentage of mangrove cover versus the total area of tidal wetlands (Duke et al., 2019a). For the Gulf dieback event in 2015, the derived annual estimates of the WCI varied between 28.14% and 28.86% during the 2013–2016 period. By comparison, those measured from available mapping data at the time (Duke et al., 2017) were around 27.1%.

It appears that moisture levels due to rainfall had been maintained within normal limits for these otherwise resilient trees. In fact, during the previous 25 years, the proportion of mangrove extent had risen overall from ~20% to just more than 30% (Figure 4.3f). This suggests that any downward pressure of recent drier weather conditions is considered unlikely to have had a strong influence on the mass dieback of mangroves in 2015–2016.

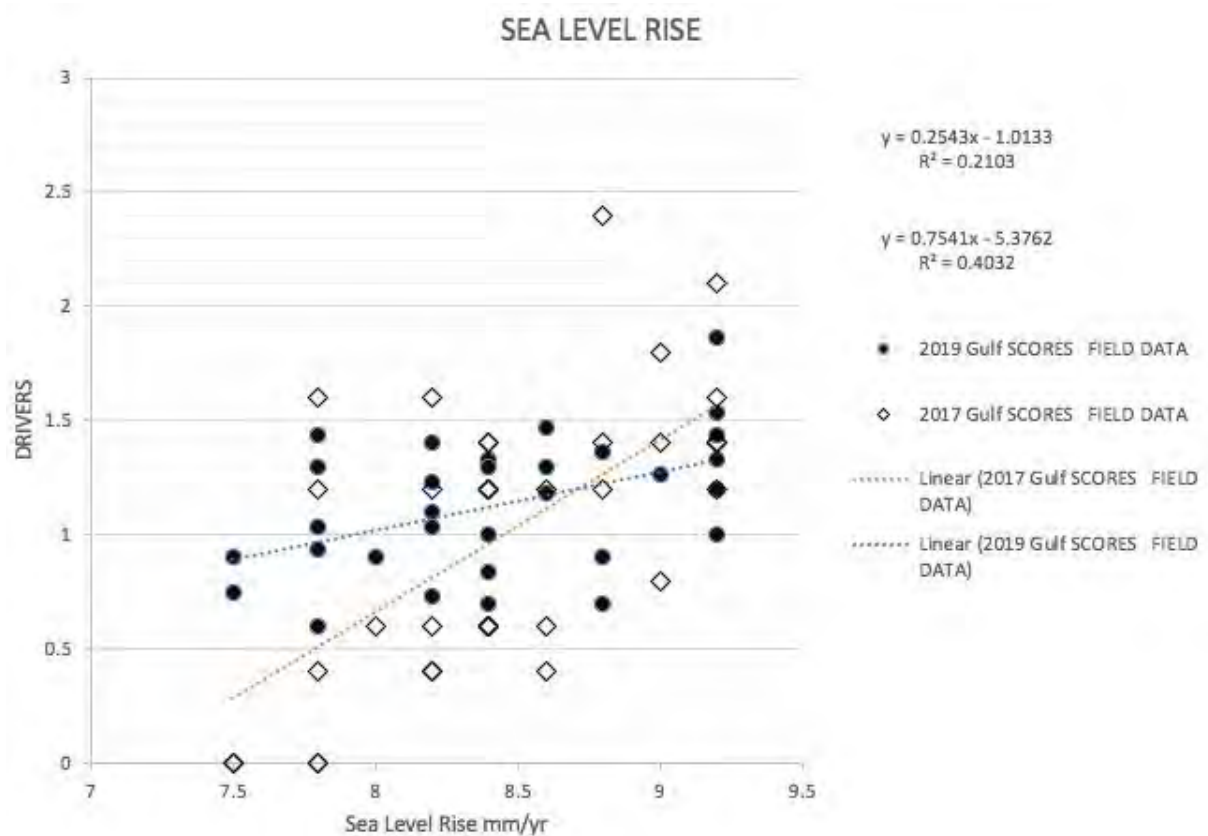
Importantly, a notable positive correlation with sea level rise was the severity of the 2015 mangrove dieback around individual estuaries (Figure 4.4). This relationship suggests that where sea level rises were greatest, the sensitivity of estuarine and shoreline mangroves to sudden drops in sea level would also be greater. Therefore, in places generally where the resilience of mangroves was appreciably weakened, then any additional event, like the sudden drop in sea level has resulted in greater damage. This may be difficult to quantify and evaluate further, but these results do suggest that the poorer condition of shoreline trees curbs their ability to respond to higher rates of sea level rise. And, this would reduce their ability to re-locate upland. This poses a serious threat to the longer-term survival of tidal wetlands faced with rapidly rising sea levels.

Figure 4.4. Plot of 2015 mangrove dieback (driver) and sea level rise (Church et al., 2009; Hobday & Lough, 2011) showing a significant relationship in 2017 estuary severity scores (Table 4.3). Scored with surveys in 2017 and 2019 for the 31–37 estuarine mouth sites.

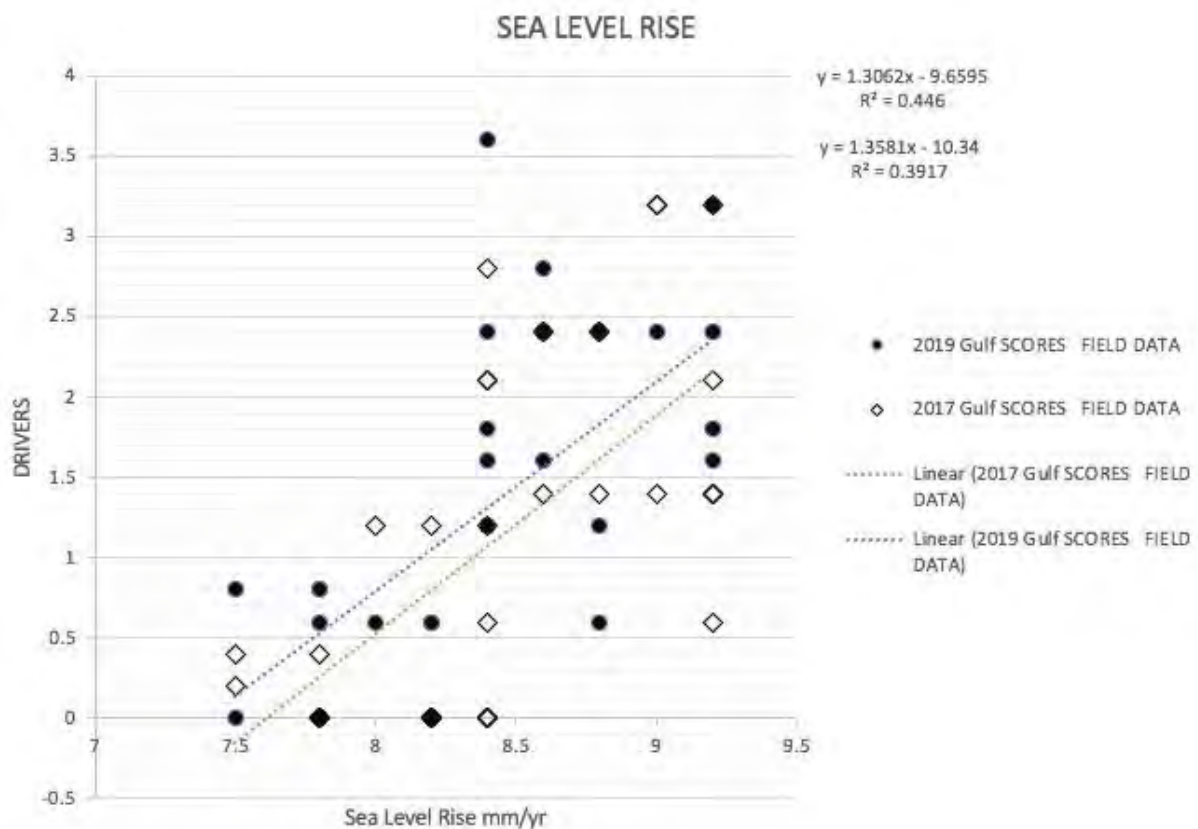
Other indicator severity scores for the 31–37 estuaries and six region groupings also had significant positive correlations with rising sea levels, notably terrestrial retreat, and saltpan scouring (Table 4.3, Figure 4.5). While no such correlation was found between sea level rise and shoreline erosion, this was consistent with the observation of other more random factors directly impacting sea edge stands, such as the harsh localised weather conditions associated with severe tropical cyclones and flooding events. This suggests that the impacts on upland mangrove and saltmarsh-saltpan zones were largely due to rising sea levels.

Figure 4.5. Plot of 2015 terrestrial retreat (driver) and sea level rise (Church et al., 2009; Hobday & Lough, 2011) showing significant relationships in 2017 and 2019 estuary severity scores (Table 4.3). Scored with surveys in 2017 and 2019 for the 31–37 estuarine mouth sites.

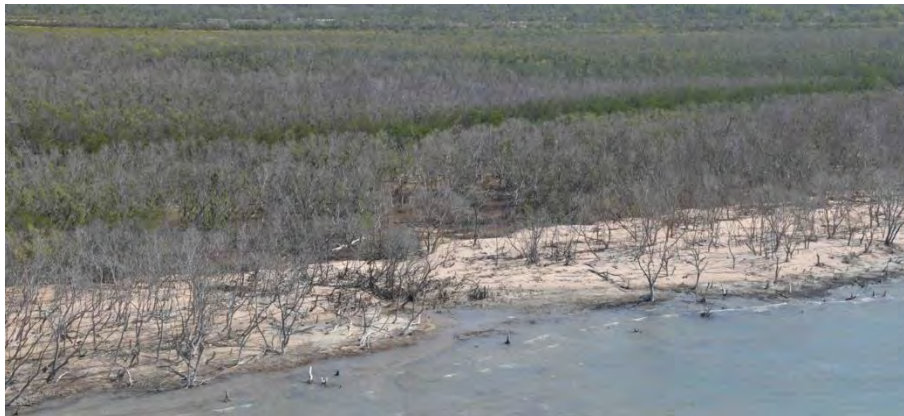
*Figure 4.6. Exposed shoreline mangroves were uprooted, and those further inshore were mostly fatally stripped of foliage by Category 4 Tropical Cyclone Trevor in February 2019.*

It was significant for this investigation that two severe cyclones occurred between the 2017 and 2019 aerial surveys, including TC Owen (Category 3) affecting the area west of the Limmen estuary and shoreline in December 2018, and TC Trevor (Category 4) affecting the Robinson, Calvert and Wearyan estuaries in March 2019 (Figure 4.6). The collective impact of these storms caused severe damage to around 600 km of Gulf shoreline. The types of damage ranged from shoreline erosion and retreat, sediment wash root burial dieback, wrack piles of 2015 dieback and scour, large patches of fallen and broken stems, and defoliation of canopy leaving estuary edge exposed trees intact.

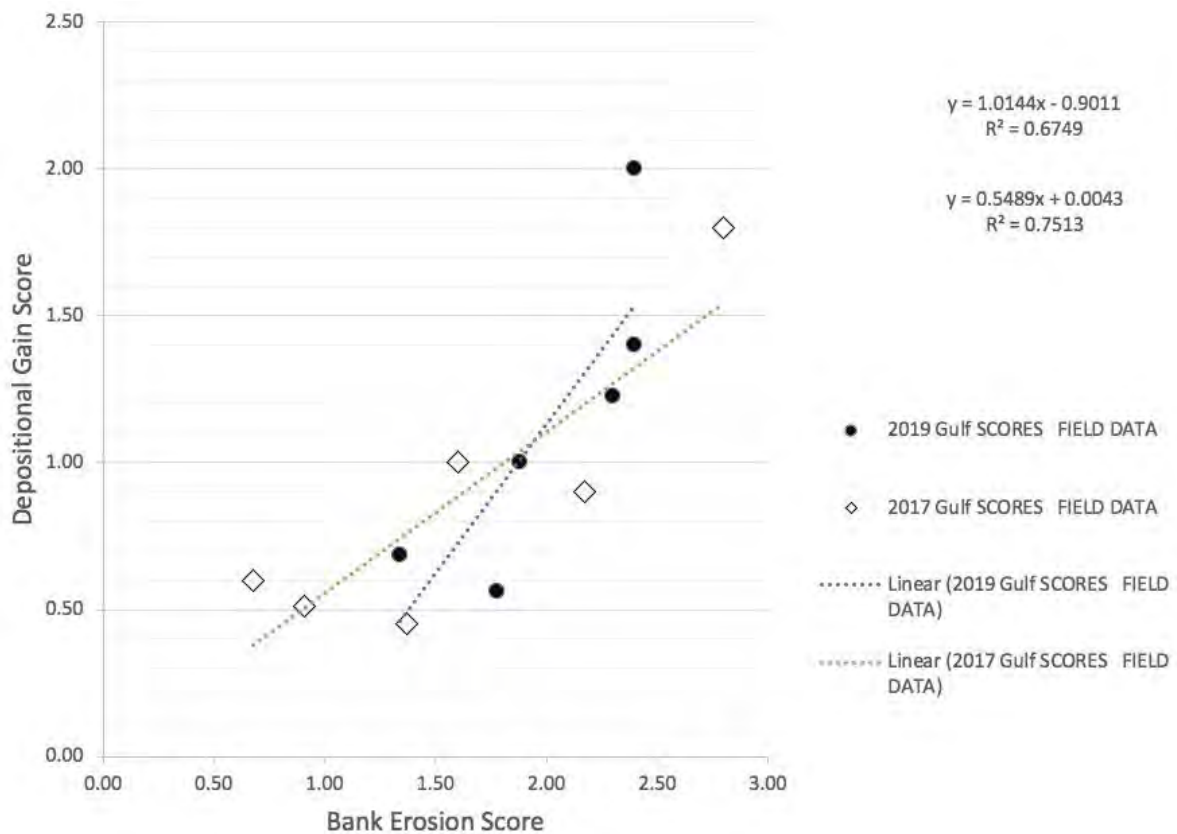
Figure 4.7. Plot comparing bank erosion and depositional gain with a relationship implying a link with flooding impacts as bank scouring and sediment relocated leads to the emergence of depositional banks and their colonisation by mangrove seedlings and saplings.

The observations made during this project document both the 2015 mass dieback of mangroves along Gulf shorelines, as well as a number of subsequent accumulative damaging events of severe cyclones and flooding up to 2019. This assessment identified a significant positive relationship between the severity of bank erosion and depositional gain (Figure 4.7).

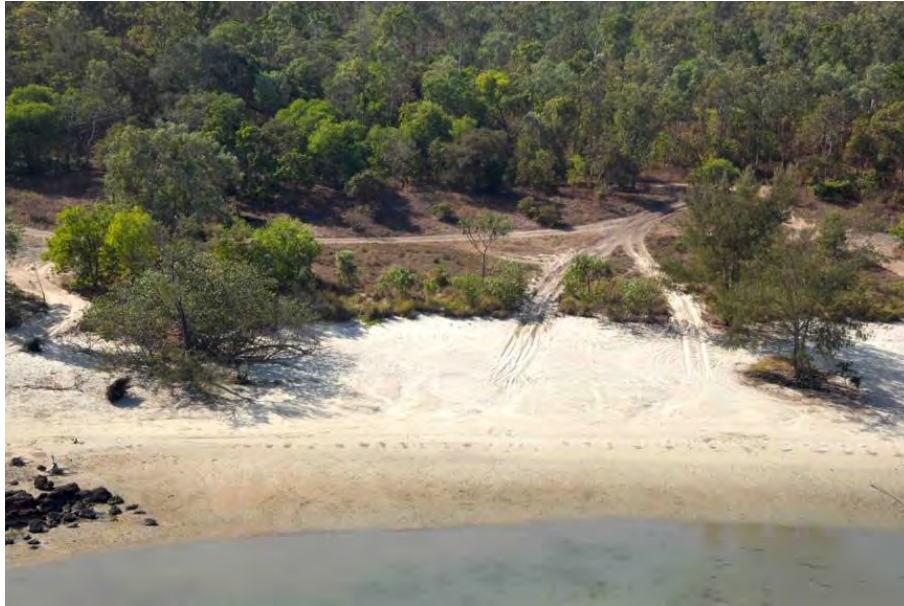
Figure 5.6. Damage from access tracks, a notable issue for the Mission River estuary.

The location is shown in Figure 5.7 and observed issues listed in Figure 5.6 and Table 5.4.

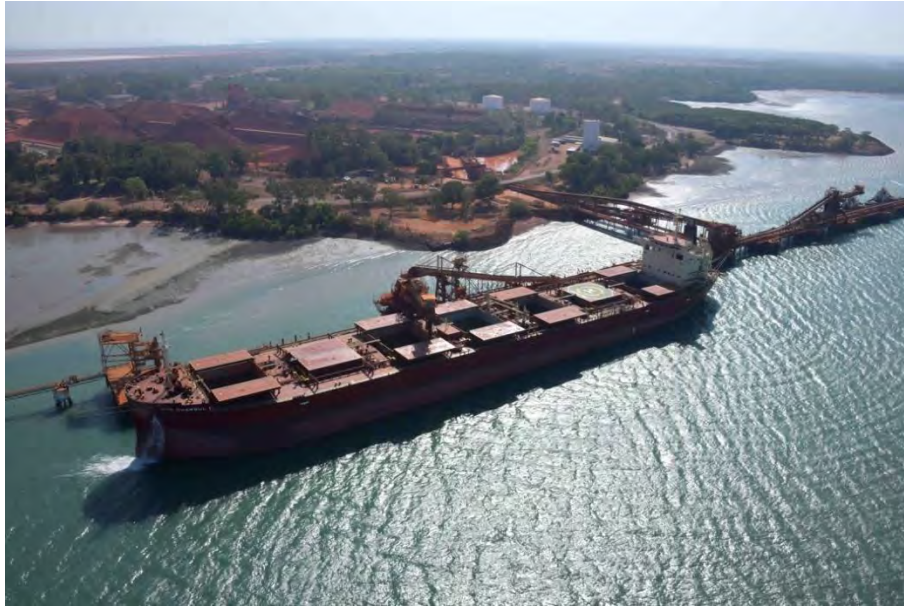
Figure 5.9. Shoreline modification, a notable issue for the Embley estuary.

The location is shown in Figure 5.10 and observed issues listed in Figure 5.9 and Table 5.6.

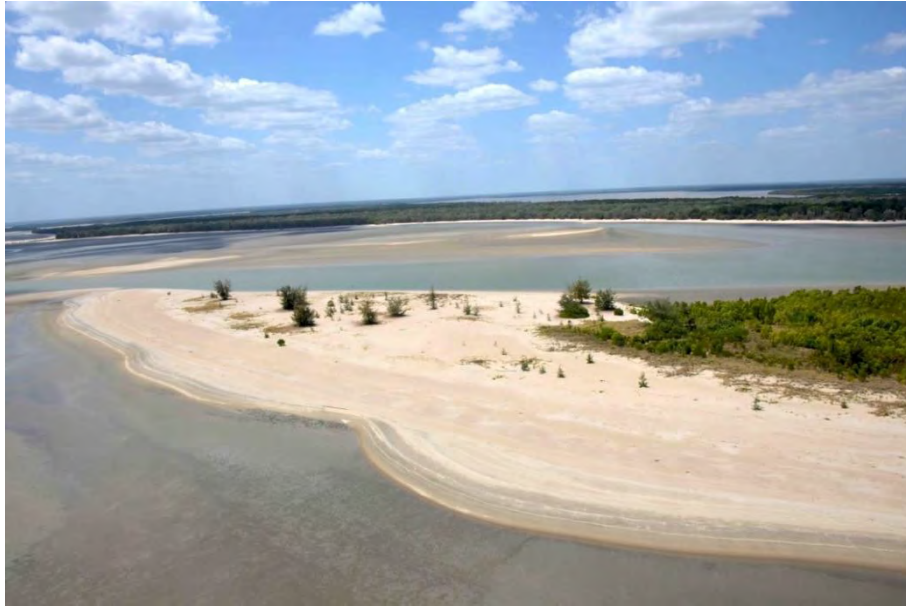
Figure 5.12. Shoreline changes at the mouth, a notable issue for the Watson River estuary.

The location is shown in Figure 5.13 and observed issues listed in Figure 5.12 and Table 5.8.

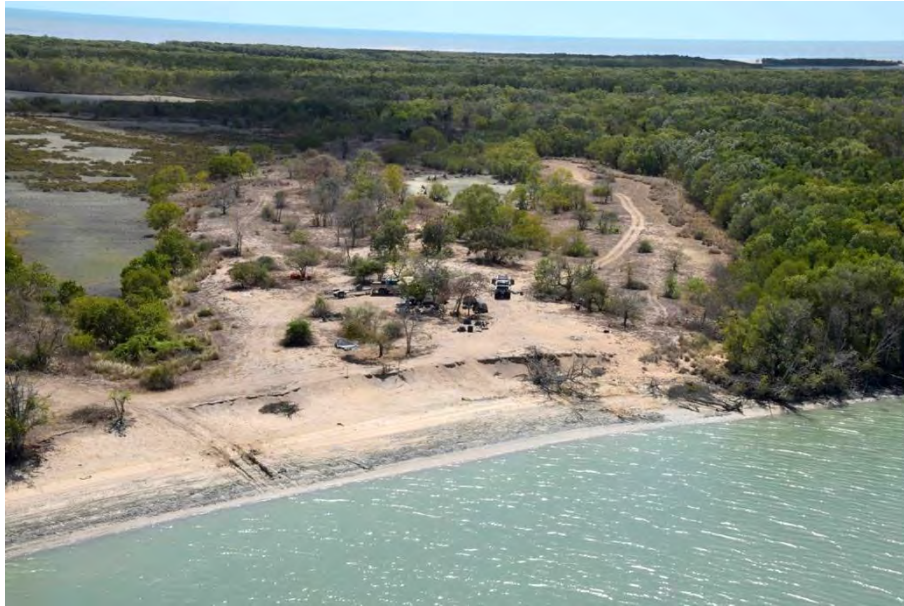
Figure 5.15. Damage from access tracks and bank erosion, notable issues in the Holroyd.

The location is shown in Figure 5.16 and observed issues listed in Figure 5.15 and Table 5.10.

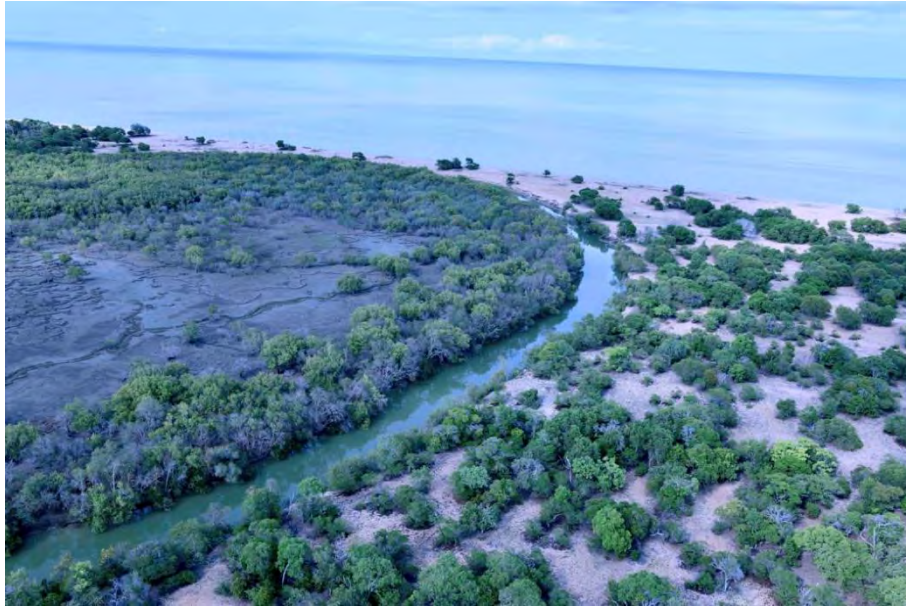
Figure 5.18. Bank erosion and ecotone shift loss is an issue in Christmas Creek estuary.

The location is shown in Figure 5.19 and observed issues listed in Figure 5.18 and Table 5.12.

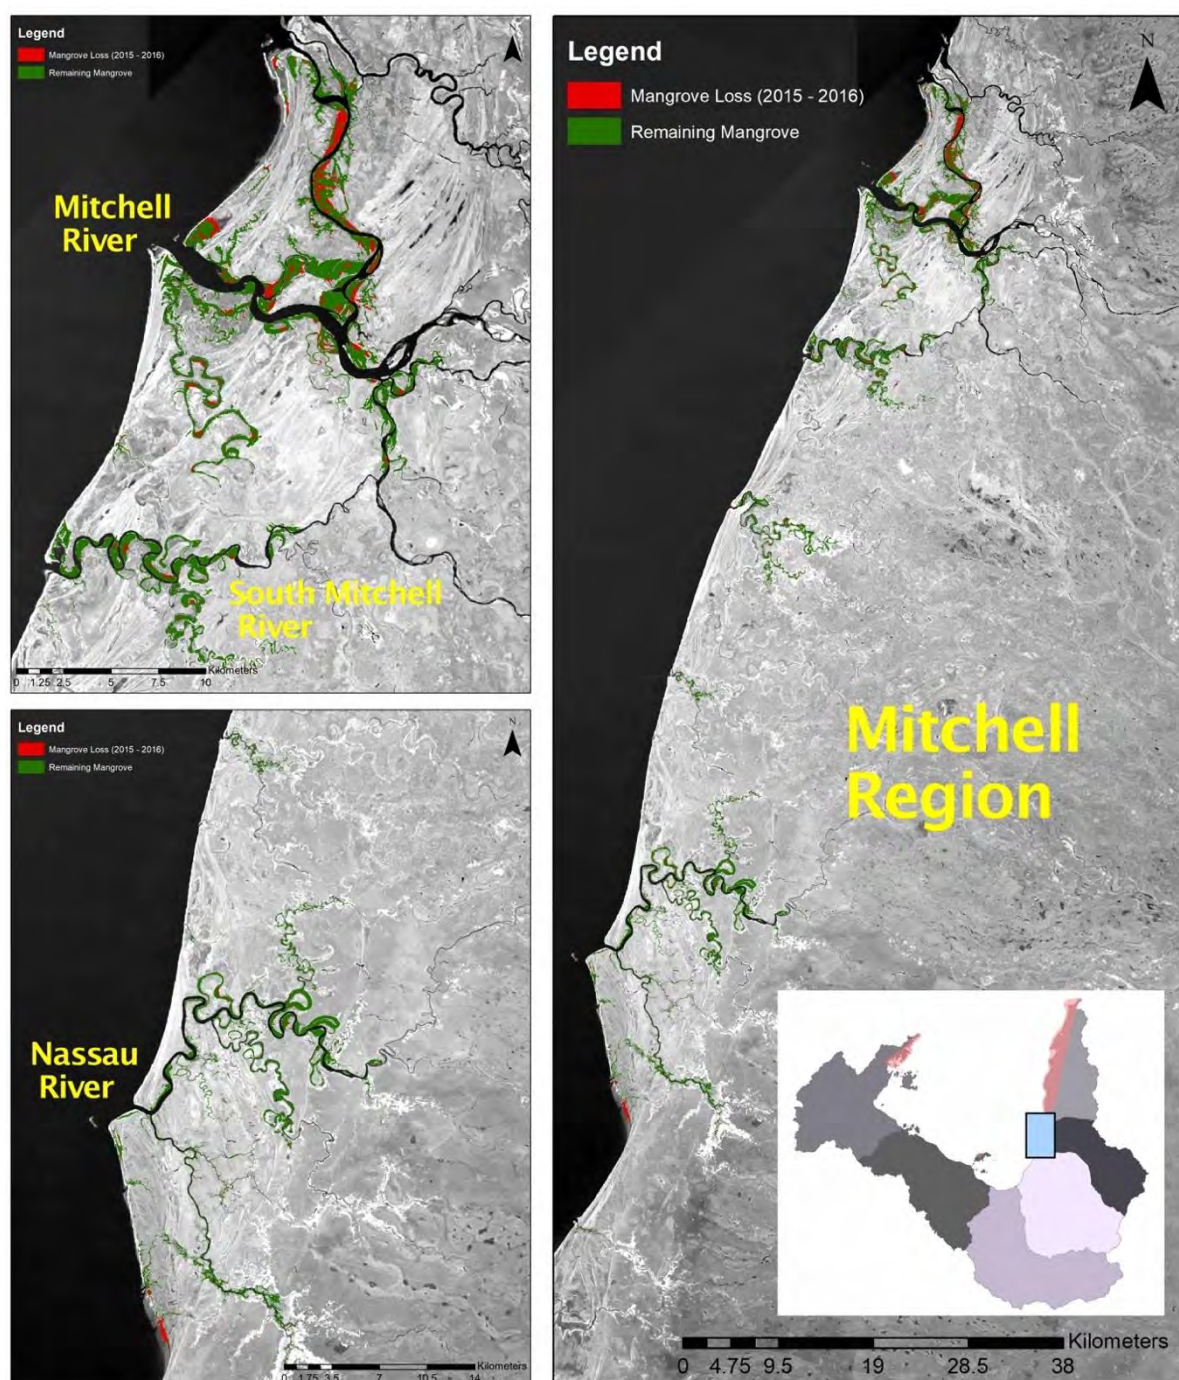
Figure 5.21. Mapped areas of mangrove dieback for the Mitchell region, plus the southern part of the Western Cape region.

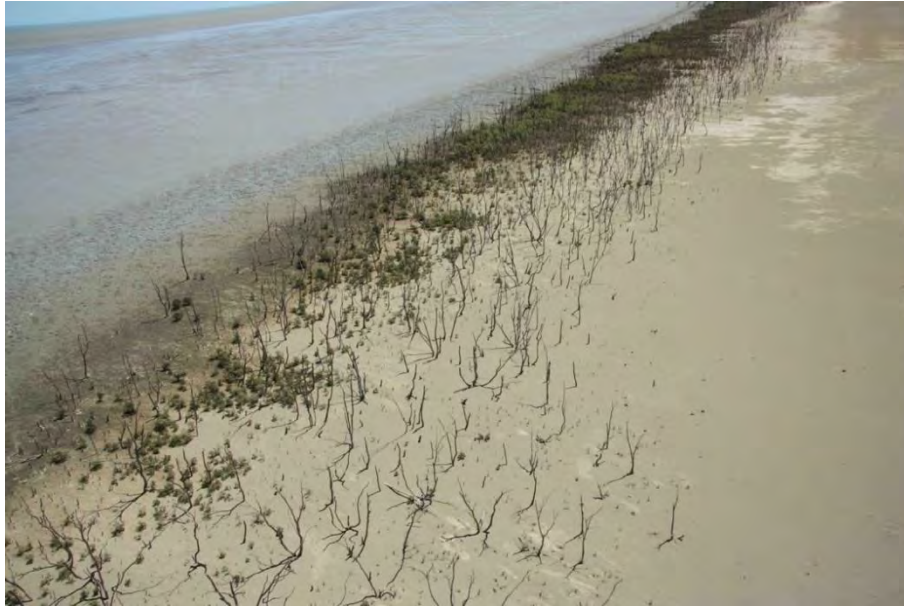
Figure 5.23. Shoreline mangroves severely damaged by the 2015 dieback often have surviving shrubby, low stature plants, like saltmarsh species and the club mangrove *Aegialitis annulata*.

The location is shown in Figure 5.24 and observed issues listed in Figure 5.23 and Table 5.16.

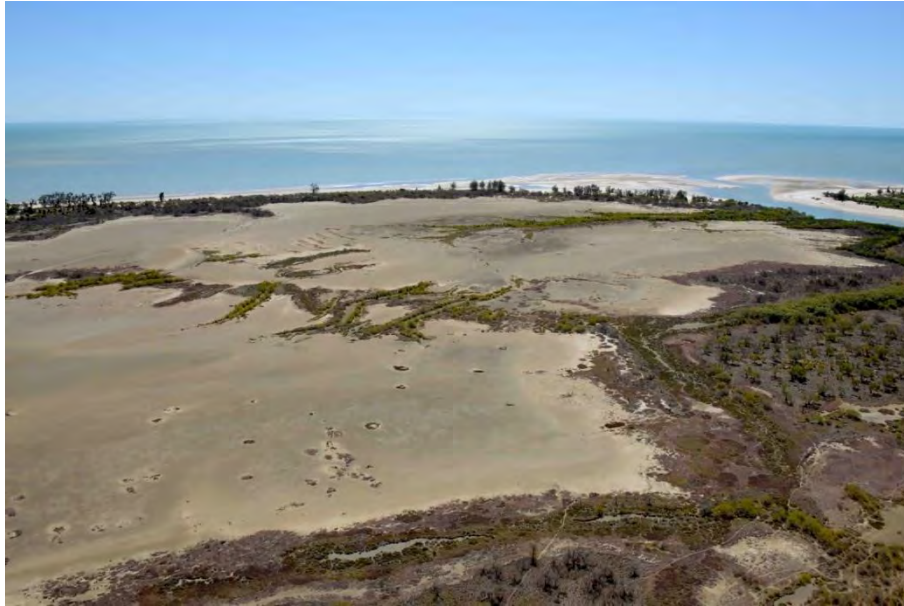
*Figure 5.26. Scouring of salt pans, a notable issue for the South Mitchell estuary.*

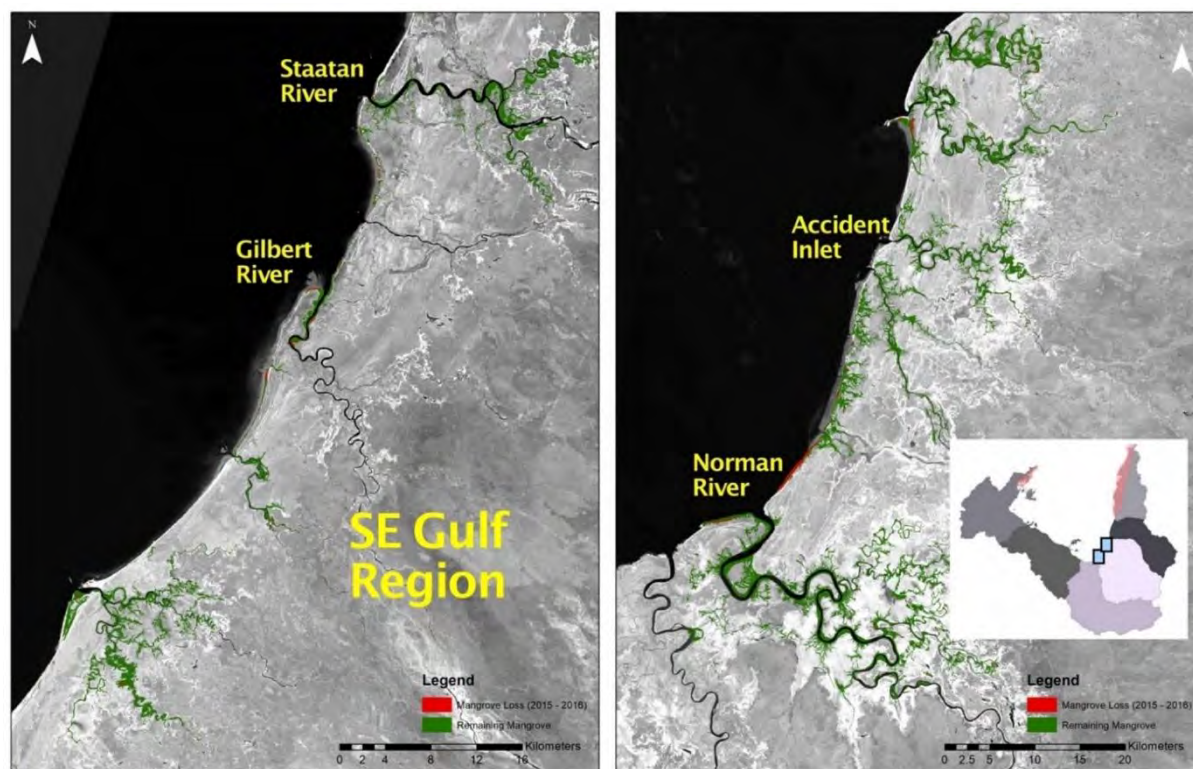
Figure 5.32. Mapped areas of mangrove dieback for the South-East Gulf region.
