# Assessing the Gulf of Carpentaria mangrove dieback 2017–2019

## Volume 1: Aerial surveys

by Norm Duke, Jock Mackenzie,  
John Kovacs, Grant Staben, Rob Coles, Apanie Wood & Ysabel Castle

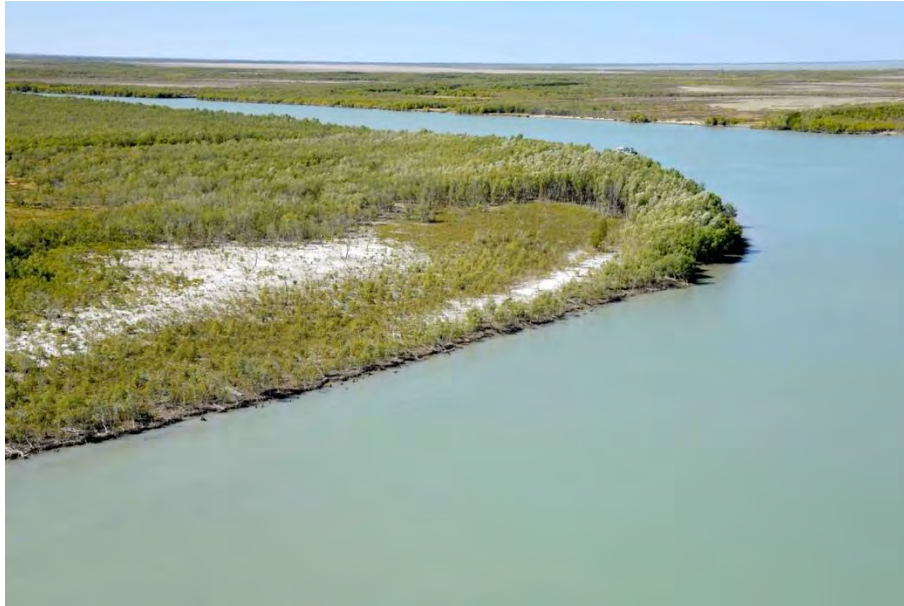
*Figure 5.34. Damage from bank erosion, a notable issue for the Staatan estuary.*

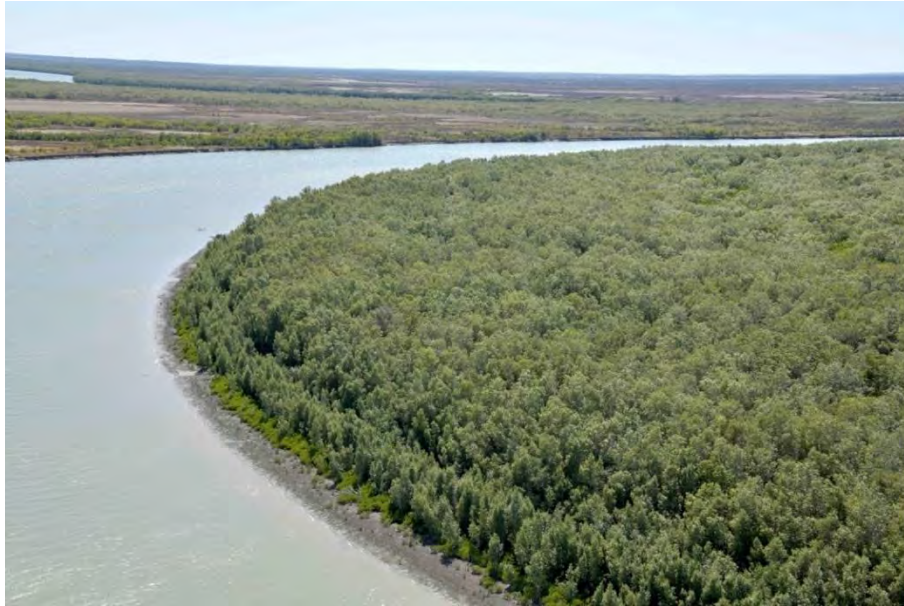
Figure 5.37. Bank erosion and depositional gain, notable issues for the Gilbert estuary.

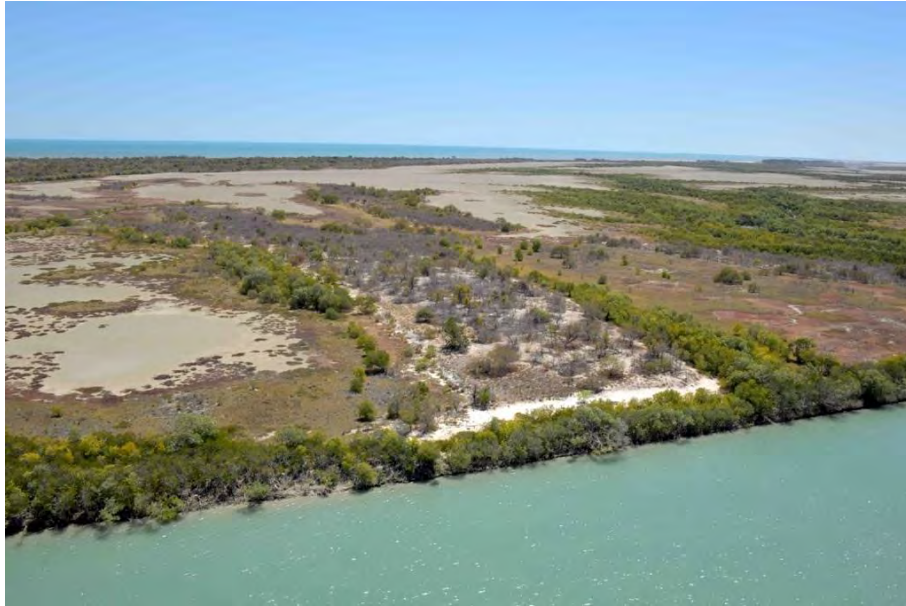
Figure 5.40. Bank erosion, pan scouring and weeds, notable issues for the Accident estuary.

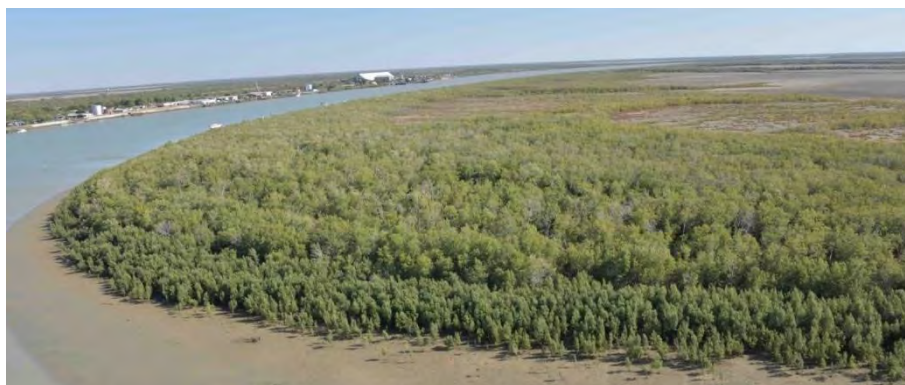
Figure 5.43. Shoreline modification and access tracks, notable issues for the Norman estuary.

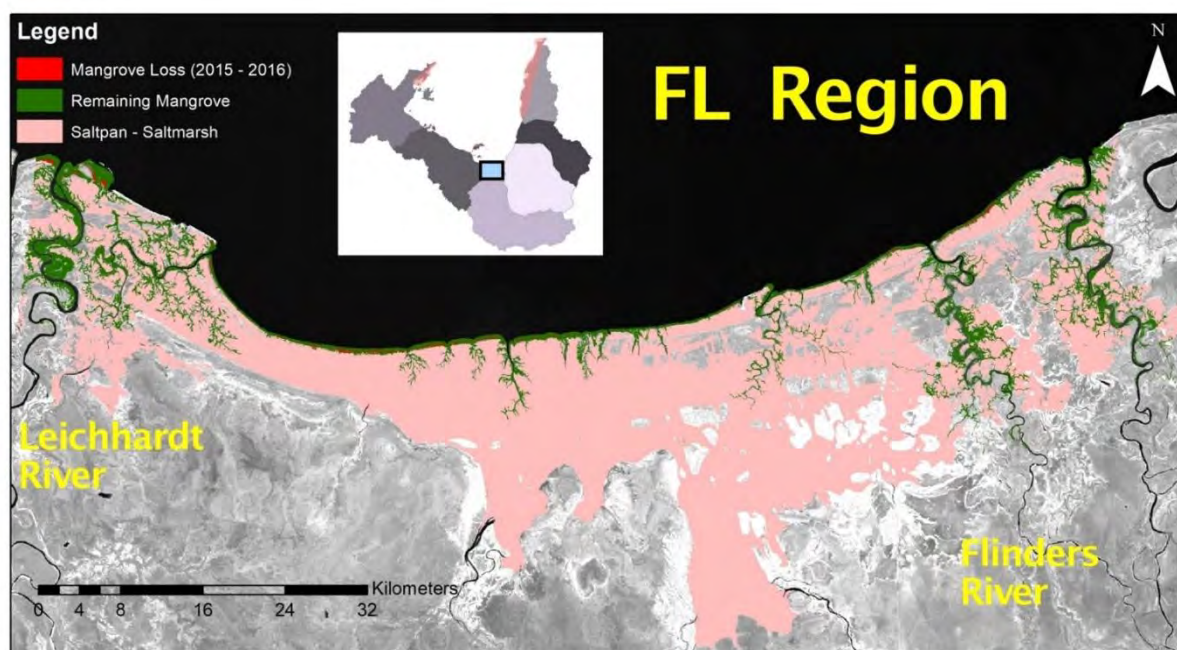
Figure 5.46. Mapped areas of mangrove dieback for the Flinders–Leichhardt Region.

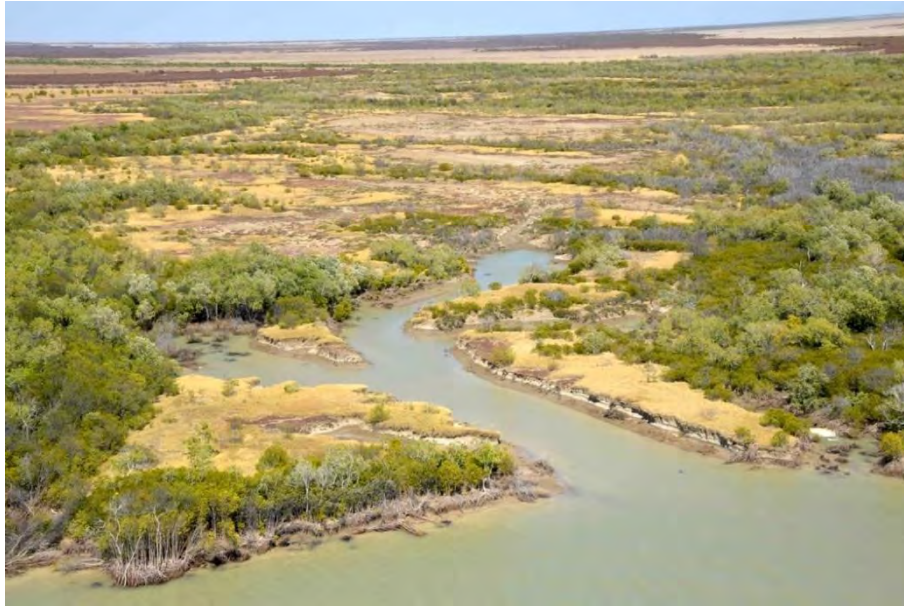
Figure 5.48 Scour damage from recent flooding, a notable issue in the Flinders estuary.

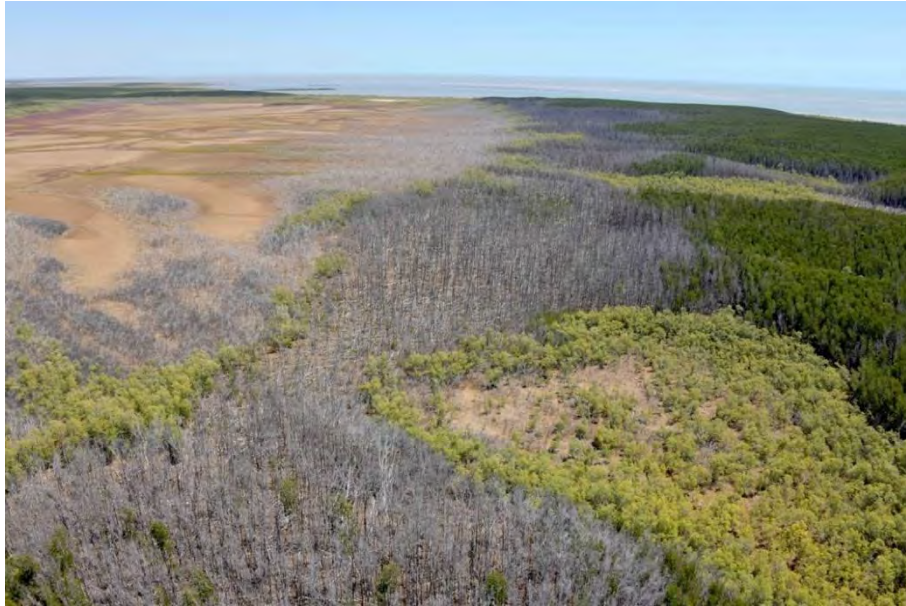
*Figure 5.51. Mangrove dieback from 2015, a notable issue in the Leichhardt estuary.*

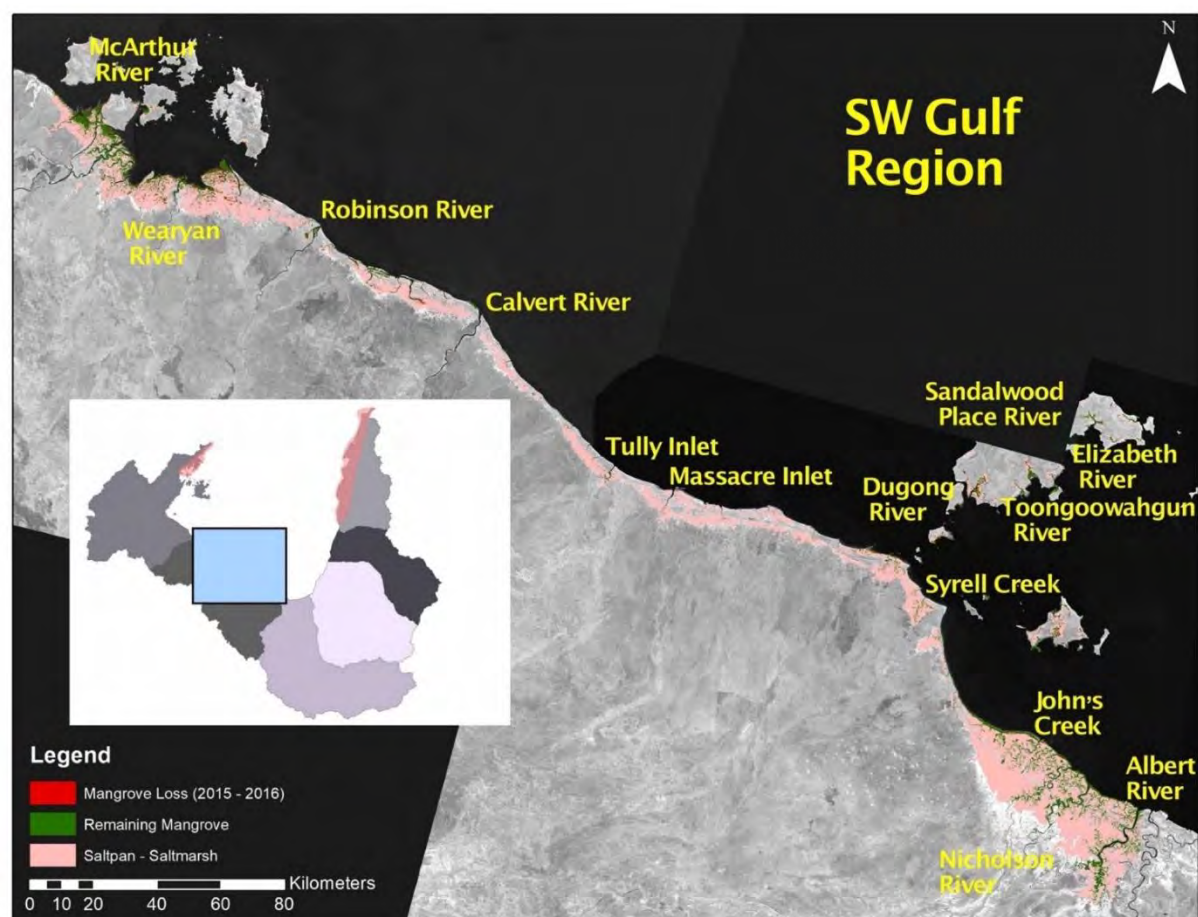
Figure 5.54. Mapped areas of mangrove dieback for the South-West Gulf region.

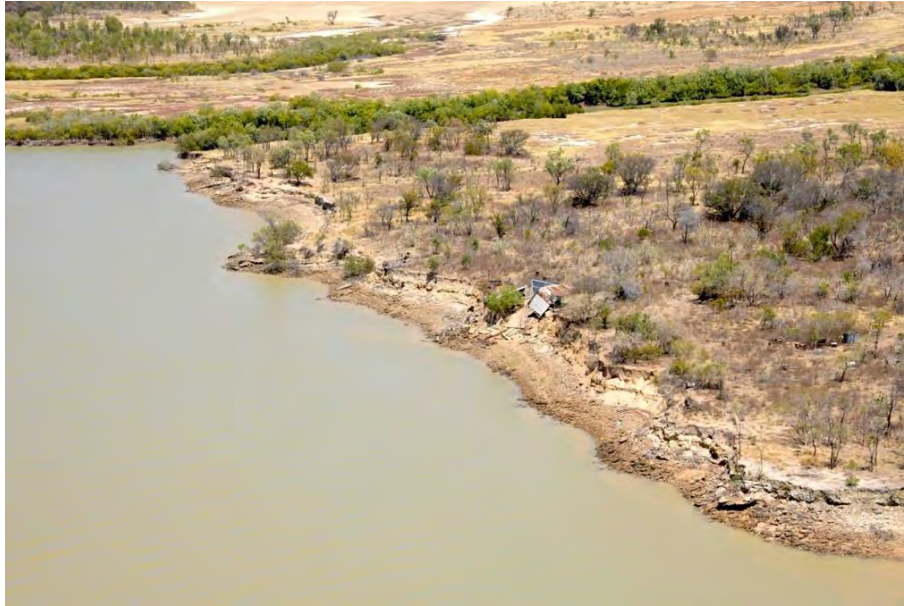
Figure 5.56. Damage from access tracks and bank erosion, notable issues for the Albert.

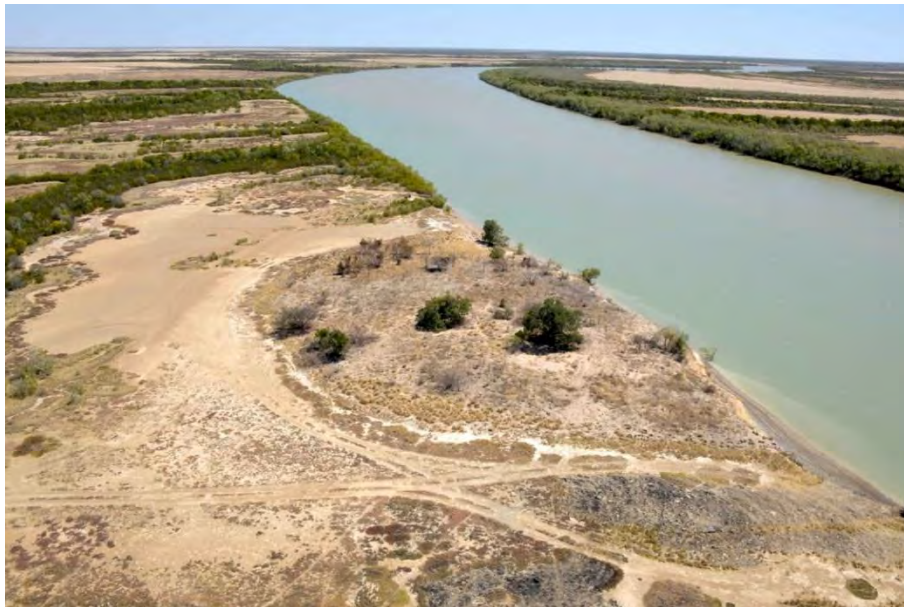
Figure 5.59. Damage from access tracks, a notable issue for the Nicholson estuary.

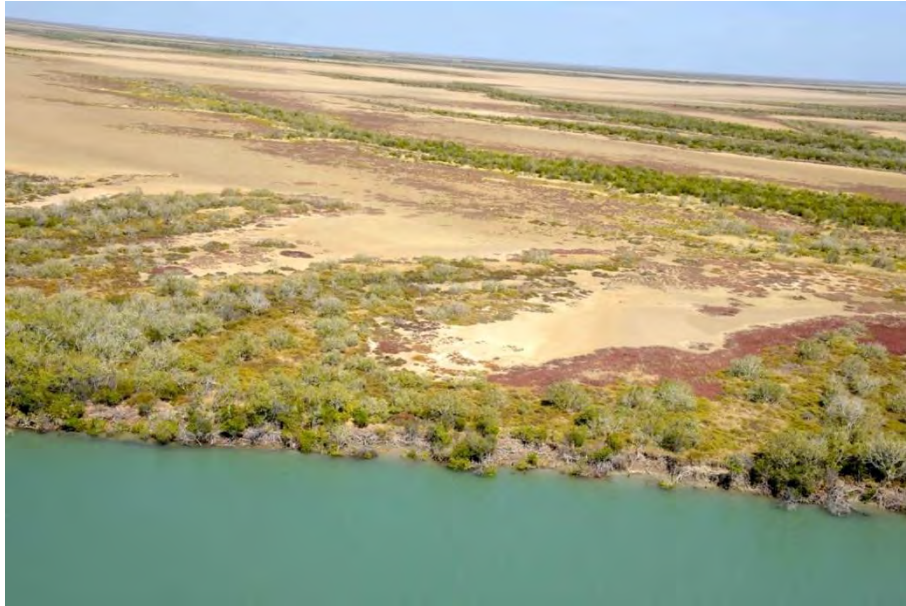
Figure 5.62. Bank erosion, a notable issue for John's estuary.

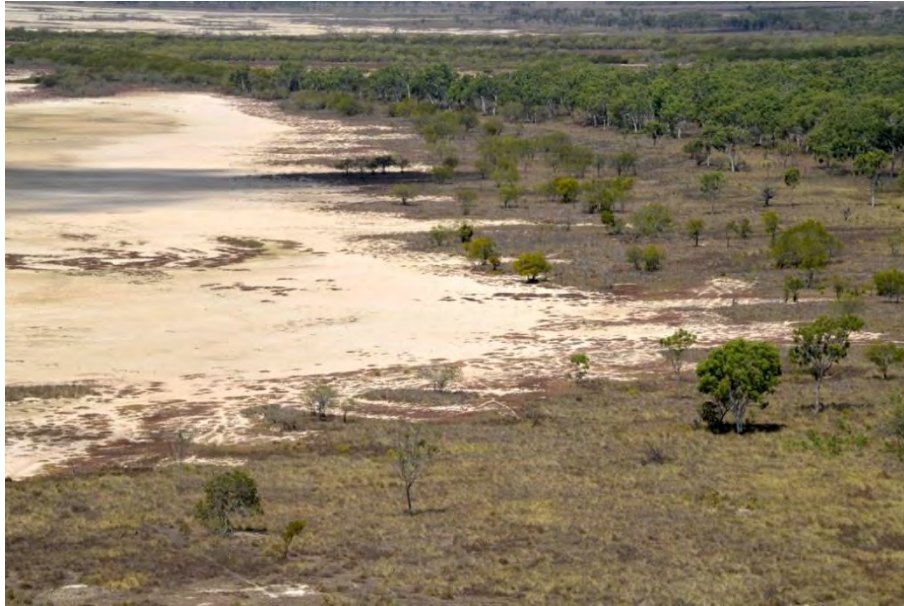
Figure 5.68. Pan scouring and terrestrial retreat, notable issues for the Massacre estuary.

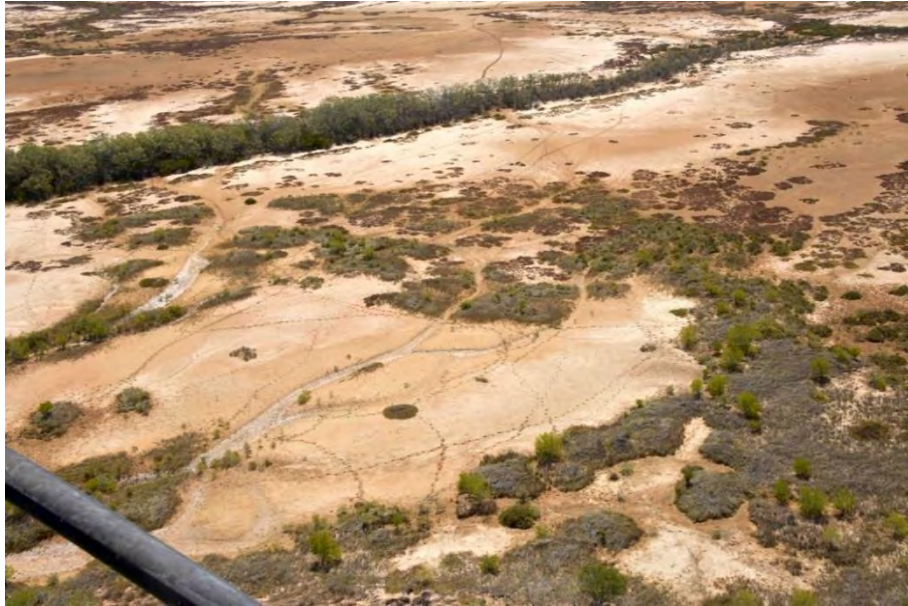
Figure 5.71. Tracks from feral animals and stock, notable issues for the Tully estuary.

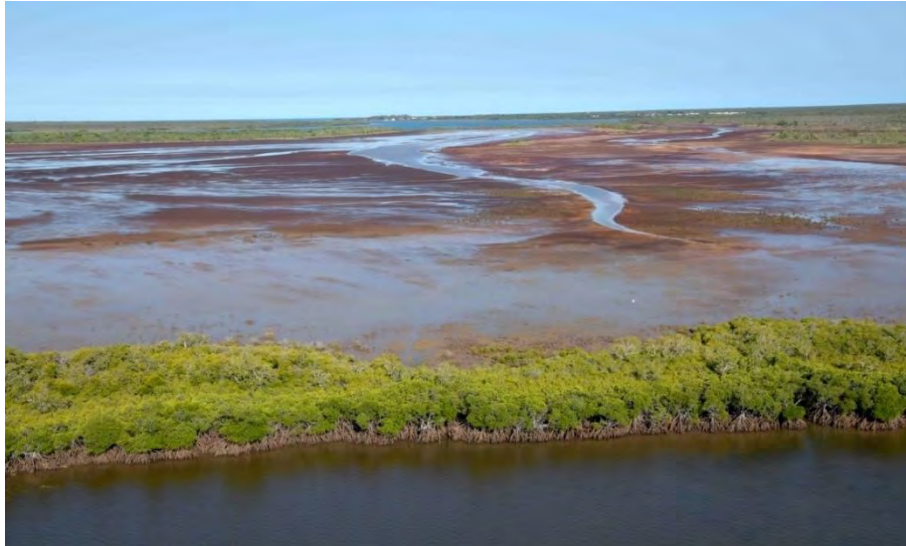
Figure 5.74. Scouring across salt pans, a notable issue for the Dugong estuary.

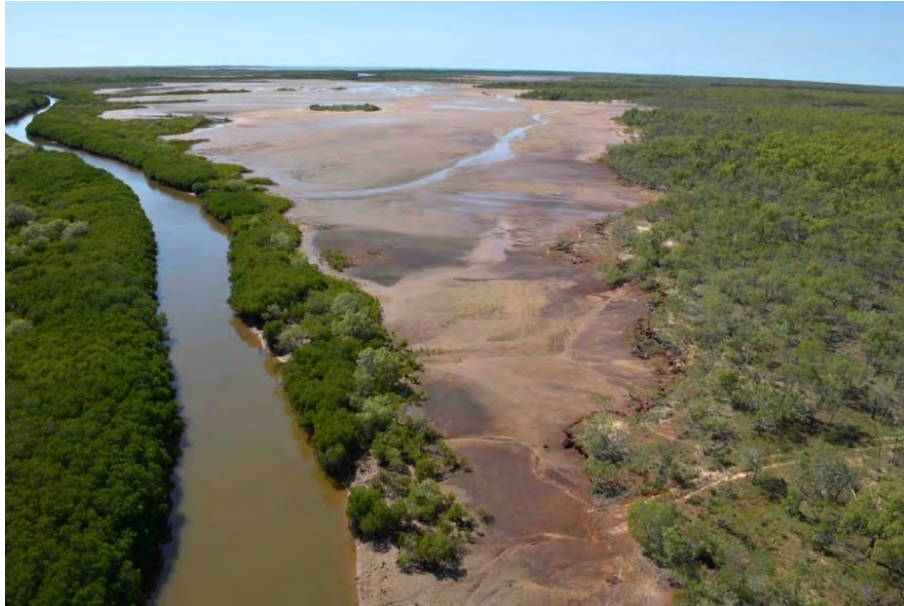
*Figure 5.77. Scouring of salt pans and terrestrial retreat, notable issues for Toongoowahgun.*

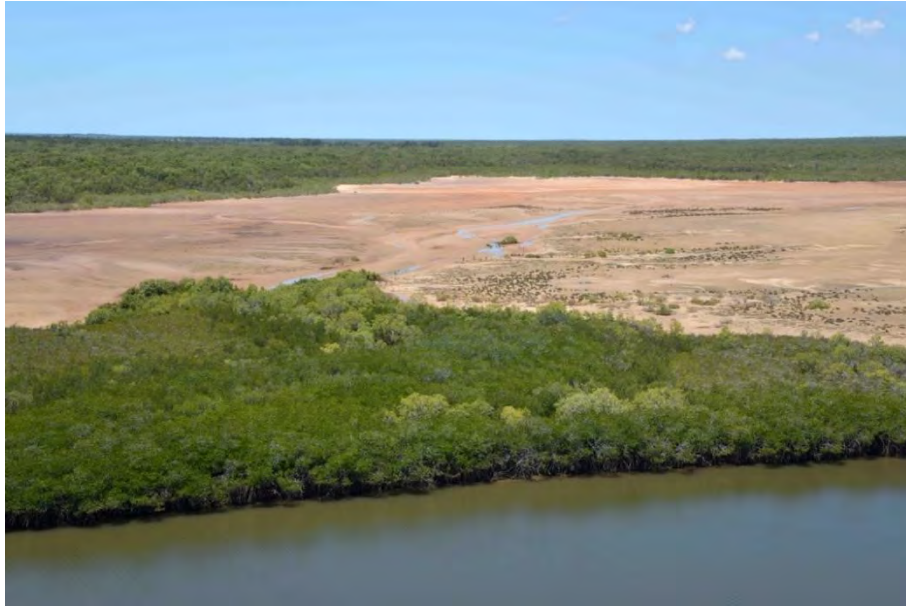
Figure 5.80. Pan scouring and terrestrial retreat, notable issues for the Elizabeth estuary.

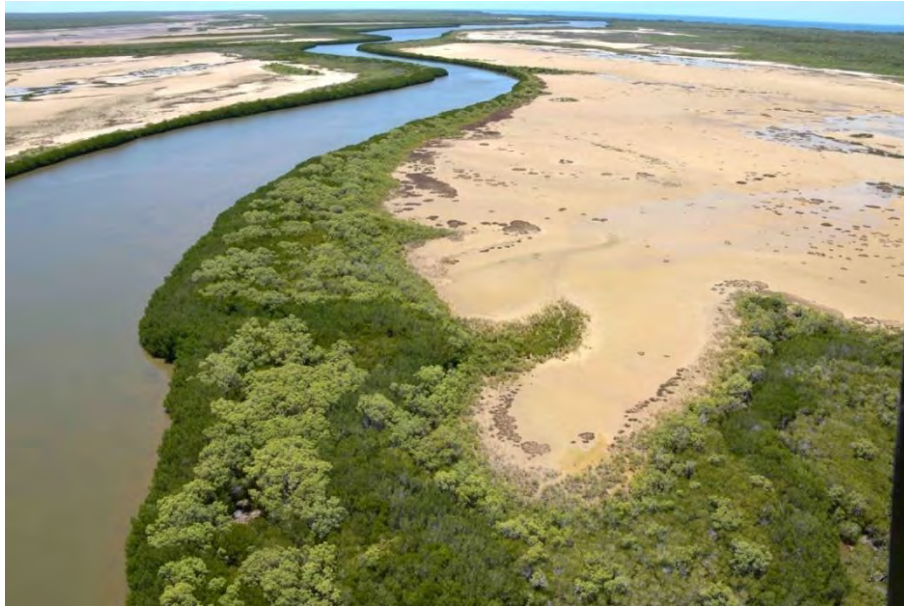
*Figure 5.83. Saltpan scouring, a notable issue in the Sandalwood estuary.*

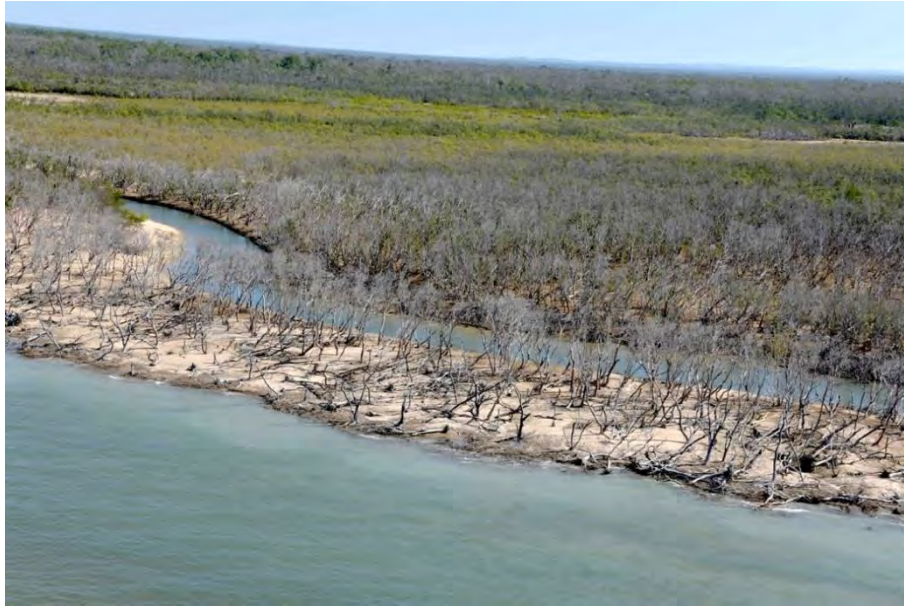
*Figure 5.86. Damage from Cyclone Trevor, a notable issue in the Calvert estuary.*

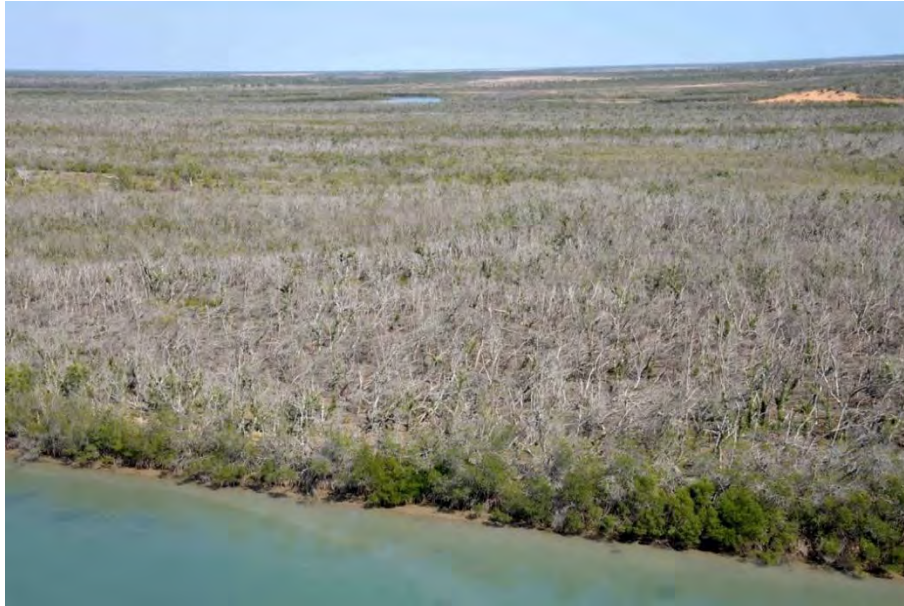
*Figure 5.89. Damage from Cyclone Trevor, a notable issue for the Robinson estuary.*

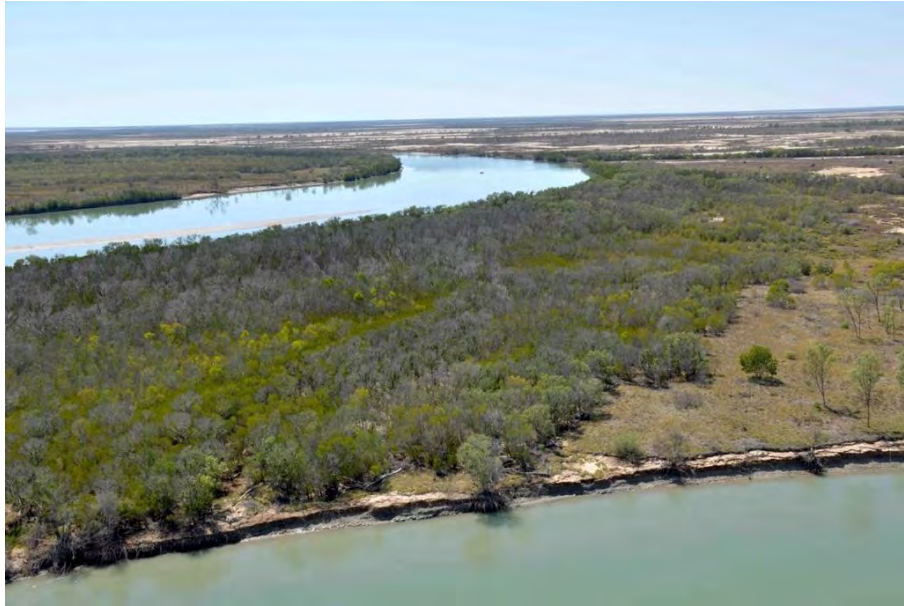
Figure 5.92. Cyclone damage plus bank erosion, notable issues for the Wearyan estuary.

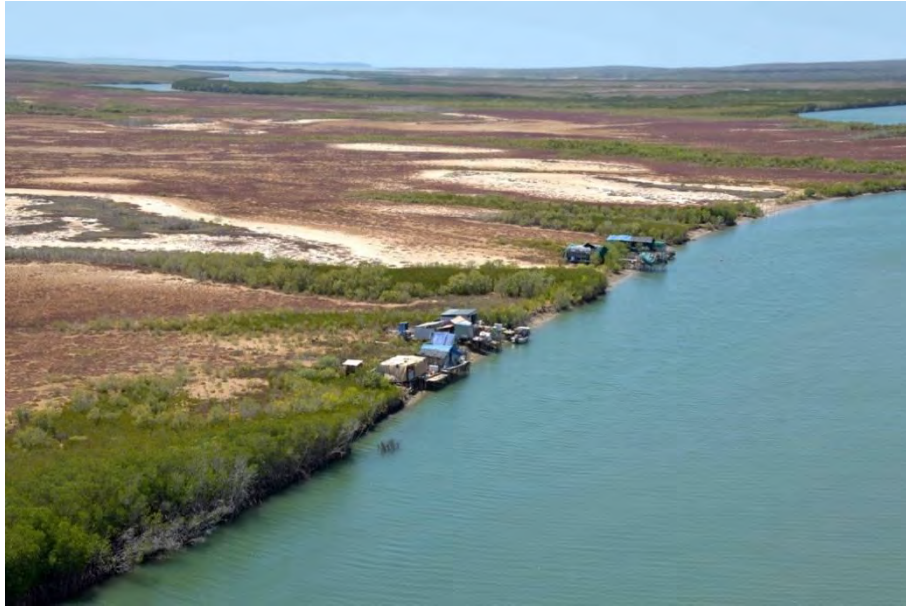
Figure 5.95. Bank erosion and access constructions, notable issues in the McArthur estuary.

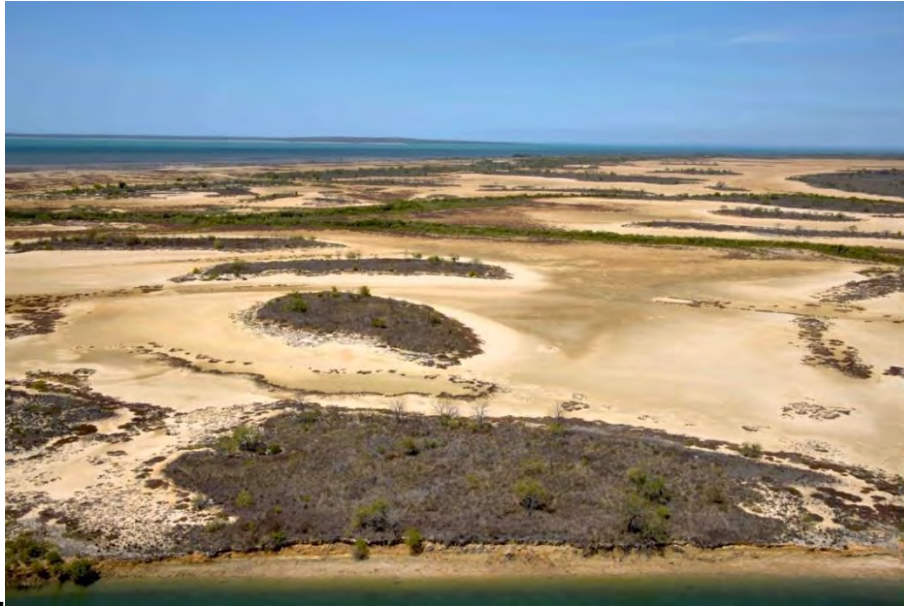
*Figure 5.100. Terrestrial retreat and pan scouring, notable issues for the Mule estuary.*

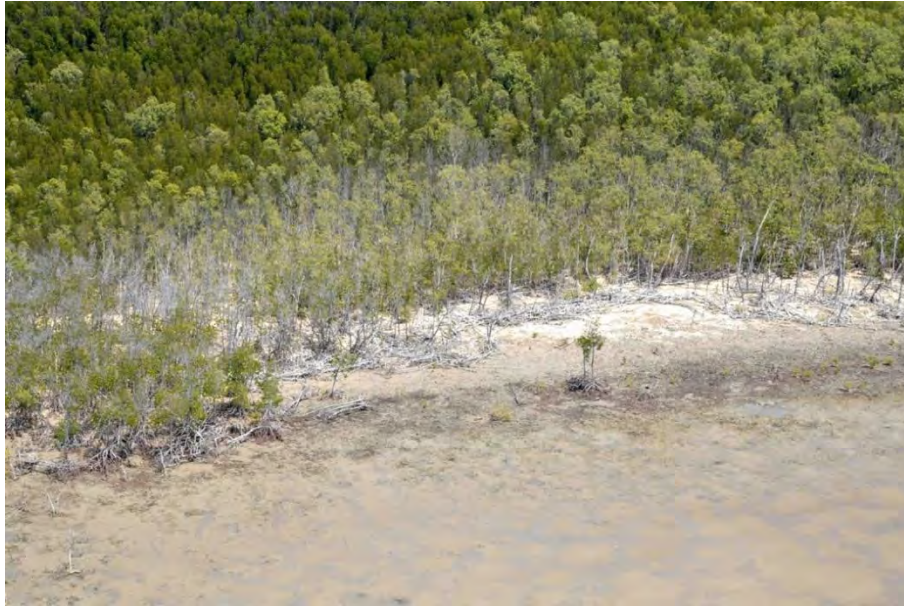
Figure 5.103. Shoreline erosion and retreat, a notable issue for the Limmen estuary.

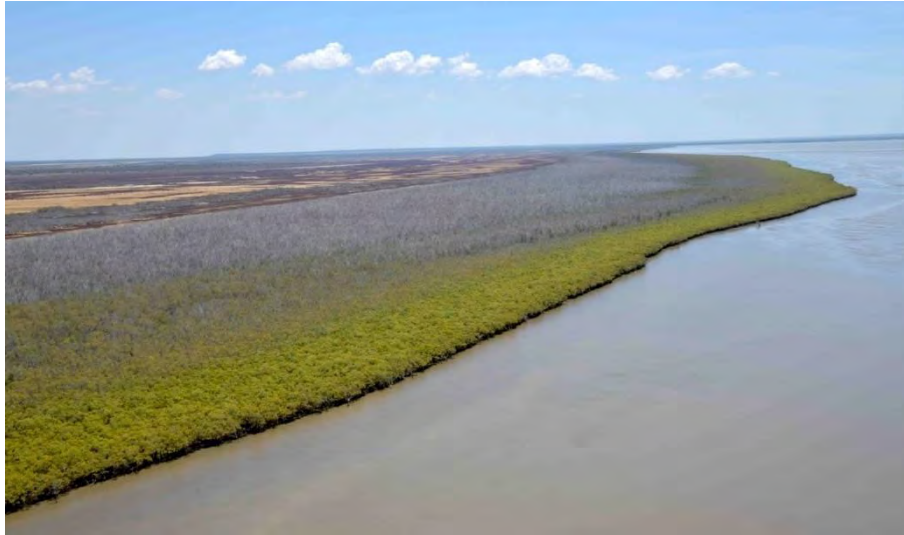
Figure 5.109. Damage from the 2015 mangrove dieback, a notable issue for the Roper estuary.

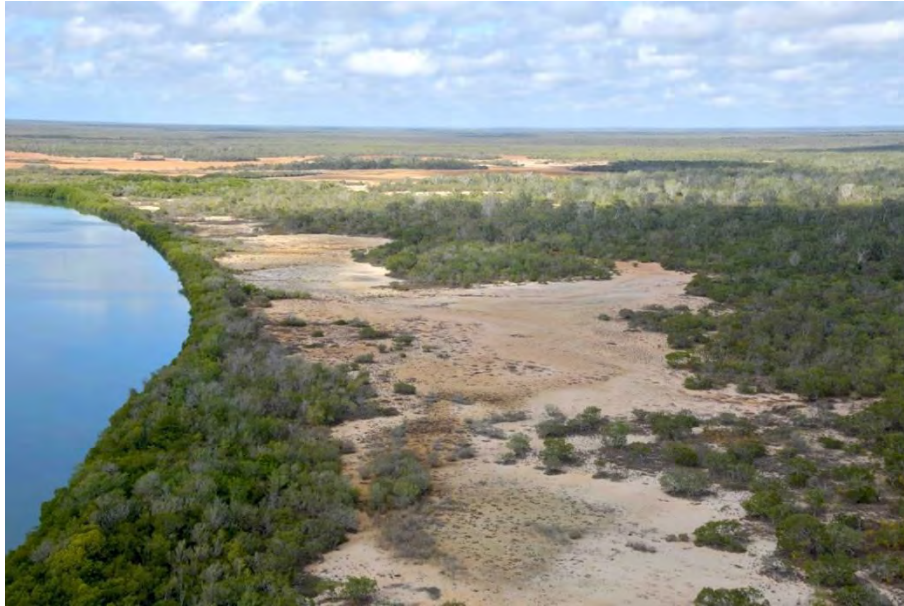
Figure 5.115. Pan scouring and terrestrial retreat, notable issues for the Rose estuary.

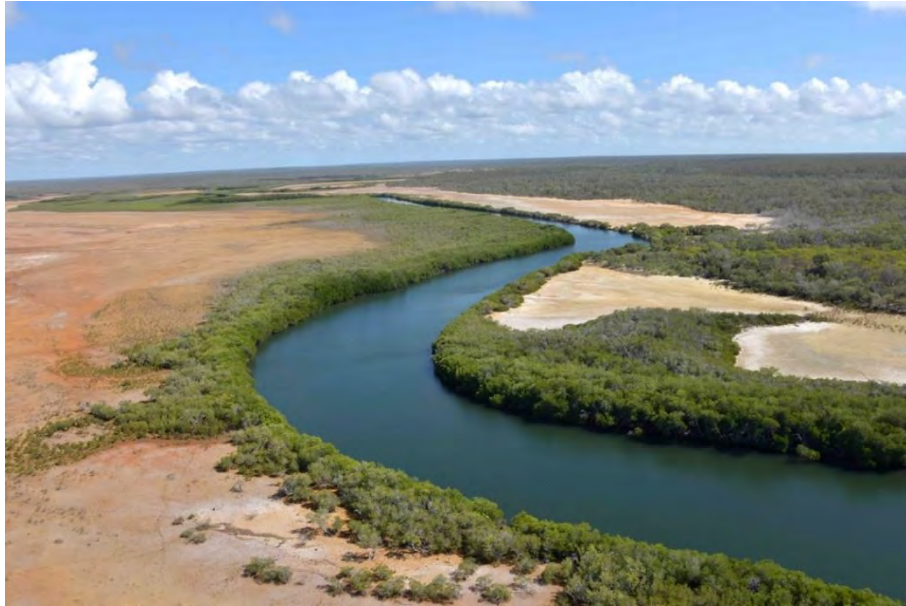
Figure 5.118. Terrestrial retreat and pan scouring, notable issues for the Muntak estuary.

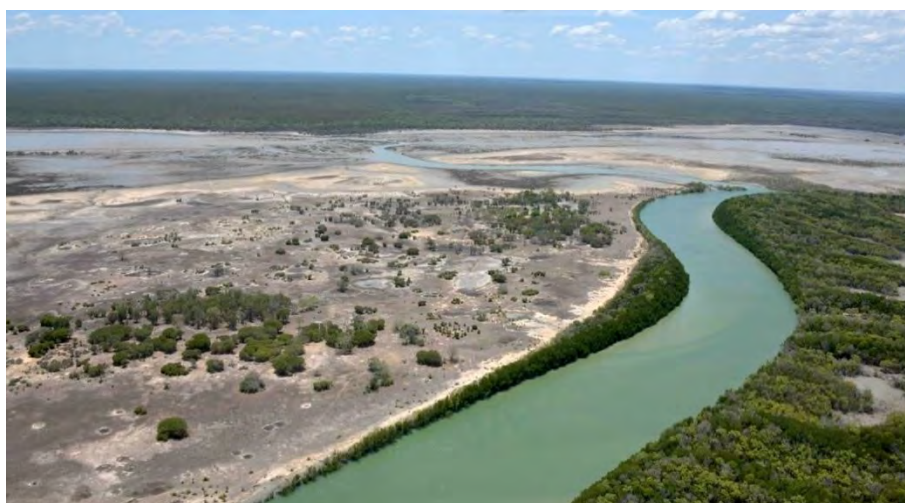
Figure 5.121. Pan scouring and terrestrial retreat, notable issues for the Walker estuary.

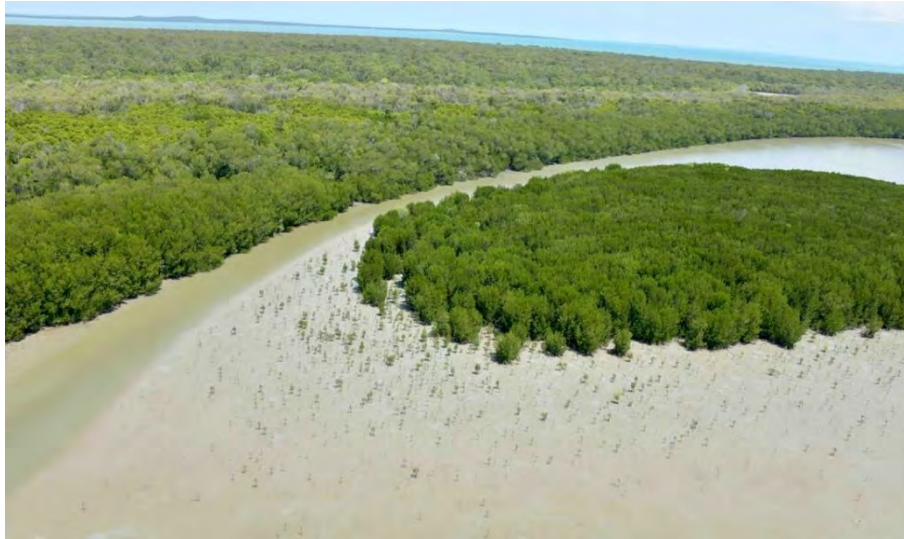
Figure 5.124. Depositional gain at the mouth, a notable issue for the Koolatong estuary.
