Kannan, M. Bobby, and Dietzel, W. (2012) Pitting-induced
hydrogen embrittlement of magnesium–aluminium alloy.
Materials and Design, 42. pp. 321-326.

Pitting-induced hydrogen embrittlement of magnesium-aluminium alloy

ABSTRACT

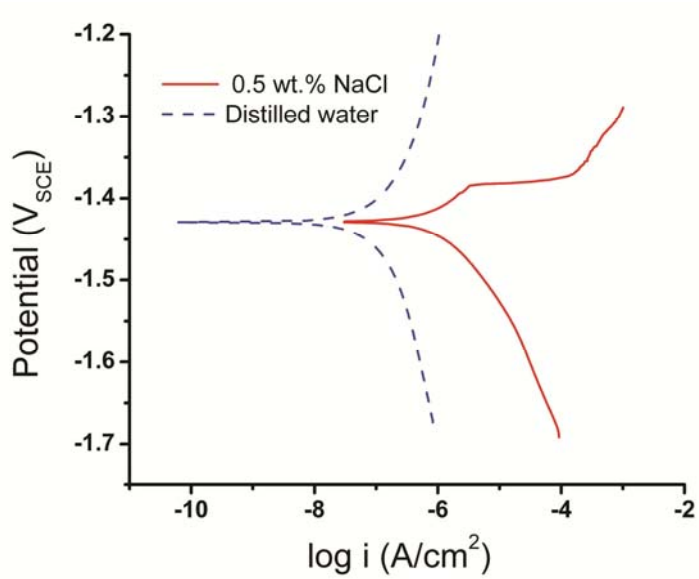
Fig. 3. Potentiodynamic polarisation of AZ80 magnesium alloy in 0.5 wt.% NaCl and in distilled water.

The polarization curve of the alloy obtained in 0.5 wt.% NaCl solution is shown in Fig. 3. The anodic curve of the alloy showed a break-down potential just

50 mV above the corrosion potential (E_{corr}). Generally, an observation of a break-down potential in the anodic curve is related to passive-film breakdown/pitting corrosion of the alloy. In order to confirm this, AZ80 alloy was tested in distilled water. The alloy showed no break-down potential in distilled water (Fig. 3), thereby confirming that the breakdown potential was an indication of the alloy's susceptibility to pitting corrosion in chloride-containing environment. Further, the SEM micrographs of the sample after polarisation in 0.5 wt.% NaCl also showed large pits (Fig. 4a). A higher magnification of the corroded sample revealed a large number of small pits and coalescence of pits (Fig. 4b).

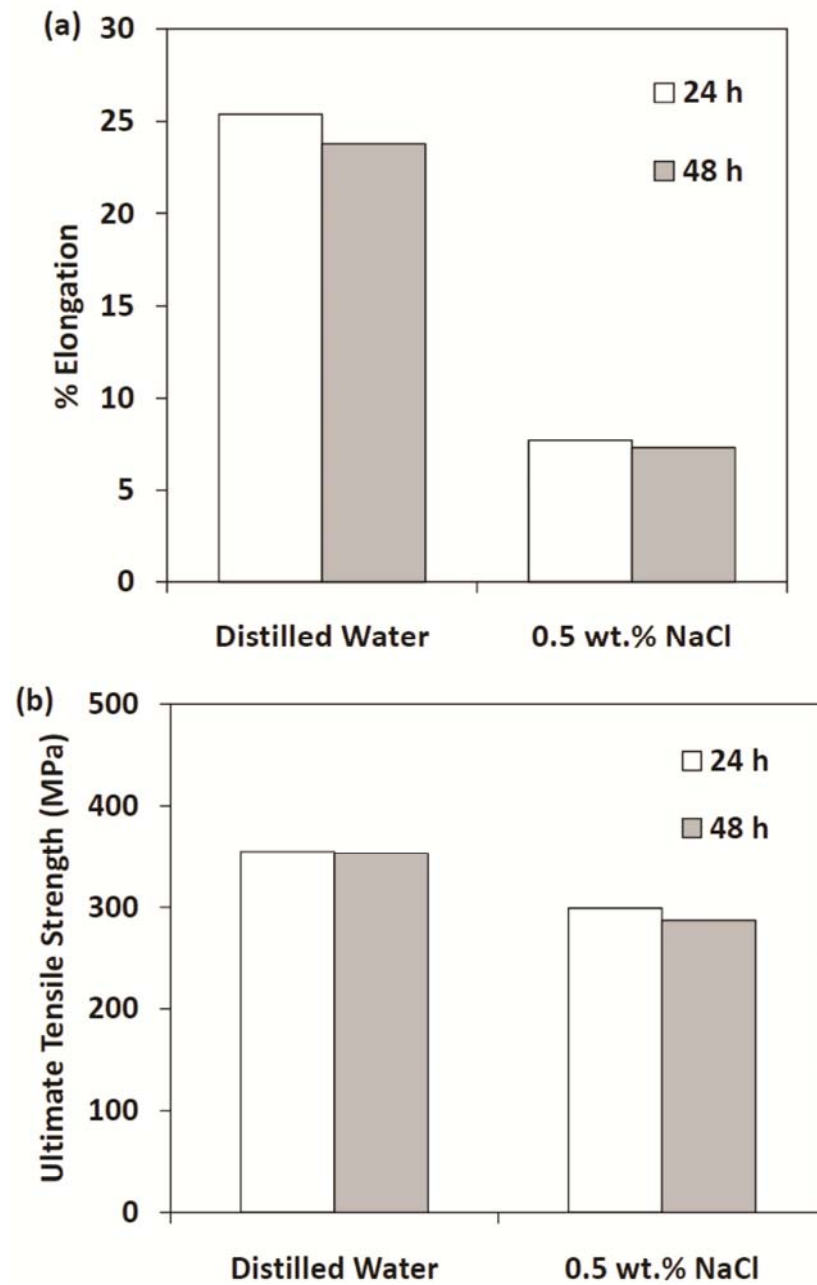
Fig. 6. SSRT data of AZ80 alloy pre-exposed to different environments for two different period of time: (a) % Elongation and (b) Ultimate tensile strength.

The SSRT data of AZ80 alloy tested in air after pre-exposure to distilled water and in 0.5 wt.-% NaCl for 24 hours period is shown in Fig. 6. The alloy pre-exposed to distilled water did not show any noticeable difference in the mechanical properties from that of the air tested samples; accordingly, the pre-exposed alloy exhibited: $\epsilon_f = 25$ % and UTS = 355 MPa. However, the alloy pre-exposure to 0.5wt.% NaCl solution showed a drastic loss in the mechanical properties. Thus, the alloy pre-exposed to 0.5wt.% NaCl solution exhibited: $\epsilon_f = 8$ % and UTS = 300 MPa. In order to see whether there was any influence of increasing pre-exposure period, the samples

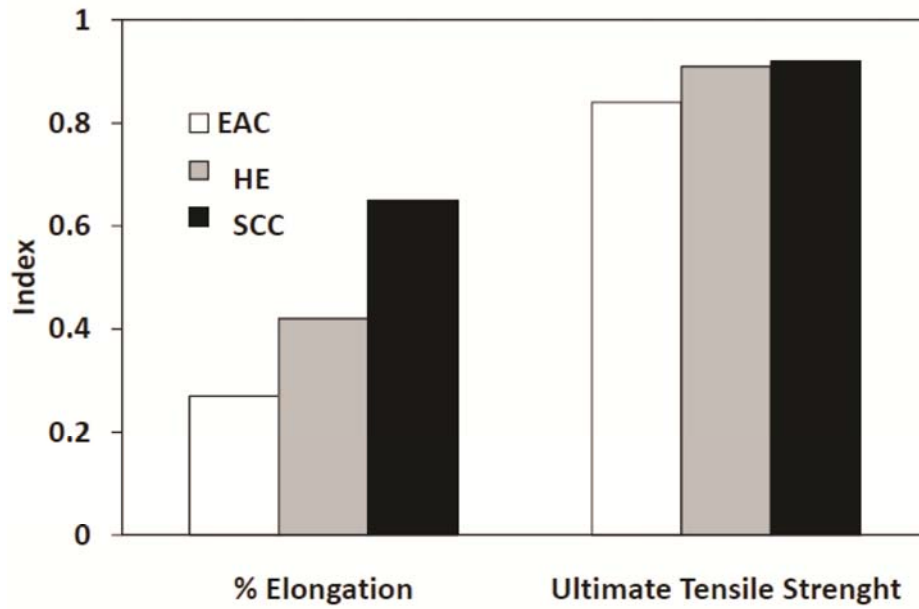
Fig. 9. Environmental assisted cracking, hydrogen embrittlement and stress corrosion cracking susceptibility indices for AZ80 alloy.

to a particular environment, and when the index approaches unity it means that the alloy is highly resistant to the particular environment. The calculated indices presented in Fig. 9 suggest that both chloride and hydrogen played a role in the EAC susceptibility of the alloy and that in fact they had a synergetic effect.
