Chapter 2 Study area and study sites

2.1 Introduction

2.3 Sampling sites

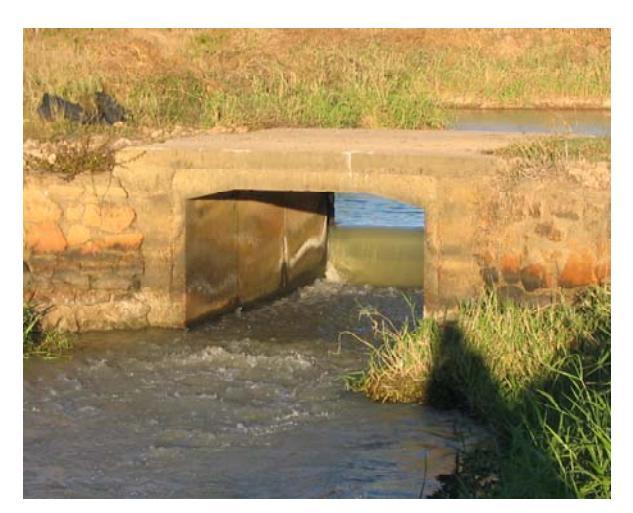
a) Culvert drop board system on Sheep Station Ck.

- Weirs and dams, drop boards and bund walls create physical barriers to fish movement, greatly reducing connectivity within the sub-catchments and reducing recruitment and dispersal pathways (Plate 2.1 a and b). Drop boards are installed into culverts at outlet points in the lagoons. The drop can be over one metre, allowing no passage of fish. Drop boards can also create a wash out below the structure which itself is a barrier even when drop boards are removed.

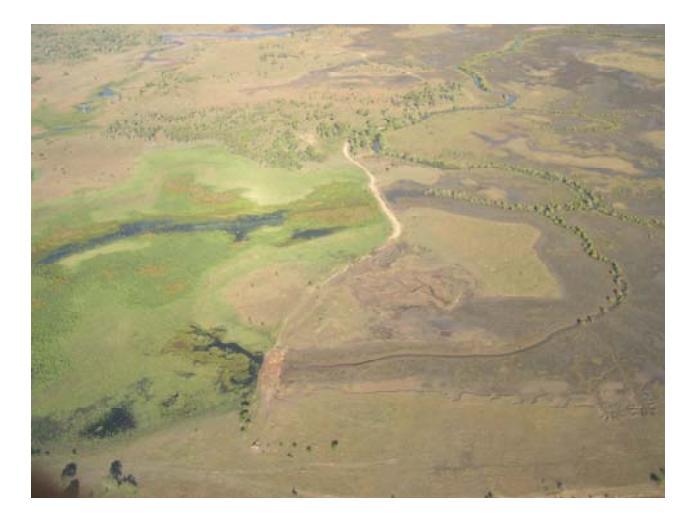
b) Bund walls on the saltwater interface of Sheep Station Ck.

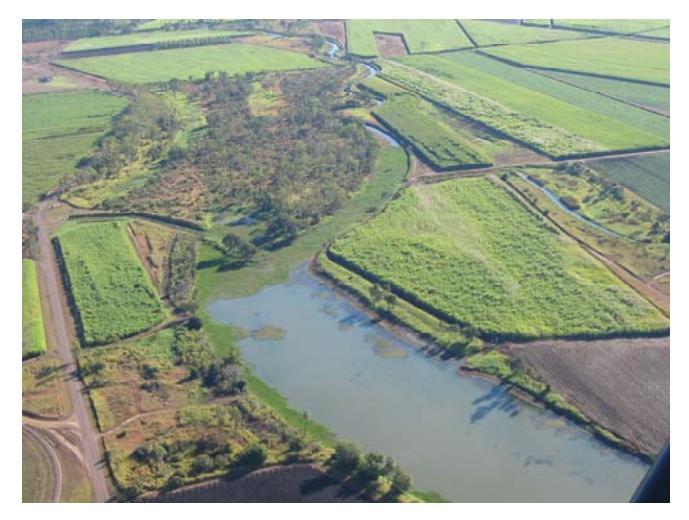
c) Weeded channels that create physical and chemical barriers to fish migration.

- Weed species such as para grass, *E. crassipes* and olive hymenachne (*Hymenachne amplexicaulis*), and native species such as bulrush (*Typha orientalis*), hornwort or duck weed (*Ceratophyllum demersum*) and rice grass (*Leersia hexandra*), have proliferated as a result of the perennial nature of the irrigation area. Increased nutrient loads have exacerbated the problem (Gutierrez *et al.*, 2000). These weeds may create both physical and chemical (hypoxia) barriers to fish movement (Plate 2.1 c). Floating weed mats block the interface between the water and air and shade out submerged macrophytes such that there is no input of oxygen to the water (Julien *et al.*, 2001), thus creating a barrier of hypoxia. The weed mats are so thick that only the largest flood events (when the Burdekin breaks its banks) can remove them (A. Darwen pers. com.). This poses its own problems in relation to flood heights and damage to infrastructure.

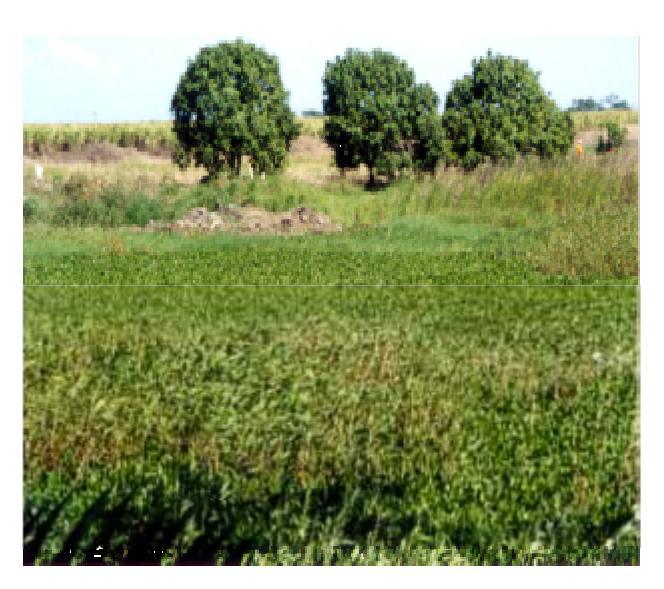
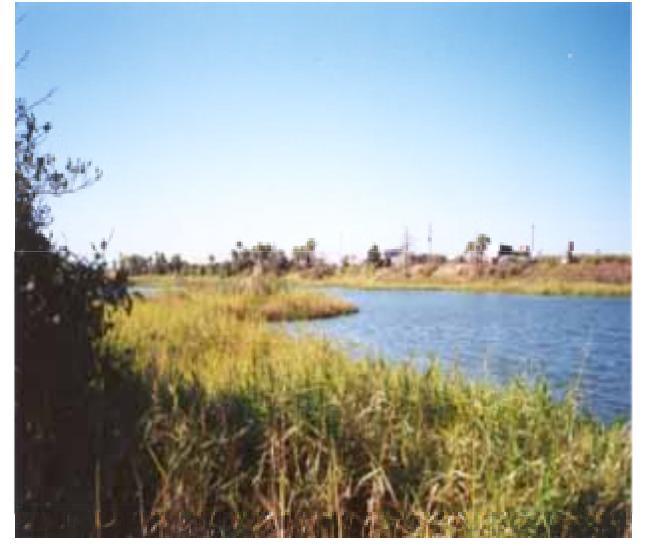
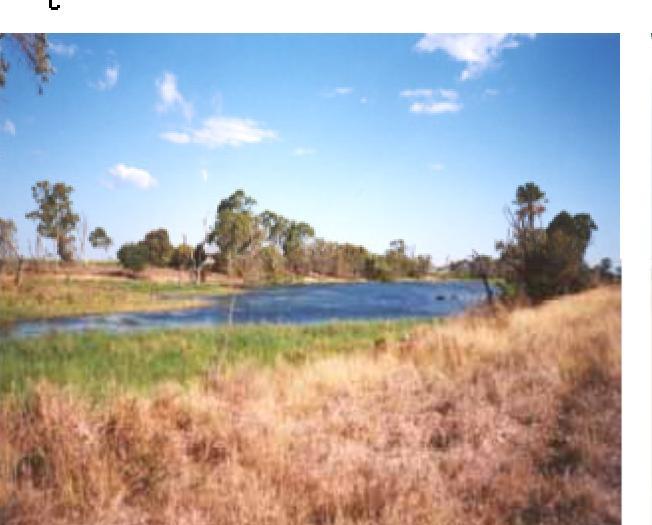
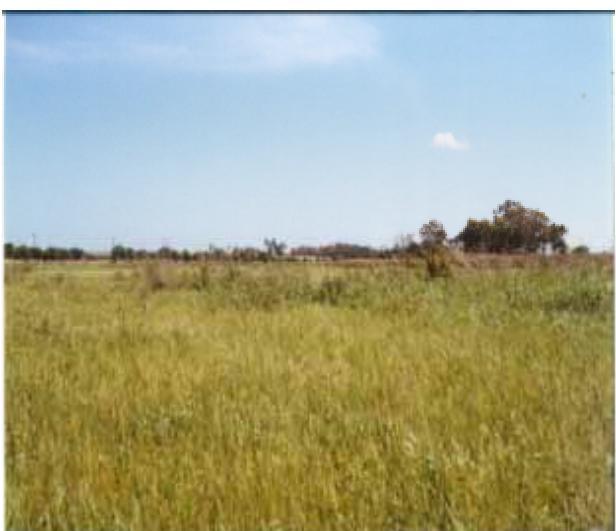
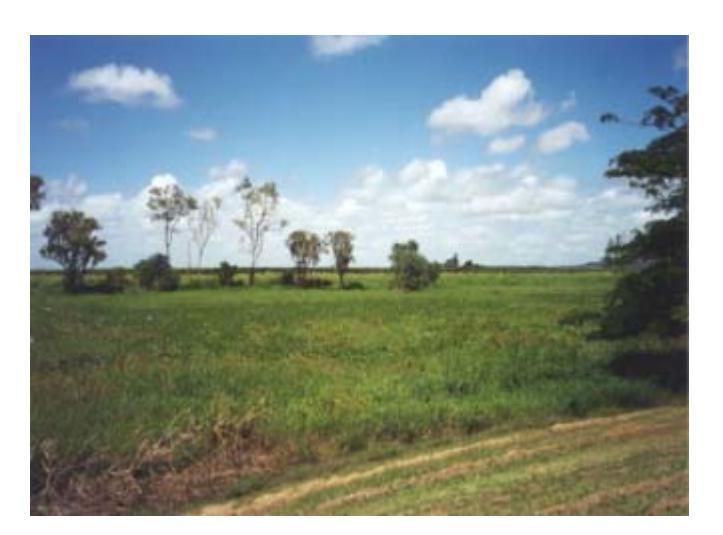
Plate 2.2 Sheep Station Ck. main sites

a) Payard's Lagoon (August 2000)

b) Dick's bank Lagoon taken from east bank looking downstream (9-August-2001)

c) Kelly's Lagoon taken from south-east end looking upstream (at 8-August-2001).

d) Gorizia's looking downstream while standing on the weed mat (2-August-2001)

e) Jack's Lagoon from west bank looking upstream (8-August-2001)

Payard's Lagoon is the second large deep water lagoon downstream of the pump station on Sheep Station Ck (Fig. 2.4). This lagoon was fully covered by weeds at the beginning of the project and was cleaned out in August 2000 (Plate 2.2a). No data was collected on habitat before weeds were removed so data here show estimates (Table 2.1). The effects of weed removal are discussed in Chapter 5. Payard's Lagoon is a large lagoon with a length of 1140 m, 80 m wide and a maximum depth of 4 m. The lagoon has a north-south aspect. The western bank has a steep gradient and is up to 5 m high. The eastern bank has a smaller gradient and would be the overflow pathway in times of flood. The lagoon has cane up to the riparian zone on the eastern side, and in the inlet mangoes have been planted along the bank. The western bank has remnant riparian vegetation with goats and cattle grazing the top end; a road runs between the cane and bank. Table 2.1 show the habitat condition and community structure of the riparian and instream habitats. Silts dominate the substrate.

Dick's Bank Lagoon is approximately 2 km downstream of Payard's. This is one of the largest lagoons on Sheep Station Ck (Fig. 2.4, Plate 2.2b). The lagoon is 1450 m long by 140 m wide with a maximum depth of 5 m. This lagoon also has a north-south aspect where the west bank is the steep high bank and the east bank is the overflow at the outlet. The lagoon is mostly incised deeply in the banks except at the downstream end where floods would overflow to the east (towards the Burdekin). Silts dominate the substrate. This lagoon is also fully surrounded by sugar cane. There is a small patch of remnant riparian habitat at the upstream end on an island between the main inlet channel and the overflow inlet channel. Aside from this patch, most of the lagoon has been cleared and cane grown to the banks. The west bank has a road and houses along it. In early 2001, however, money was given to the EPA to establish revegetation sites along Sheep Station Ck and Dick's Bank was the first site for the project, so habitat is being restored, but was not considered in the collection of data for this project. Riparian and instream habitat and condition and presented in Table 2.1. Of major significance to this site is a direct link to Castelanelli's Lagoon, which has very high habitat and remnant values which contributed to fish assemblage recovery in this site (Fig. 2.6 and Chapter 4).

Kelly's Lagoon is "low impact" lagoon for Sheep Station Ck (Fig. 2.4, Plate 2.2c). It was selected as it is within the catchment but is off the distribution system of the NBWB, only receiving back water which maintains the water level. There is only one landholder on the lagoon and he has made efforts over the years to keep out weed infestations (winning the 2002 Landcare award). The lagoon is between Payard's and Dick's Bank and just west of the Sheep Station main channel. At times of flood, water flows through Kelly's from an overflow on Sheep Station Ck Kelly's is a small wash-out lagoon in an overflow pathway. The lagoon is 700 m long by 80 m wide with a maximum depth of 3.5 m. The lagoon has a north-south aspect where the east bank is high gradient and the west bank is low gradient and would overflow at moderate to high floods. Silts dominate the substrate. The channel downstream has been leveled and is now cane land. The lagoon is used for grazing and has a house on the east bank, therefore no cane is planted in the riparian areas of the lagoon. Unlike the other lagoons in Sheep Station Ck the water in this lagoon clears quickly after flood events and has the characteristic "black water". Riparian and instream habitat and condition are presented in Table 2.1.

This site is 4 km downstream of Dick's Bank (Fig. 2.4, Plate 2.2d). The site is one of the most heavily degraded with no open water except at the inlet. However, this lagoon has also been cleaned out since the beginning of the project (August 2002). As with Payard's only the preclearing data will be presented. This site also has the least riparian vegetation. The lagoon has an aspect of north-south. It is a large lagoon being 1400 m long by 300 m wide. The substrate is dominated by silt. The east bank has a very low gradient and due to high water levels maintained by irrigation water, the width of the lagoon is exaggerated and there is an area of shallow water (50 cm or less) on this bank that is 100 m wide. Due to this low flooded area the cane is planted about 300 m from the lagoon on the east bank. The west bank is a steep gradient about 3 m high, mostly vegetated bymango trees and some paper bark revegetation. The site is surrounded by cane fields and has two houses on the west bank with a road between the cane and lagoon on this bank. The maximum depth is 3 m, however most of the lagoon is 2 m or less. The weed mat was so developed that people could walk over it. Riparian and instream habitat and condition are presented in Table 2.1.

This site is 1.5 km downstream of Gorizia's (Fig. 2.4, Plate 2.2e). It is the most degraded site, with full weed cover of the lagoon. The fish sample site was a small open water area at the downstream end, 70 m long by 30 m wide with a maximum depth of 1.5 m. The substrate is dominated by silt. The whole of the lagoon is 1000 m long by 50 m wide. At the time of sampling no depth data was taken due to lack of access (weed infestation). The riparian area on the east bank is grazed and comprises mainly introduced grasses. The west bank is steep gradient about 3 m high and contains most of the remnant riparian trees. The east bank has a low sloping gradient with a large shallow area. There is a small patch of *Livistona* palms with sparse trees along this bank. This lagoon has also been cleaned out but no post-clearing data was taken. Riparian and instream habitat and condition are presented in Table 2.1.

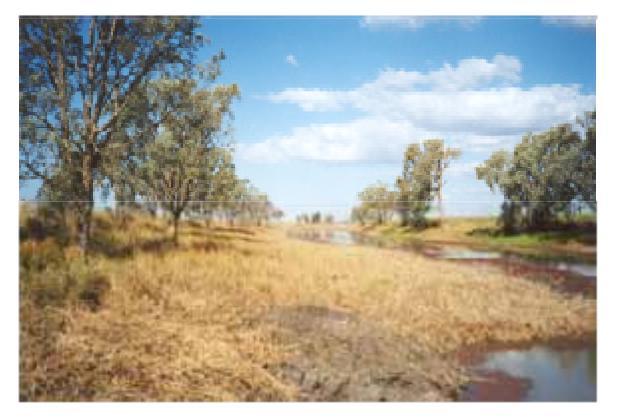
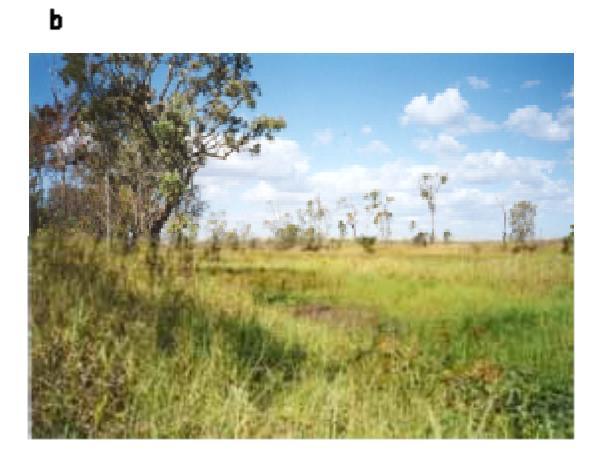
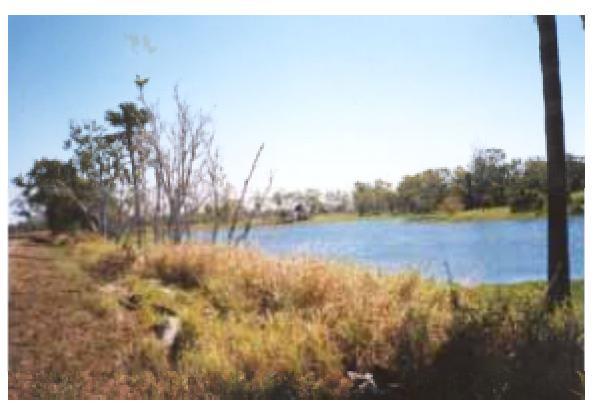
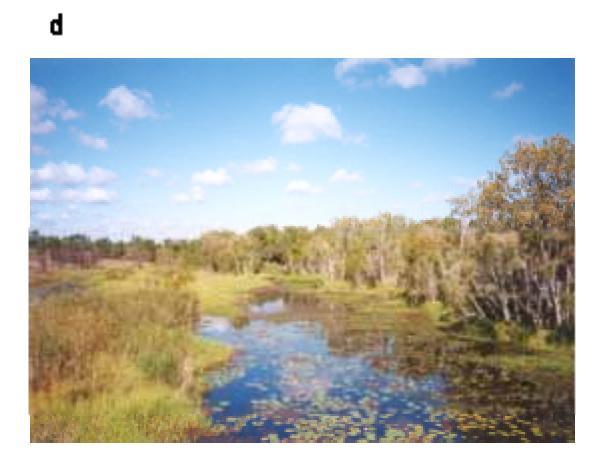
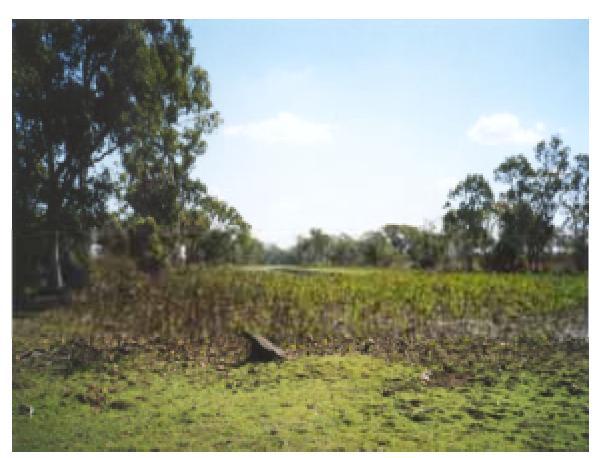
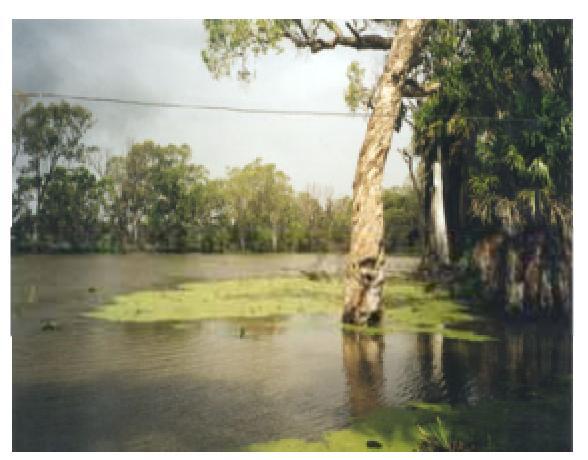
Plate 2.3 Warren's Gully main sites

a) Fowler's Lagoon looking downstream from pump station during low flow (7-August-2001) (NB. All the para grass has been sprayed)

b) Princess Lagoon looking downstream from northern bank (7-August-2001).

c) Munro's Lagoon looking upstream at the inlet channel from the south bank (9-August-2001).

d) Saltwater Lagoon taken from the south bank looking upstream (8-August-2001).

e) Inkerman Lagoon looking upstream from bottom end (7-August-2001). (NB. The lagoon is drying back because there is no artificial top up from irrigation water).

f) Inkerman during the November 2001 floods looking downstream from the boat ramp.

This is the most upstream site and is the first lagoon that occurs on Warren's Gully (Fig. 2.5, Plate 2.3a). The site is a very narrow channel – like lagoon, which would not be perennial without Water Board pumping. This site is shallow with a maximum depth of 2.5 m and a silt substrate. The site is 700 m long by 30 m wide with an east-west aspect. Both the north and south banks are of medium gradient about 2 m high. There is cane to the banks on both sides of the lagoon and flows are typically high with high turbidity. The site has moderate to high impacted habitats. Riparian and instream habitat and condition are presented in Table 2.2.

Princess Lagoon is located 4 km downstream of Fowlers (Fig. 2.5, Plate 2.3b). This site is the most degraded of the sites in the SBWB area. The site is small with a length of 580 m by 50 m wide, although a large channel runs upstream for another 1000 m but was not considered for this

Munro's is a large lagoon 2 km downstream of Princess (Fig. 2.5, Plate 2.3c). This lagoon is 1060 m long by 100 m wide with a maximum depth of 4.5 m. The substrate is dominated by silt and sand. The aspect of the lagoon is east-west with medium to high gradient banks about 2 m high. The irrigation channel enters the lagoon on the north bank in the middle. There is a large infestation of *E. crassipes* and grass (in the upstream section) 50 m upstream of the inlet. Cane is planted on both banks, but the upstream section has a wide shallow area where the channel widens. The cane is planted on the levees and the lower lying area within the channel still has some vegetation. Riparian and instream habitat and condition are presented in Table 2.2.

This site was selected as the control site for the SBWB area (Fig. 2.5; Plate 2.3 e and f). This site receives no irrigation water at all and is on Saltwater Ck catchment above where Warren's Gully overflows into the system. The natural hydrology and water quality data indicate strong groundwater relationship (Chapter 3). The lagoon is large, 1500 m long by 130 m wide with a maximum depth of 5.5 m, and is located 200 m to the south of Munro's. The substrate is dominated by silt with some sand, and a rock bar of granite bedrock in the top end. The aspect is east-west and both the banks have a low gradient with a height of 1.5 m. Cane is grown at the upstream end on the north bank and is planted within 20 m of the bank. Horses and, at times, cattle graze the remainder of the lagoon, but the riparian zone is mostly intact and has high species diversity. This lagoon has high remnant habitat quality and instream habitat diversity. Riparian vegetation and instream habitat and condition are presented in Table 2.2.

This is the most downstream site, 3 km downstream of Inkerman (Fig. 2.5, Plate 2.3d). Water from Warren's Gully overflows from Washpool Lagoon on Warren's Gully, into Saltwater Ck 500 m upstream of this site. Water levels are maintained by this overflow; however, the SBWB diverted the overflow in 2002 and the site almost dried out before seasonal rain started to fill it again (B. Lowis, pers. com.). The lagoon is large but shallow, 1000 m long by 50 m wide with a maximum depth of 2 m and a silt/sand substrate with patches of bedrock. The south bank has a medium gradient and is 2 m high, while the north bank is low shallow gradient to 1 m high. The riparian zone on the north bank is State-owned and is a Main Roads easement, with intact buffer. The south bank is grazed and moderately disturbed. Riparian and instream habitat and condition are presented in Table 2.2.

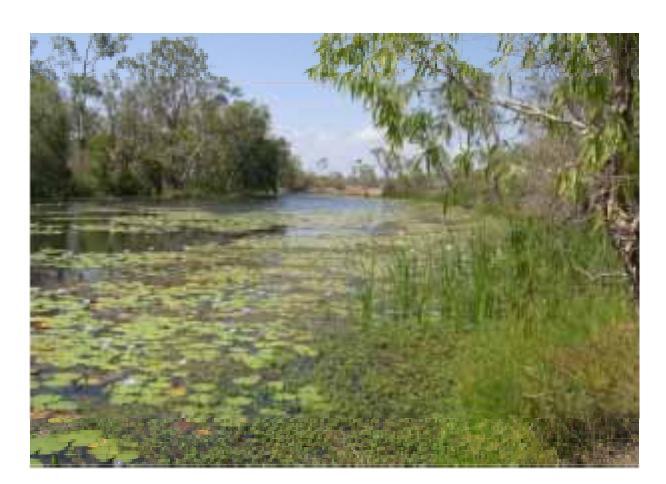
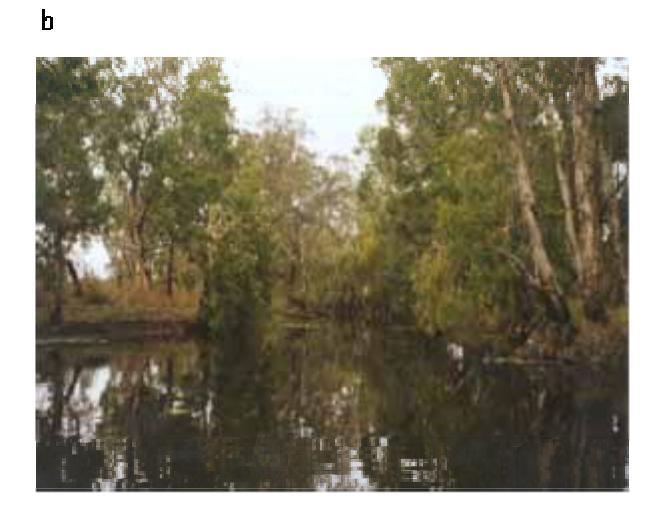
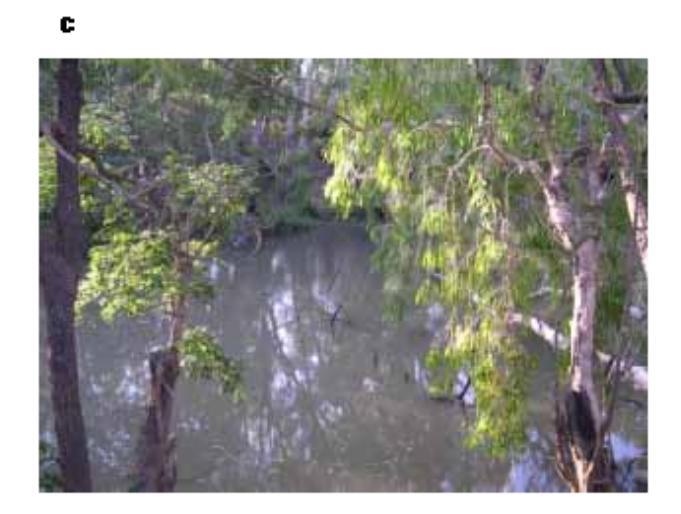
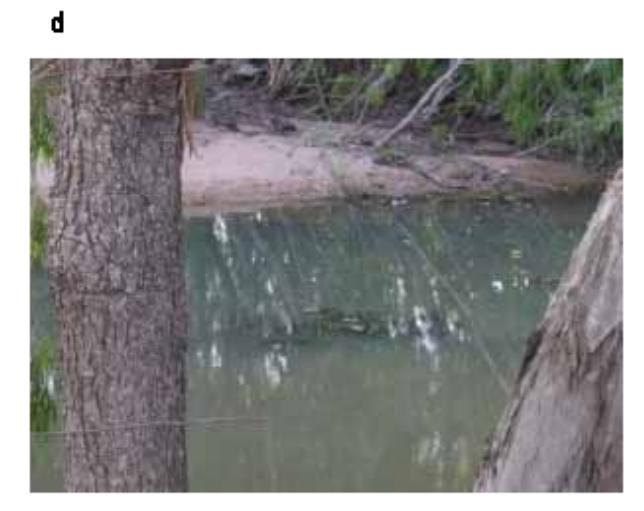
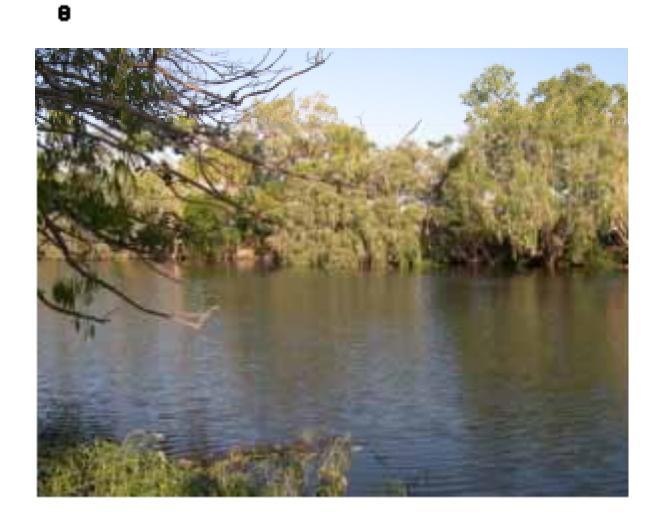
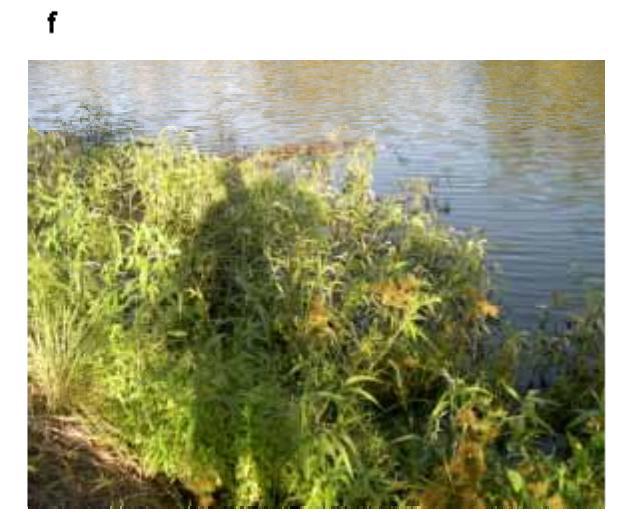
Plate 2.4 Barratta Ck. sites

a) Woodhouse from the east bank looking downstream on the main lagoon (30-January-2002).

b) Woodhouse clear water channel downstream of the lagoon proper (22-August-2002).

c) Barratta Ck. Allen Rd. Taken from the south bank showing the various types of habitat (30-January-2002). The images were taken midway from Allan Rd. to the Fork.

d) Clay Hole taken from south Bank showing intact riparian and instream snags (22-August-2002).

e) & f) West Barratta from west bank 500m downstream of highway. Images show riparian trees (e) and dominant instream habitats (f) (30-January-2002).

This is the most upstream lagoon on the Barratta Ck (Fig. 2.2, Plate 2.4 a and b). The lagoon is on Woodhouse Station and used for water supply and grazing. The lagoon has a north-south aspect with medium gradient bank to 2 m high. The riparian zone on the east bank has been more disturbed by clearing than the west bank, and there is a cleared area on both banks of the lagoon in the middle due to power line crossing.

This site is located on a tributary of the Barratta Ck, Pelican Ck 2 km upstream of Allan Rd. (Fig. 2.2, Plate 2.4c). The lagoon is on leasehold grazing lands with tailwater running into the creek upstream of the site. The lagoon is medium – sized, 800 m long by 40 m wide with a maximum depth of 3 m. The lagoon has a north-south aspect with high gradient banks 2 m high. Due to tailwater the site is perennial. This site has very low cover of submerged macrophytes and the dominant instream habitat is woody debris and leaf beds, with a sand silt substrate. There is still good connectivity through to the Barratta and estuary which shows in the fish surveys. Riparian and instream habitat and condition are presented in Table 2.3.

This is a lotic site (Fig. 2.2, Plate 2.4d). There were two distinct reach habitats namely, runs and pools. The area sampled was 6000 m long by 30 m wide with a maximum depth of 4 m, but averaging 2 m. The riparian buffer is all leasehold lands set aside by Department of Natural Resources as habitat and wildlife corridors (ACTFR, 1994). The site has very minimal impact aside from receiving tailwaters. There are, however, patches of *Hymenachne* establishing on the banks which may become a riparian pest if not controlled. The substrate is predominantly sand with leaf litter beds, large woody debris and silt in the deeper pools. Riparian and instream habitat and condition are presented in Table 2.3.

This is one of the largest sites, running 4000 m by 70 m wide with a maximum depth of 6.5 m, averaging 4.5 m (Fig. 2.2, Plate 2.4 e and f). The substrate is mainly sand with leaf litter, large woody debris and silt. This is a channel lagoon having lentic and lotic characteristics, although it lacks any run or riffle habitat. The aspect is north-south with high gradient banks up to 3 m high.

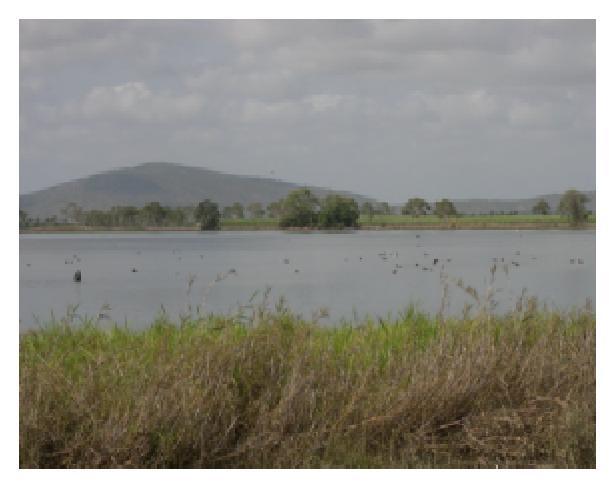
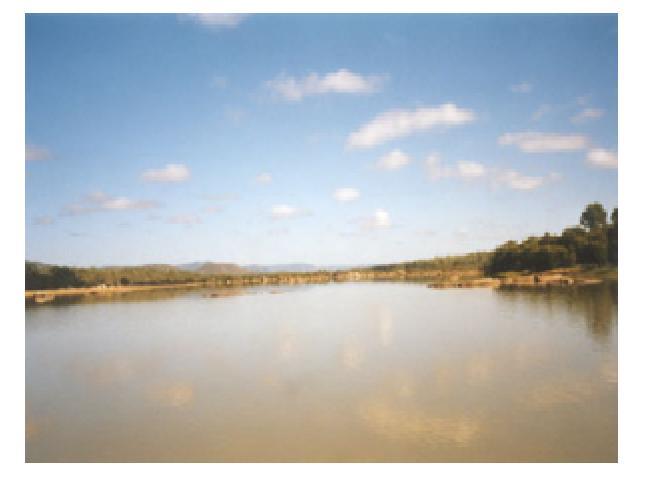
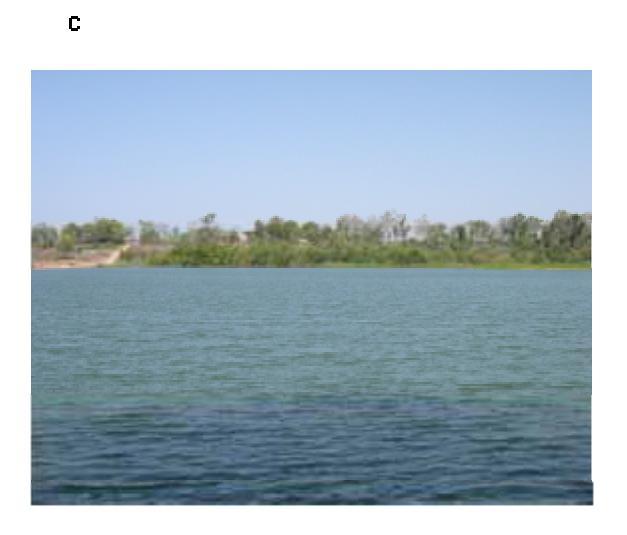
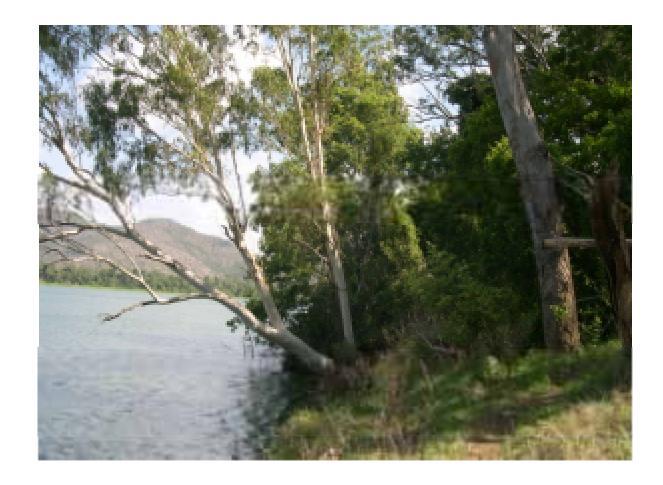
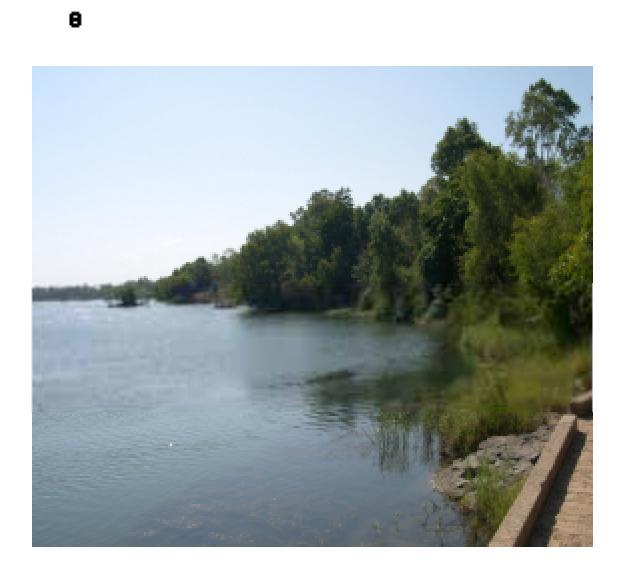
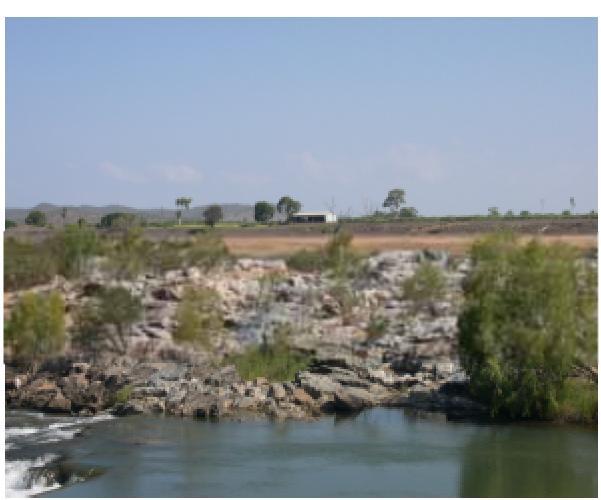
Plate 2.5 Burdekin River sites and Horseshoe Lagoon

a) Horseshoe Lagoon Taken from the north bank looking upstream (30-January-2002).

b) Bowen River looking downstream to the junction with the Burdekin (01-September-2002).

c) Clare Weir looking east from the west bank

d) Clare Weir looking upstream on the west bank (30-January-2002).

e) The Rocks looking upstream on the west bank.

f) The Rocks east bank (30-January-2002).

This is the only site that is a characteristic shallow floodplain wetland (Fig. 2.2, Plate 2.5a). Horseshoe Lagoon is a large shallow basin, 1500 m long by 500 m wide, with a maximum depth of 3 m, averaging 1.5 m. The substrate is mainly silt with patches of sand. The site is characterised by dense growth of macrophyte beds and has very limited riparian habitat. *Cabomba carolinensis* has been introduced and is taking over as the dominant species. This site now receives tailwater from channels and cane fields upstream. Previously this lagoon would have dried up in most years except for the very deepest section. It is now maintained at bank full most of the year. The lagoon drains almost directly into the Haughton Estuary, so has a very good connection with the saltwater reaches. Riparian and instream habitat and condition are presented in Table 2.3.

This is the most upstream of all sites selected and is in the upper-most reaches of the defined floodplain (Fig. 2.2, Plate 2.5b). The Bowen River is the southern catchment of the Burdekin River, draining the Eungella Range. This site is 80 km from the river mouth and is well above Clare Weir. The Bowen is the clear-water tributary of the Burdekin, draining granitic ranges. The substrate at the site was sand, granitic bedrock, macrophyte beds and leaf litter beds. There is also a weir at Collinsville upstream of this site. The landuse at the site is cattle grazing and there is no exclusion from the watercourse. Both the banks have a moderate to high gradient with

This is another river site and is the holding storage above the weir (Fig. 2.2, Plate 2.5 c and d). It is a large area and only the habitat just upstream of the weir was surveyed. The river is 400 m wide at this point and flows in a north-south direction. The depth is up to 5 m with a sand, silt and bedrock substrate. The habit of the site has changed from lotic to a more lentic reservoir. The riparian habitat is intact and the eastern bank is grazed. Cane is planted on the levee of both banks. This is where water from the BFD is stored for release downstream to the water boards and BRIA. Riparian and instream habitat and condition are presented in Table 2.3.

At this site there is a small weir to lift water for the Sheep Station Ck pump station (Fig. 2.2, Plate 2.5 e and f). The site is 315 m wide. The maximum depth is 3.5 m but averages less than 2 m. The substrate is dominated by sand and granite bedroCk Flows here are moderate to fast due to releases from the Clare Weir. The river flows north-south and the banks both have a high gradient but the east bank is more gradual. The banks were 15 m or more high. Cane is grown on the levees of both sides, although the west bank is highly impacted by clearing with no riparian trees left. Riparian and instream habitat and condition are presented in Table 2.3.
